HUMBOLDT COASTAL RESILIENCY PROJECT  
AND  
CLIMATE READY PROJECT

SUMMARY DATA FOR CROSS-SHORE TRANSECTS  
WINTER 2016-SUMMER 2020

Andrea Pickart and Candace Reynolds, U.S. Fish and Wildlife Service,  
and Ian Walker, U.C. Santa Barbara

July 2021

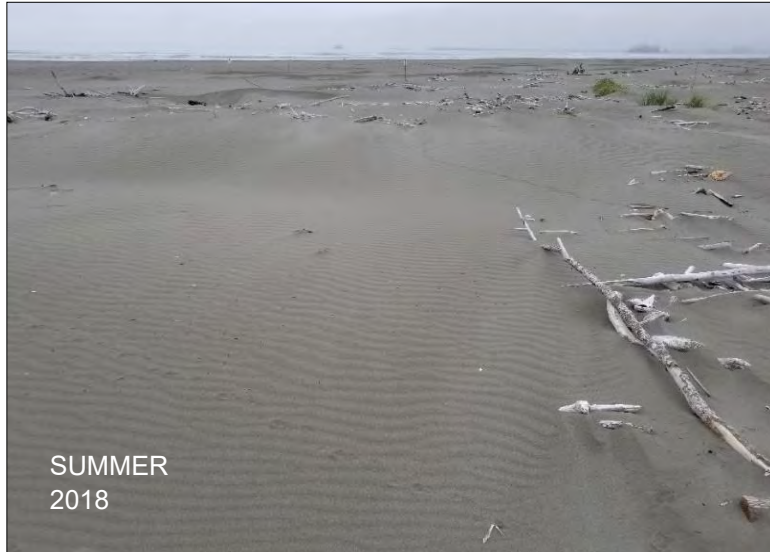
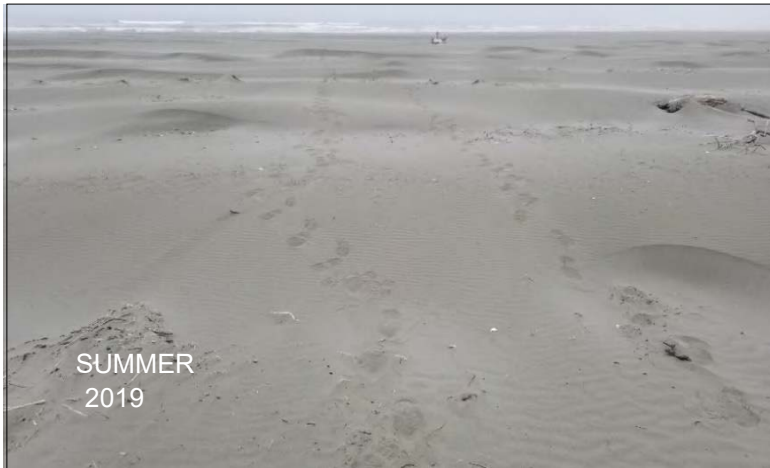
## Little River Transect 1

Upper beach.

View northwest, at 328 m,  
illustrating transverse dunes  
on the upper beach forming  
annually in summer.

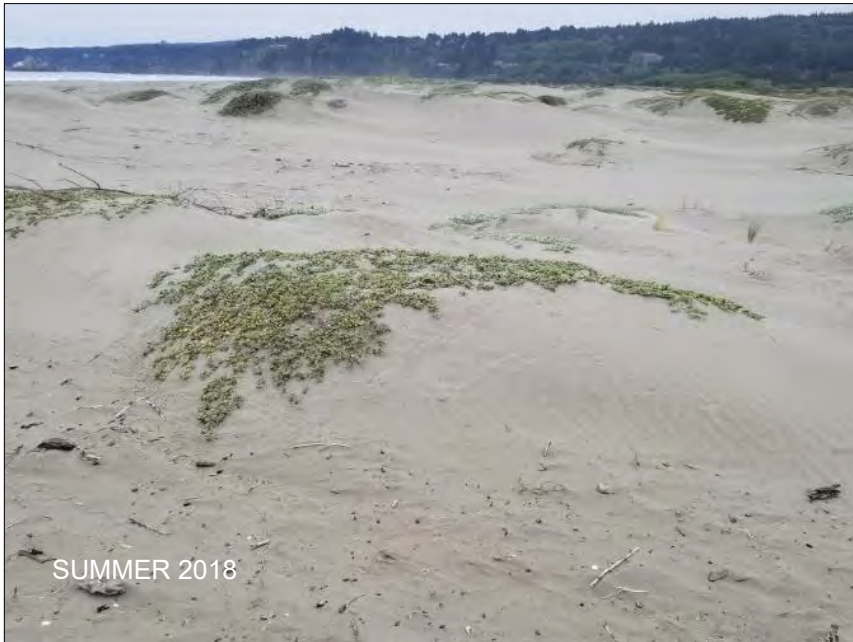
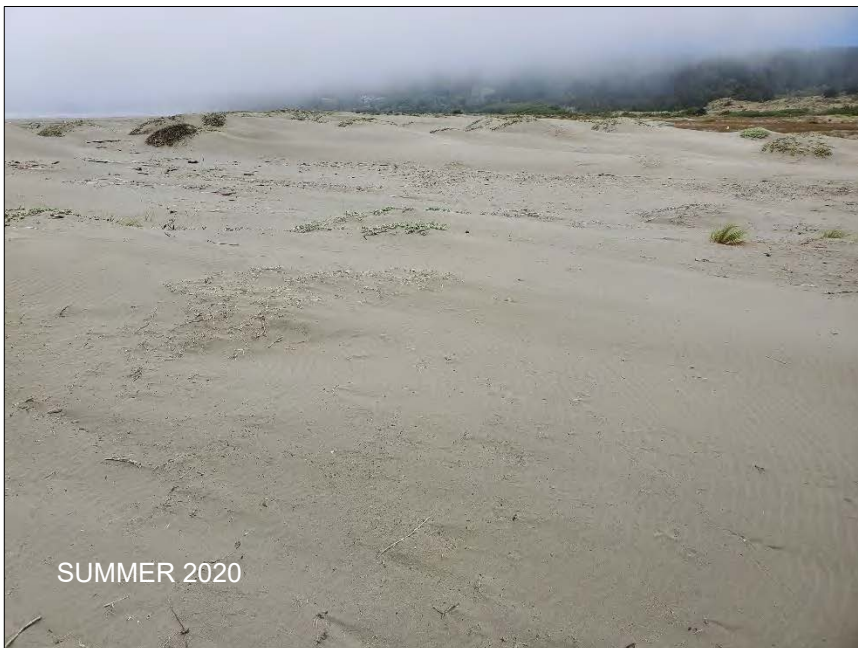
## Little River Transect 2

Foredune crest  
View north at 208  
m (foredune crest)  
showing deflation  
of nebkha

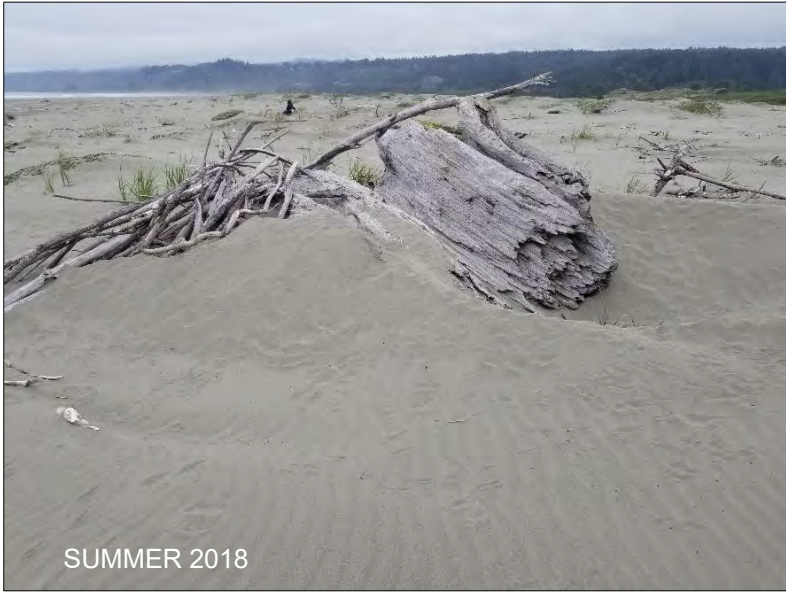
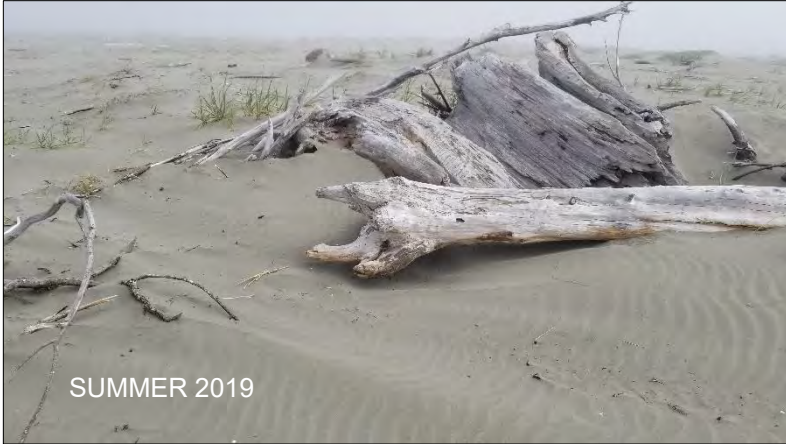
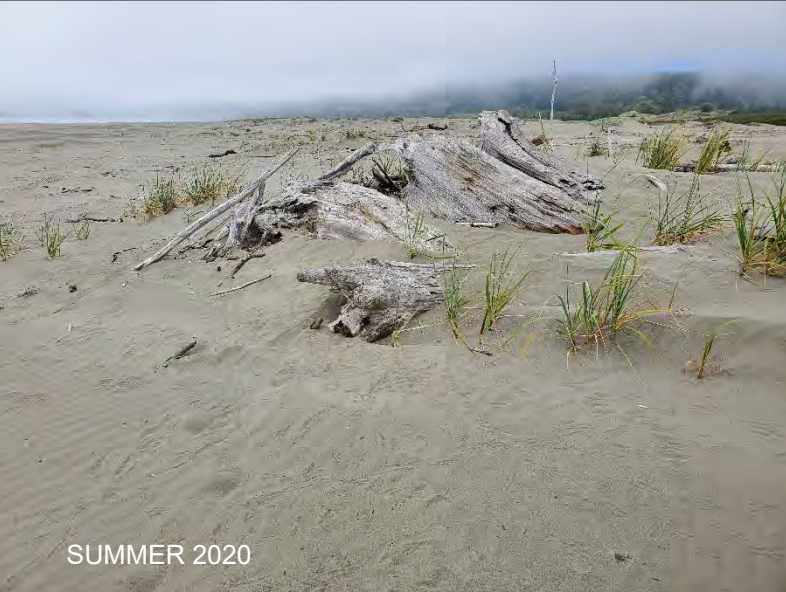
Little River Transect 3

View north at 322  
(foredune base) showing  
excavation/reburial of wood  
and spread of *Ammophila*.

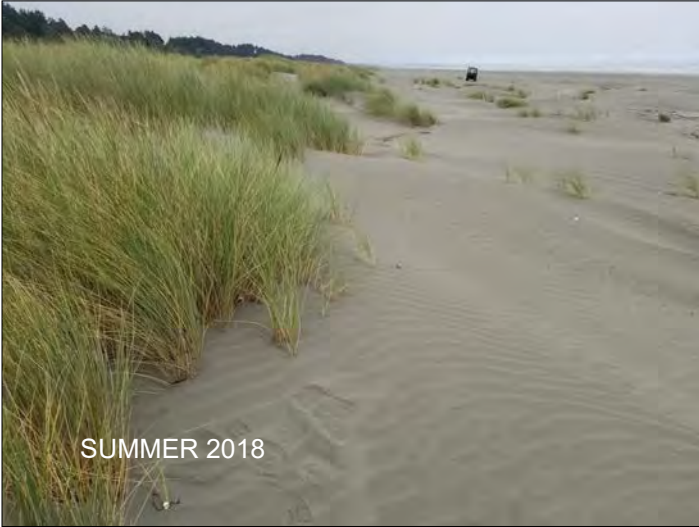
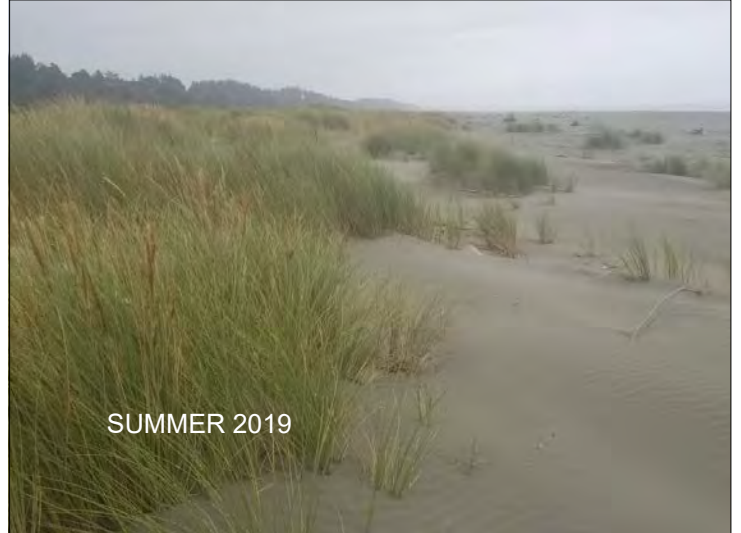
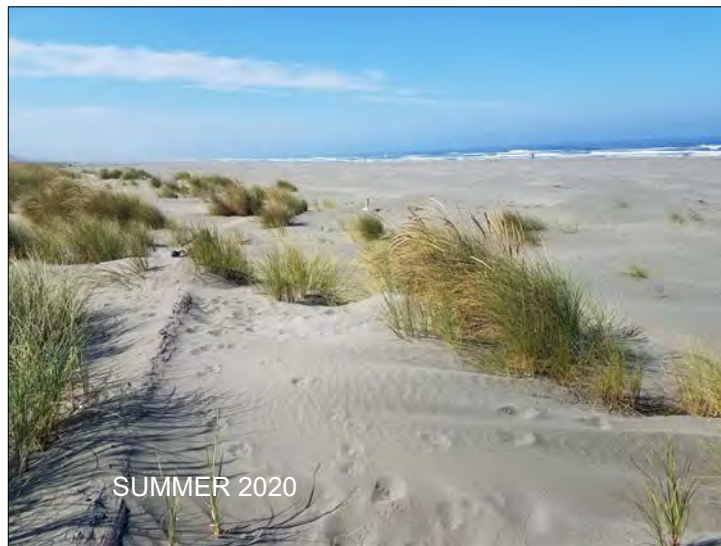
## Little River Transect 4

View south at 230 m (foredune base)

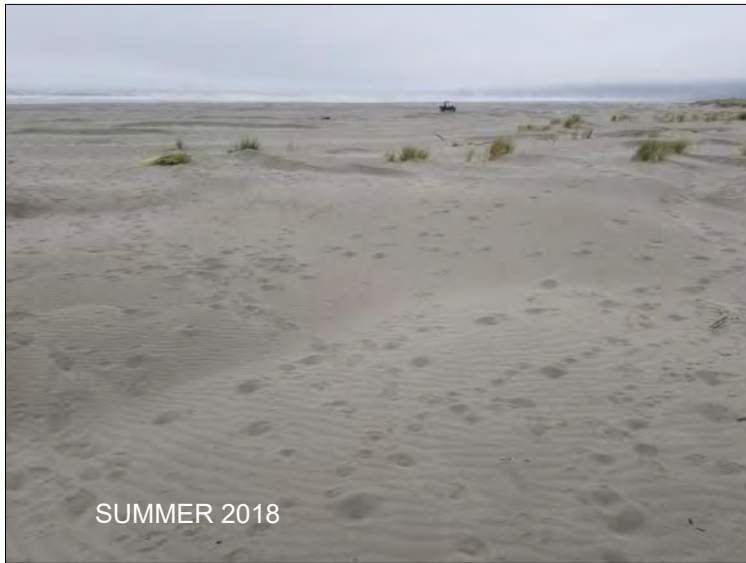
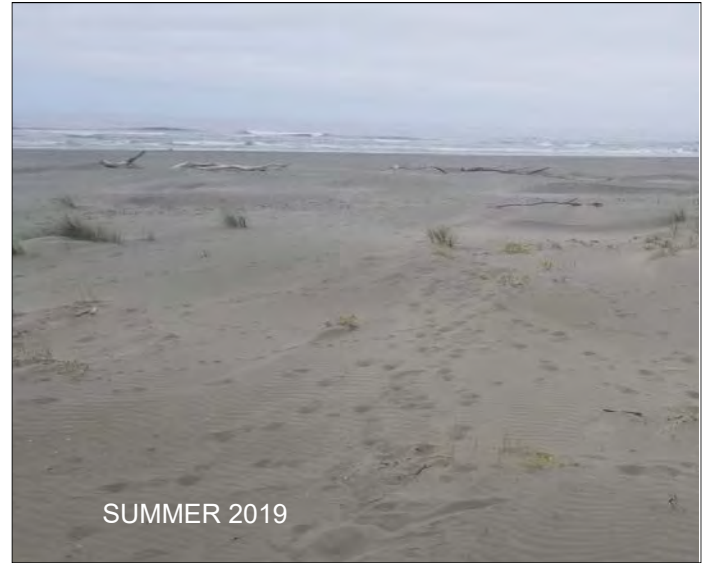
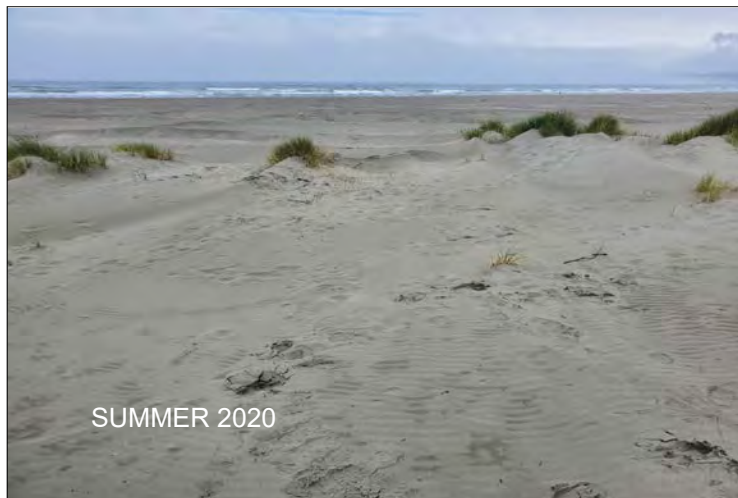
## Little River Transect 5

Photos taken at 224 m from the crest of the incipient foredune show deposition and expansion of vegetation.

Notes: Similar to Transect 4, Transect 5 (located in the unrestored portion of Little River State Beach) is characterized by a broad *Ammophila* backshore/incipient foredune that forms transverse dunes during summers. The incipient foredune experienced up to 1 m of deposition between summer 2016 and summer 2020 (see photos below). There is an established, two-peaked *Ammophila* foredune separated from a landward relict foredune by a foredune swale, and a deflation plain separates these from an older, landward, relict foredune at approximately 60 m. Overall, there was net deposition on the backshore and incipient foredune over the course of the study, while the backdune remained stable.

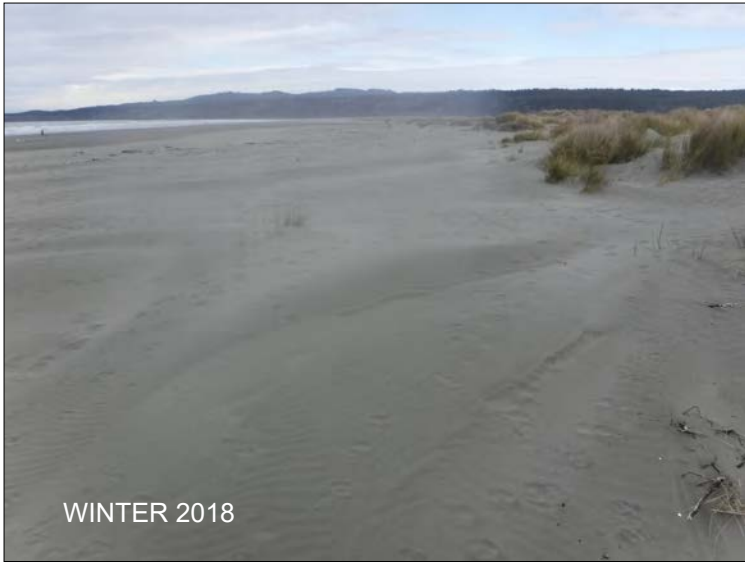
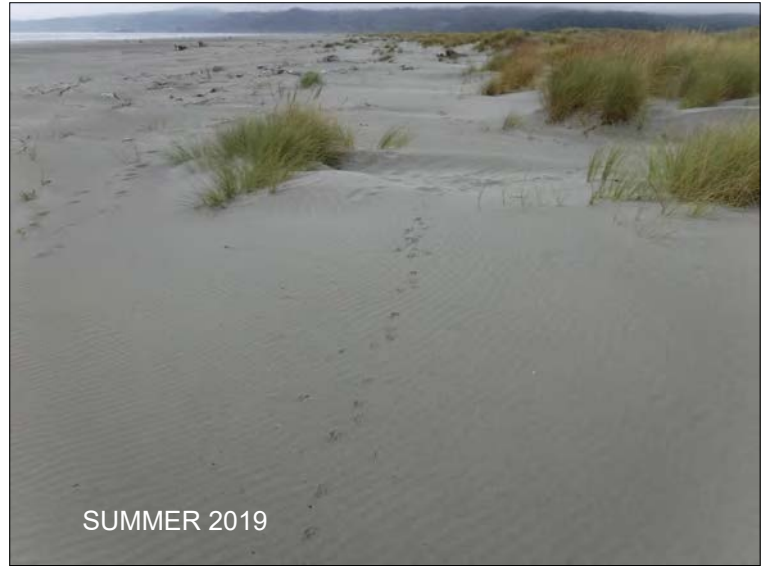
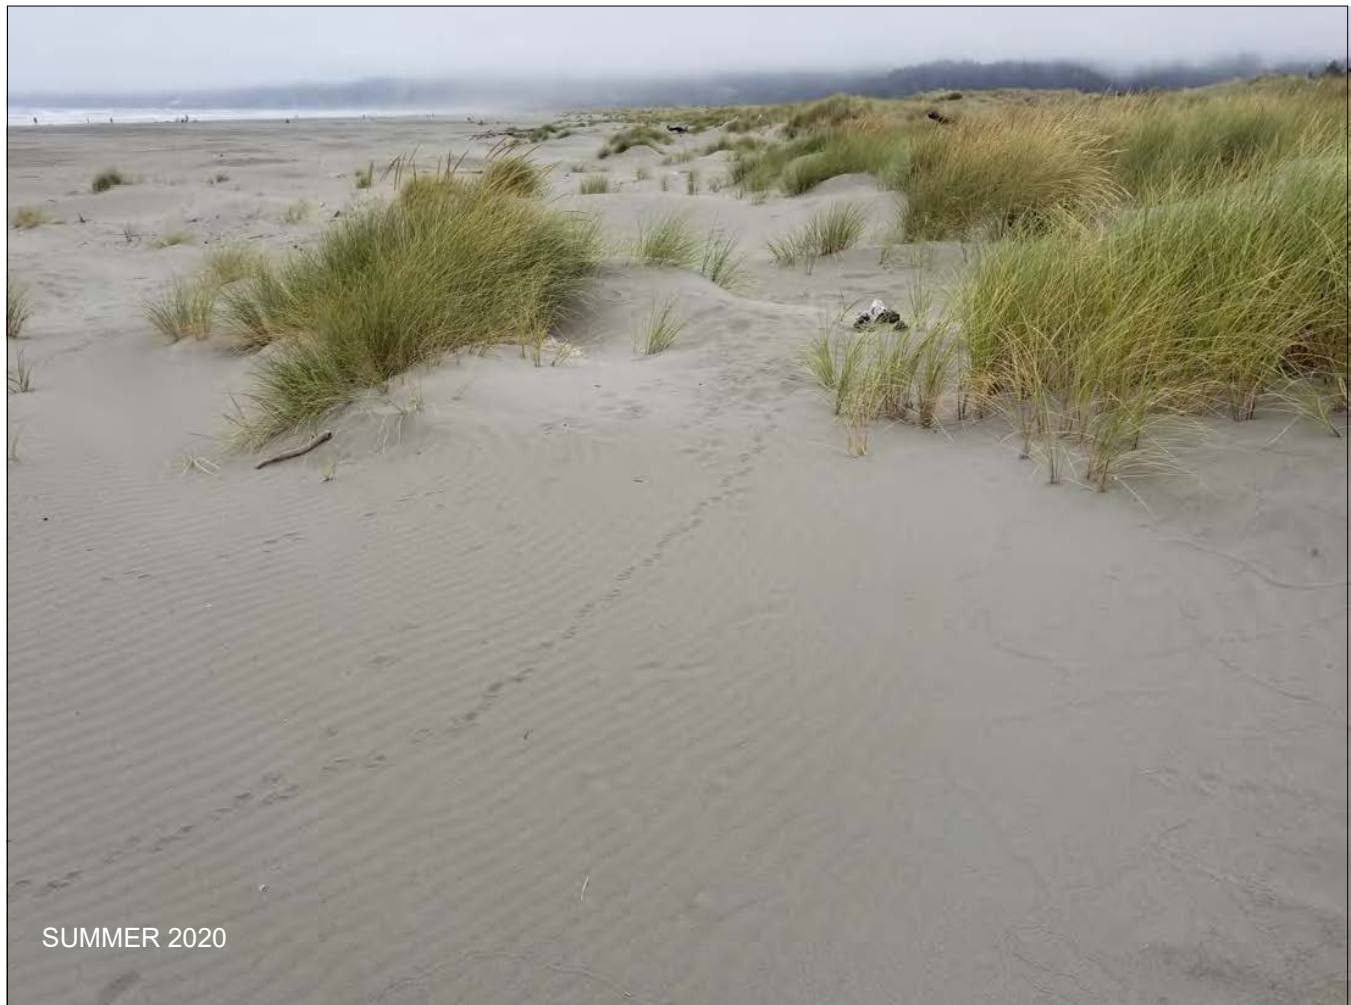
## Clam Beach Transect 6

View north from foredune base at 204 m,  
showing accretion of incipient foredune

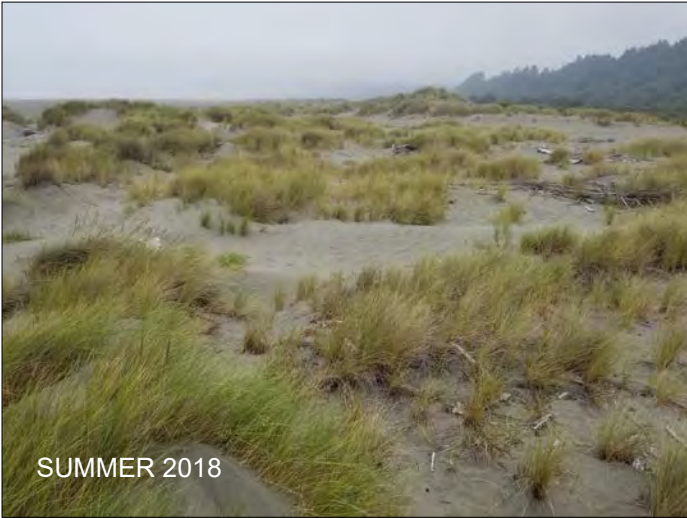
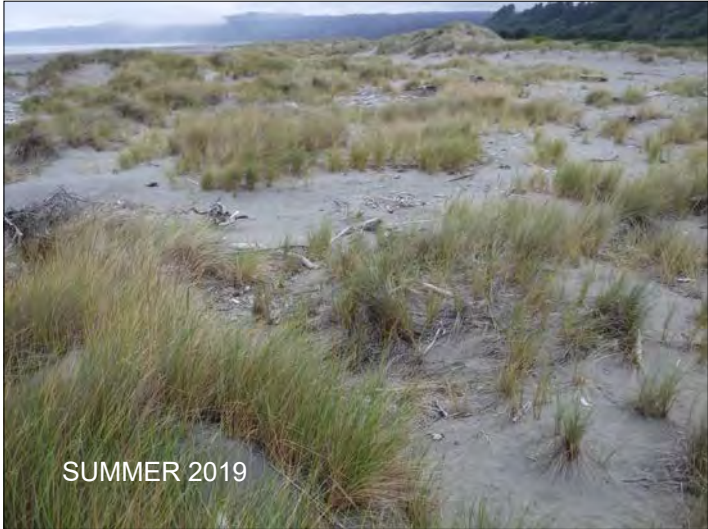
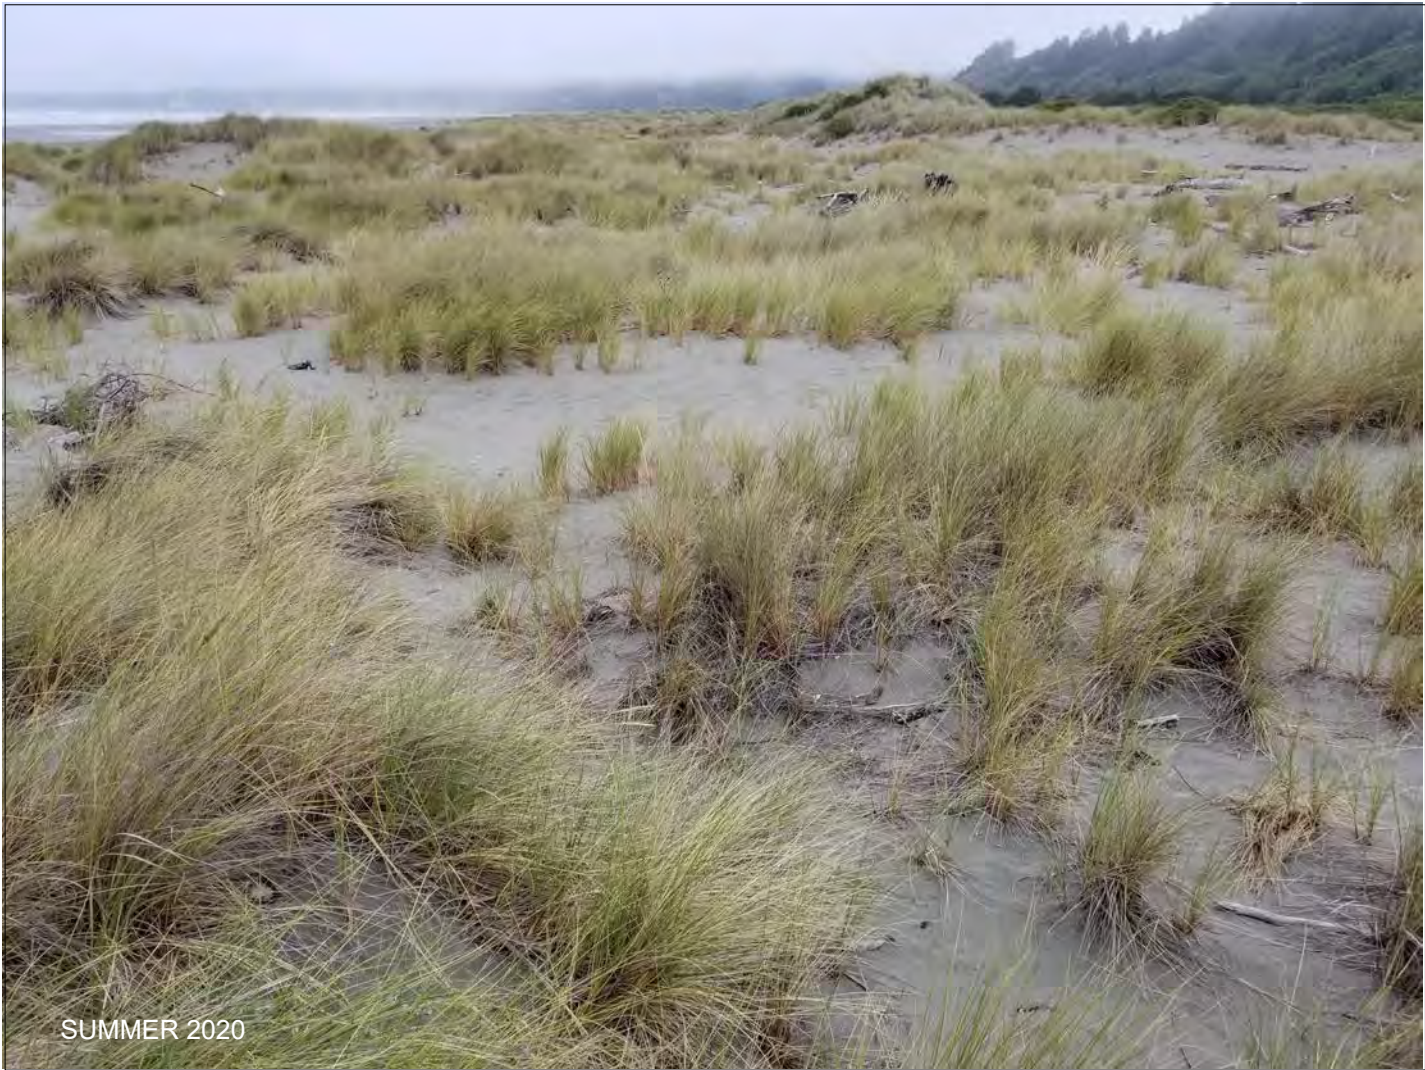
Clam Beach Transect 7

View north at 108 m (foredune crest)

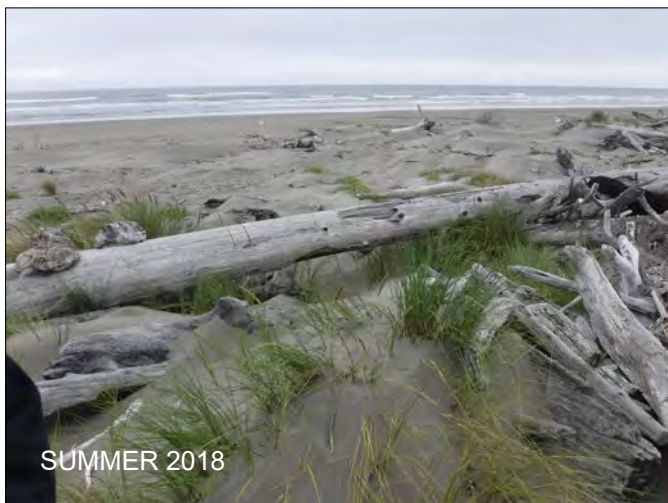
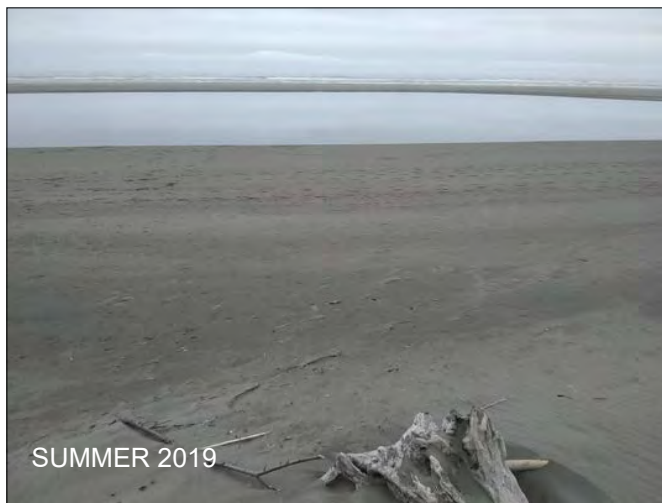
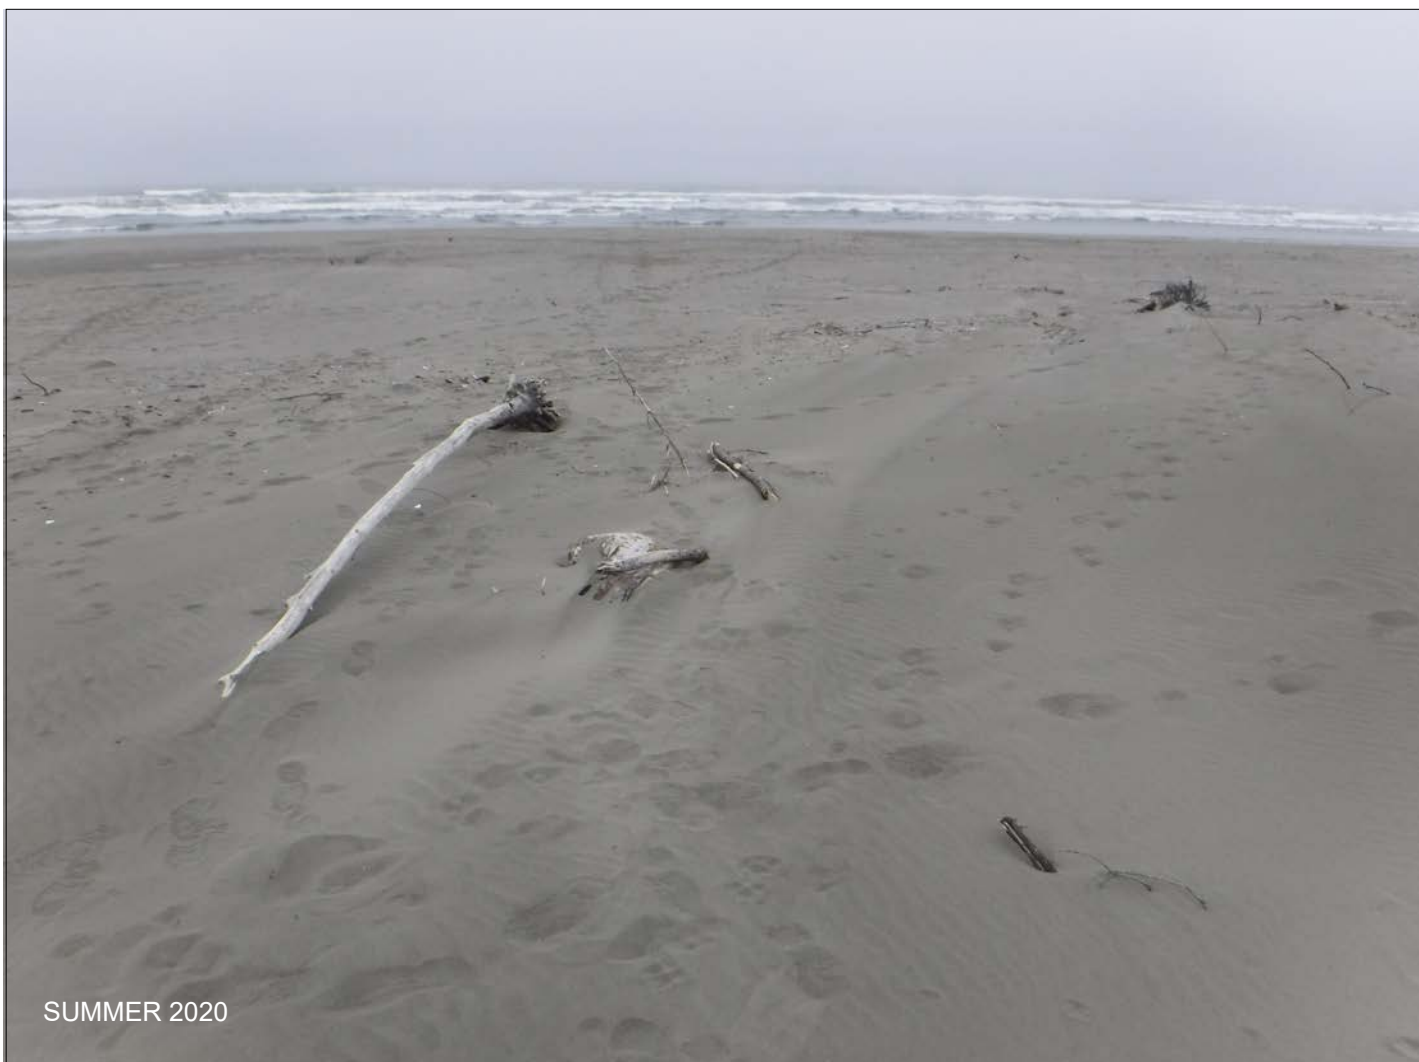
# Clam Beach Transect 8

Notes: This transect is located north of the mouth of the Mad River and represents a dynamic area. The incipient foredune present at the start of the surveys was completely eroded when the river migrated northward, with a smaller incipient foredune forming behind it at 42 m. Over the course of the study the incipient foredune was removed and a new one began to form 40 m eastward.

Clam Beach T8 View northwest at 58 m (Incipient Foredune)

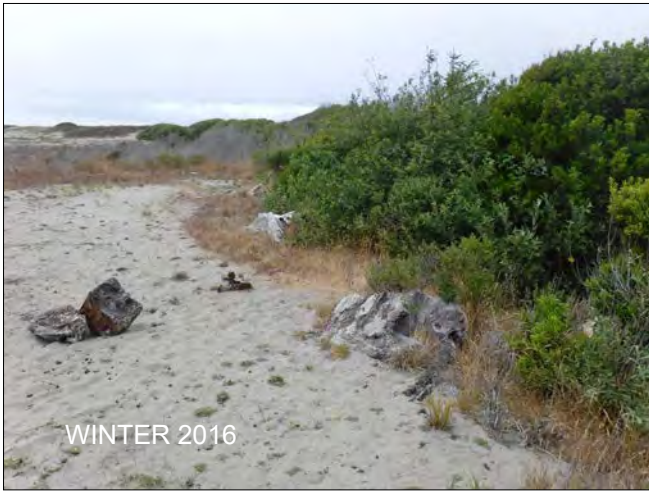
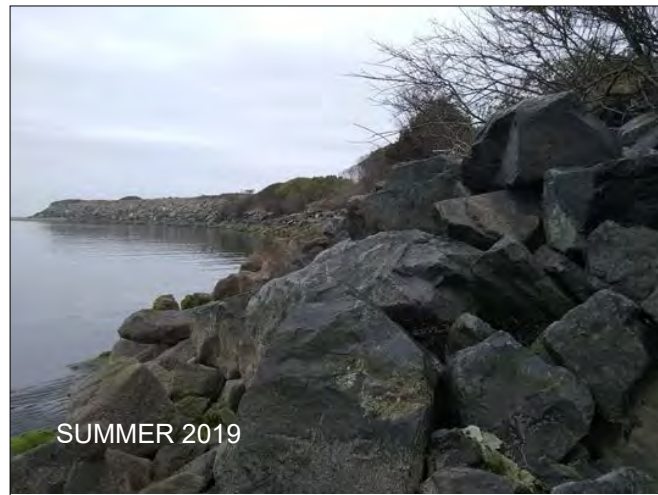
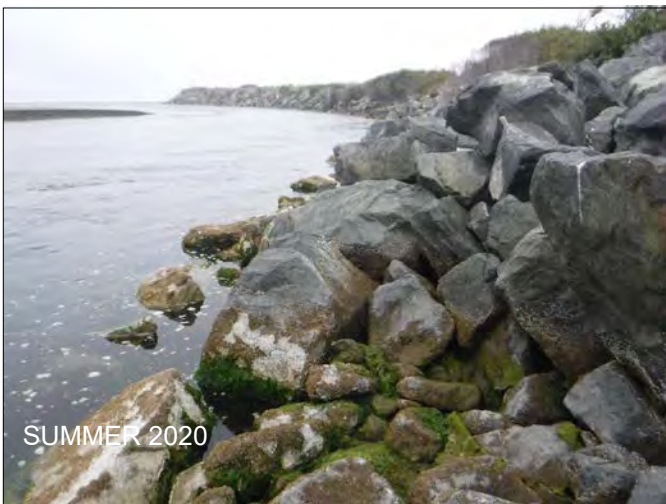
## Clam Beach Transect 9

View north from east end of transect

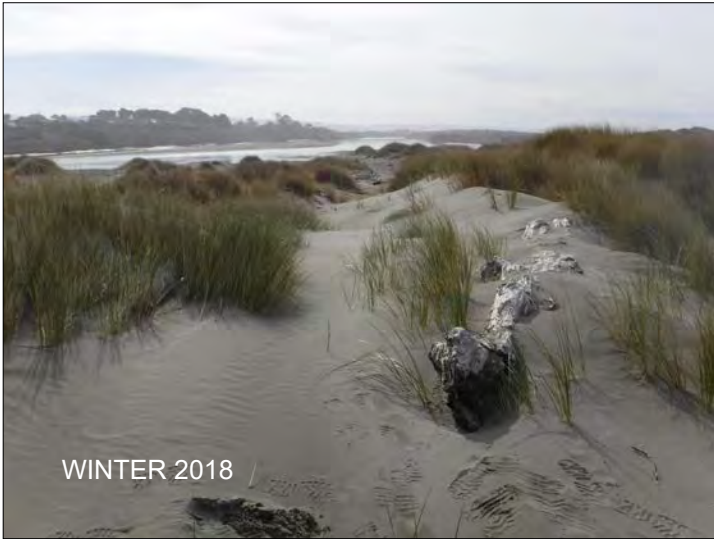
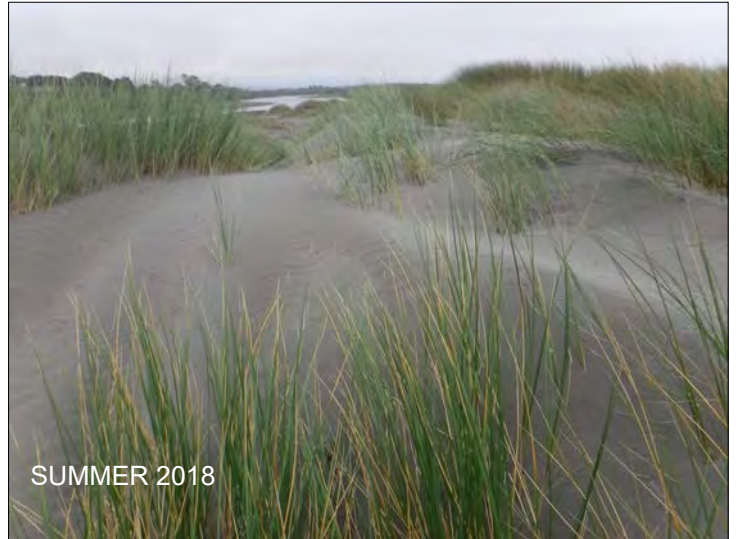
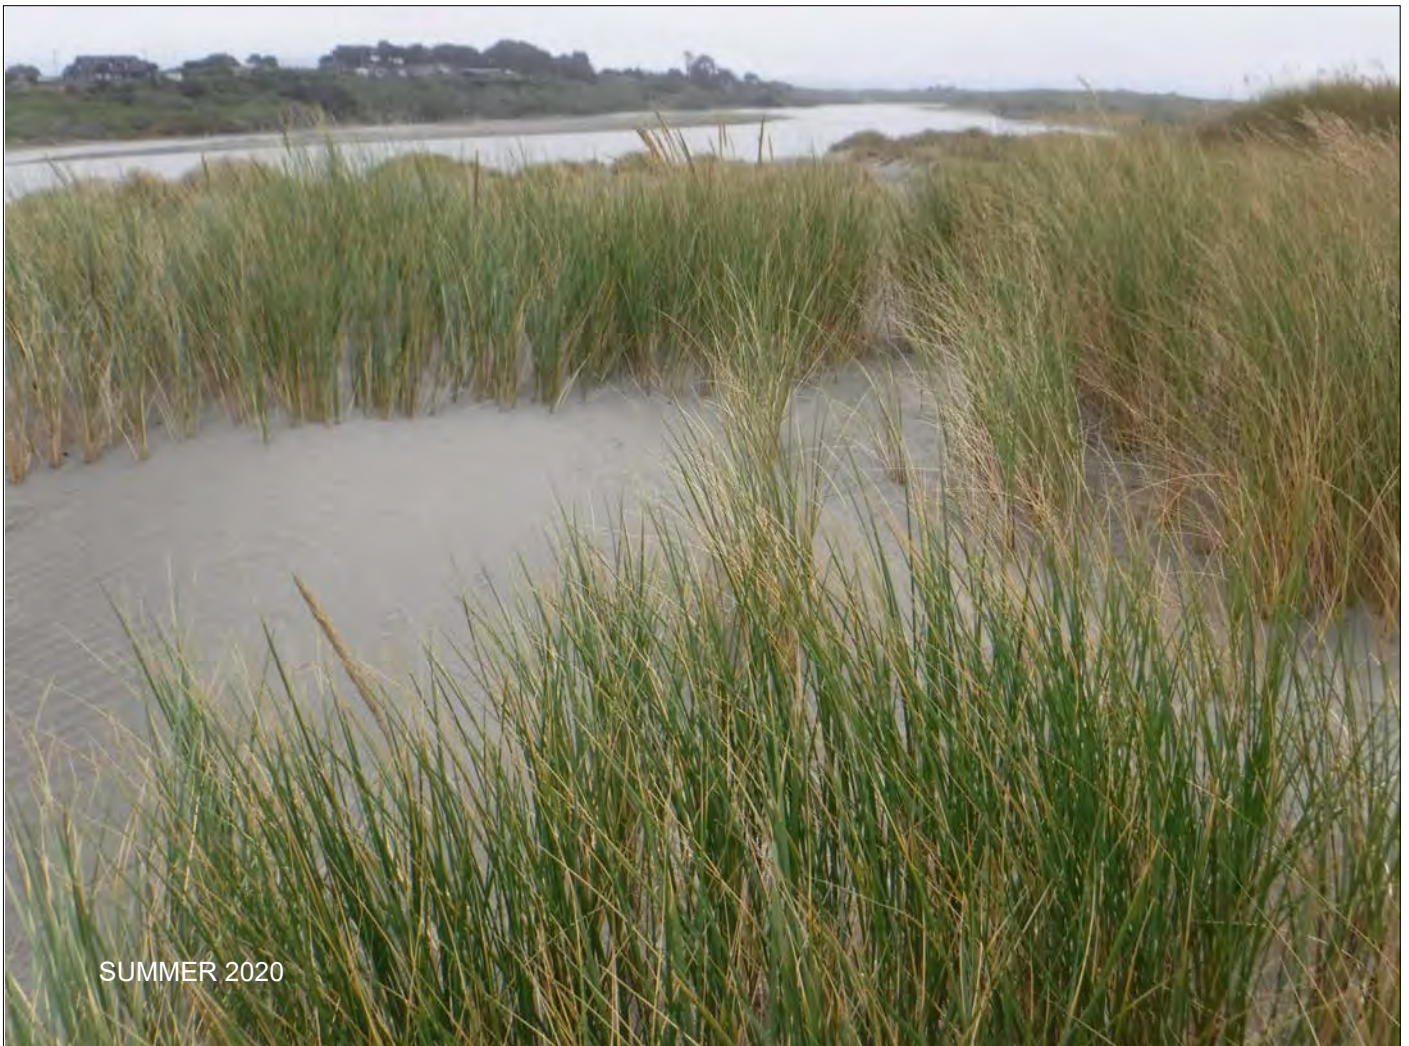
## Mad River Transect 10

View southeast at 194 m (foredune crest)

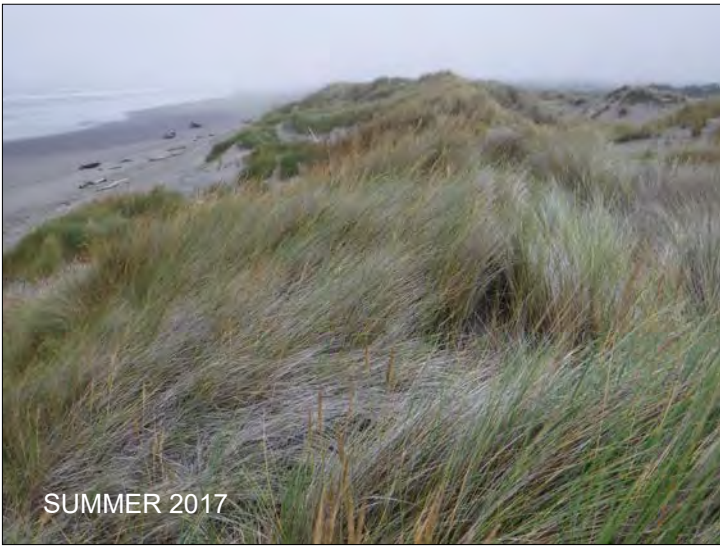
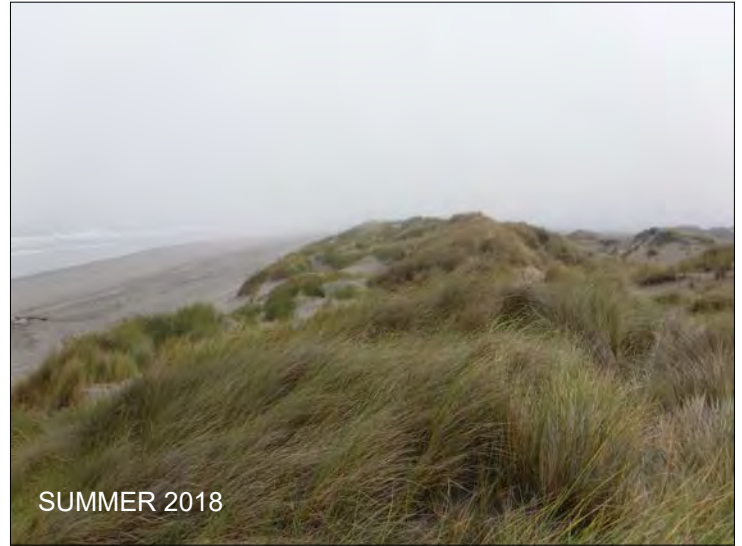
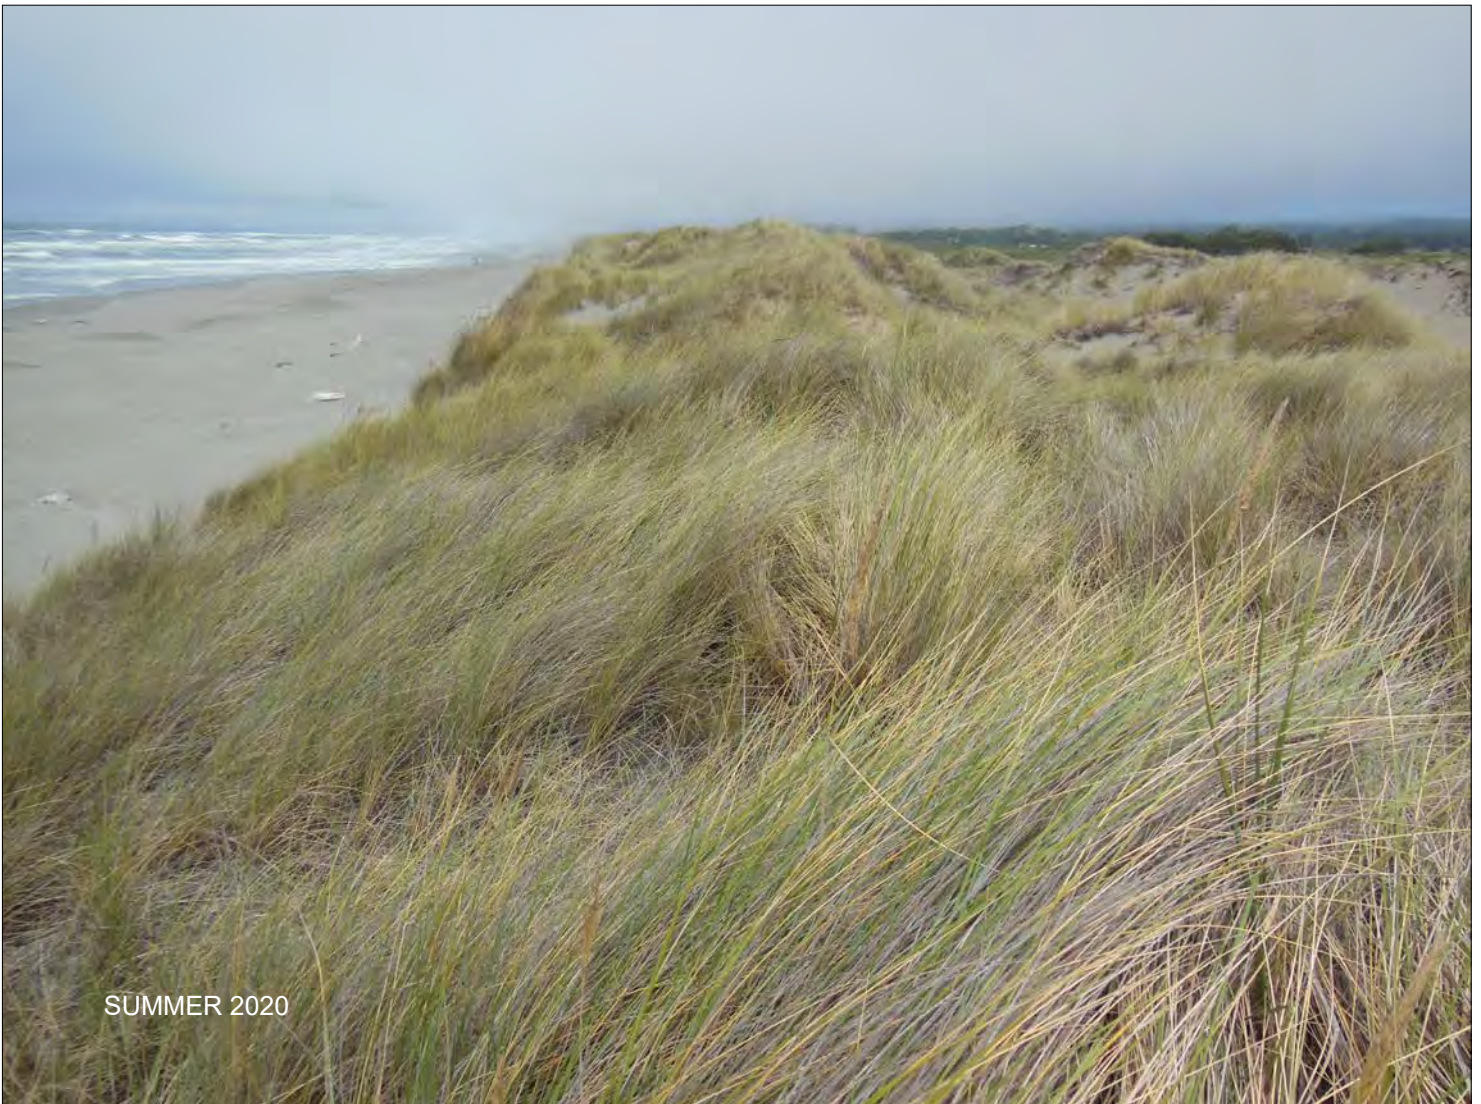
# Mad River Transect 11

View north at 282 m (foredune crest)

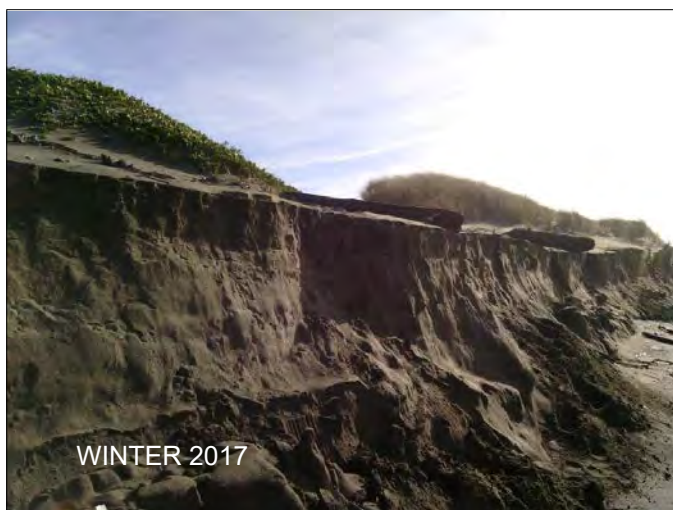
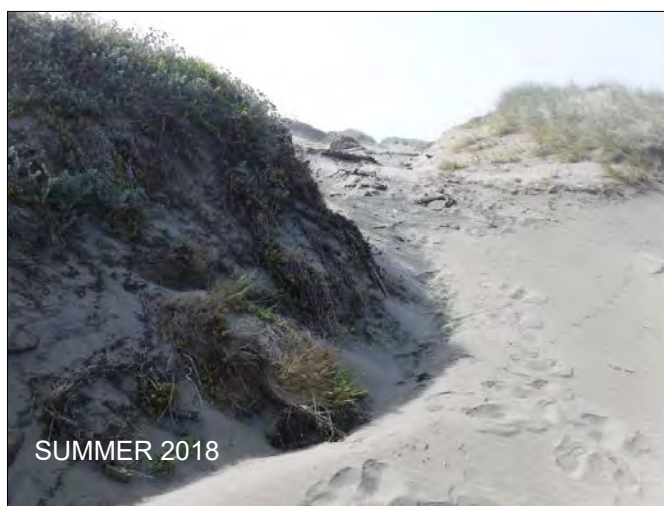
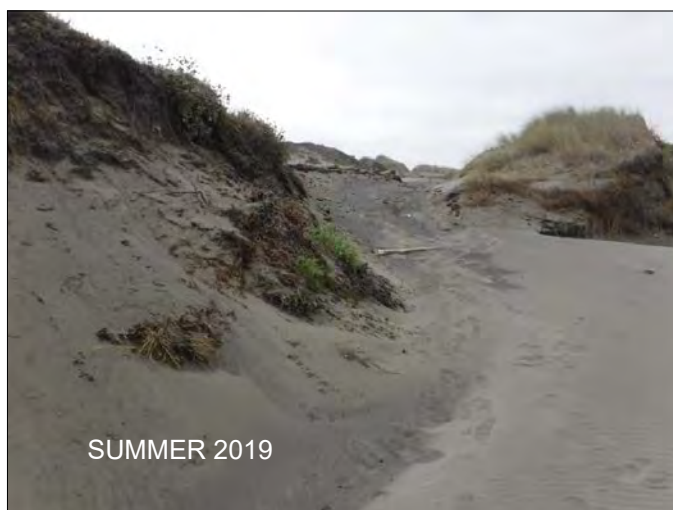
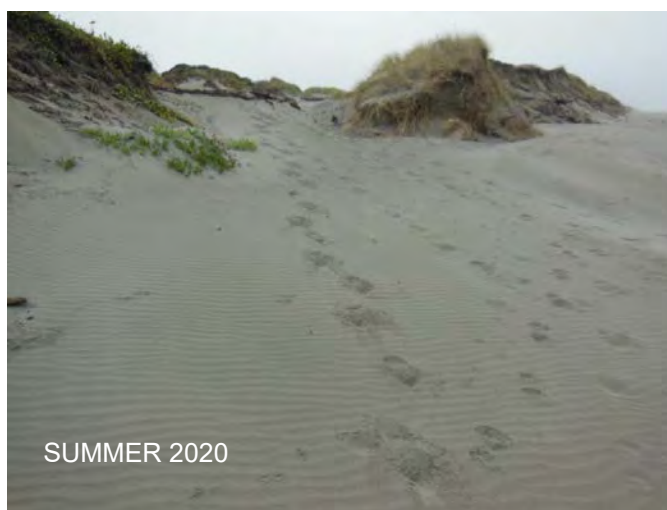
# Mad River Transect 12

View southeast at 160 m winter 2017 and at 152 m summer 2018-2020 (incipient foredune/scarp)

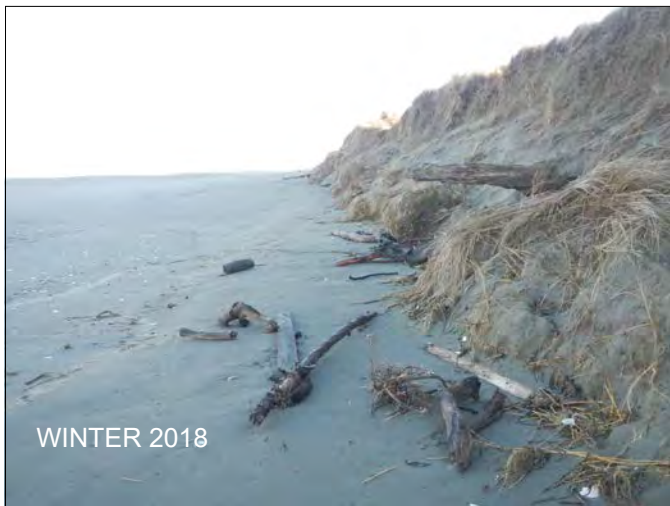
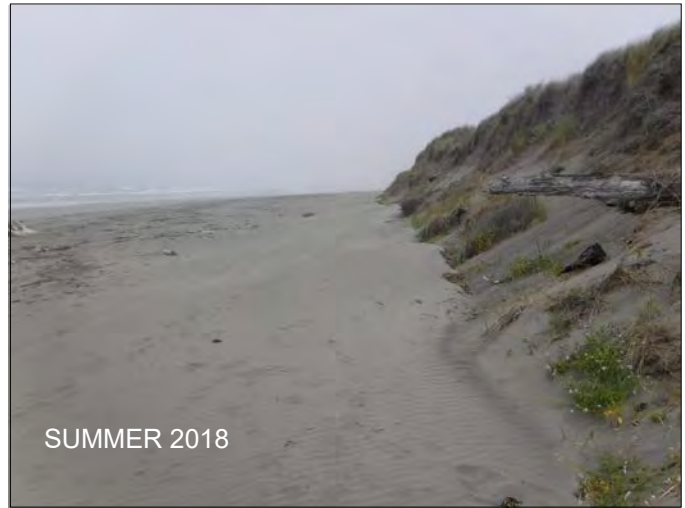
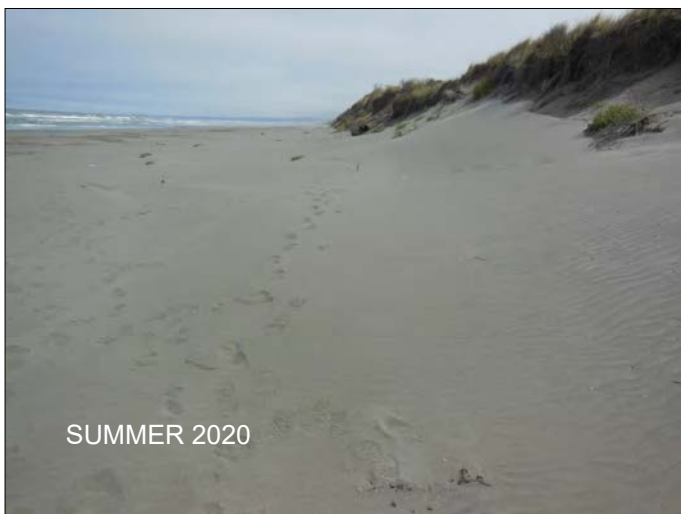
## Mad River Transect 13

Notes: The *Ammophila* foredune was significantly eroded during a high water event just before the winter 2016 survey, leaving a high, vertical scarp at the time of the survey. The scarp has since undergone slumping and additional scarping (following the winter 2017 survey). Since winter 2016 the upper beach has recovered approximately 0.8 m of elevation. By 2019 ramping had begun at the base of the foredune and continued through 2020, Over the course of the study the foredune remained steep retreating 10.0 m, with sand unable to reach the crest.

View north at 184 m (scarp)

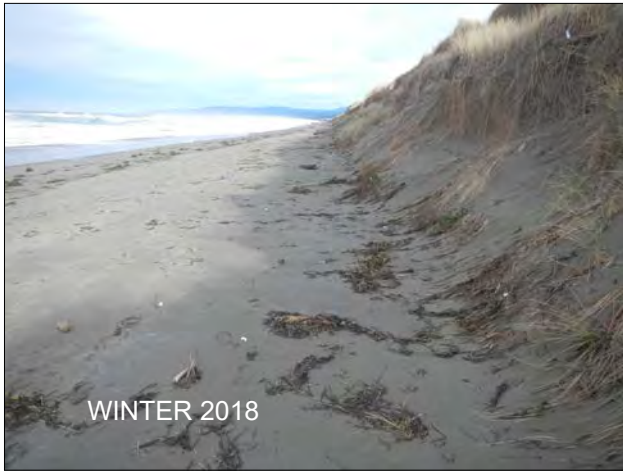
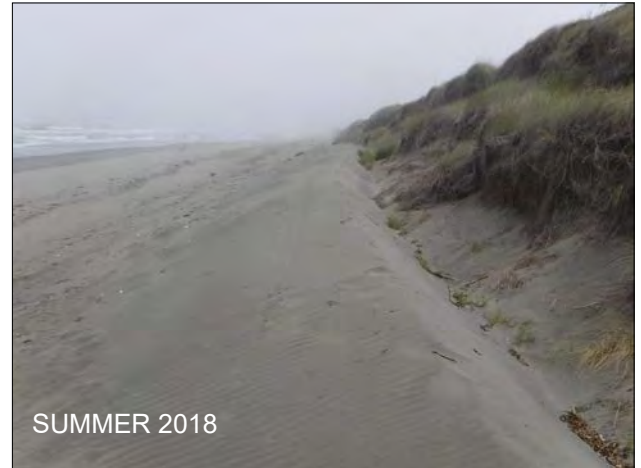
## Long Transect 14

Notes: Moving from north to south, the elevation of the foredune crest has increased, reaching a maximum on this transect of 12.0 m NAVD 88. The *Ammophila* foredune was significantly eroded during a high water event just before the winter 2016 survey, leaving a high, vertical scarp at the time of the survey. The scarp remained virtually unchanged through summer 2016, while the lower beach steepened and the upper beach underwent minor deposition at the base of the foredune. Prior to the winter 2017 survey the upper beach eroded, losing up to 1 m elevation near the base of the foredune, and block slumping occurred on the scarp. A high water event after the survey rescarped the entire foredune resulting in the inability of sand to reach the crest of the foredune. Over the course of the study the stoss face of the foredune retreated 10.0 m.

View north at 162m (scarp)

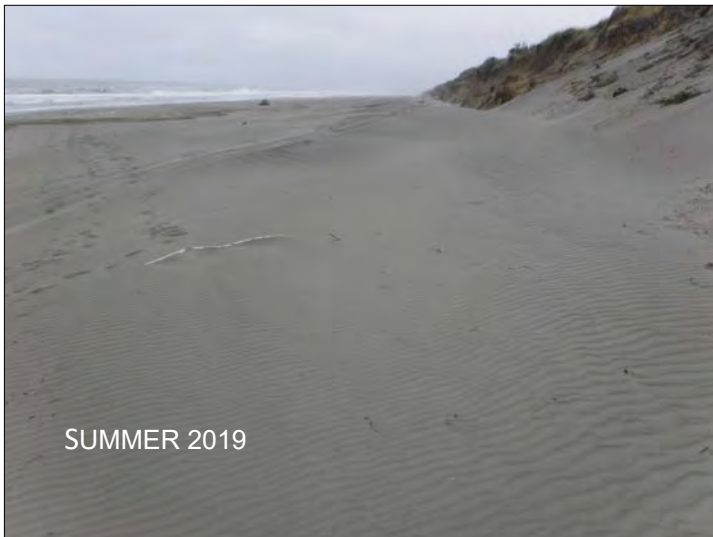
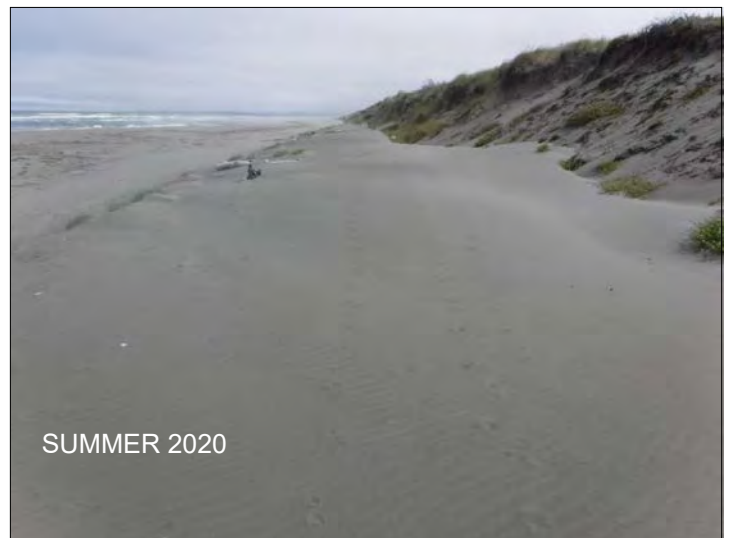
## Woll Transect 15

Notes: This high *Ammophila* foredune has a crest elevation of 12.6 m NAVD 88. The base of the incipient foredune had been scarped in winter 2016 prior to the survey, and between the winter and summer 2016 surveys it retreated an additional 5 m horizontally, although the beach gained in elevation by the summer survey. In winter 2017 the beach was lowered by 1.0 m vertically by the time of the winter survey. Soon after the survey a high water event removed the incipient foredune. By summer 2017 slumping had occurred, the upper beach had received deposition of 0.5 m, and a ramp was forming. In 2018 the stoss face of the foredune changed little, but the upper beach elevation received deposition of 0.4-0.6 m. In 2019 the scarp receded further. By summer 2019 the foredune had retreated a total of 12.0 m since surveys began, losing both the incipient foredune and part of the established foredune. The foredune remained steep with little opportunity for sand to reach the crest. A ramp was present at the toe of the foredune in summer 2020. Over the course of the study the incipient foredune eroded and the foredune retreated 12.0 m.

View north at 166 m (scarp)
