HUMBOLDT COASTAL RESILIENCY PROJECT  
AND  
CLIMATE READY PROJECT

SUMMARY DATA FOR CROSS-SHORE TRANSECTS  
WINTER 2016-SUMMER 2020

Andrea Pickart and Candace Reynolds, U.S. Fish and Wildlife Service,  
and Ian Walker, U.C. Santa Barbara

July 2021

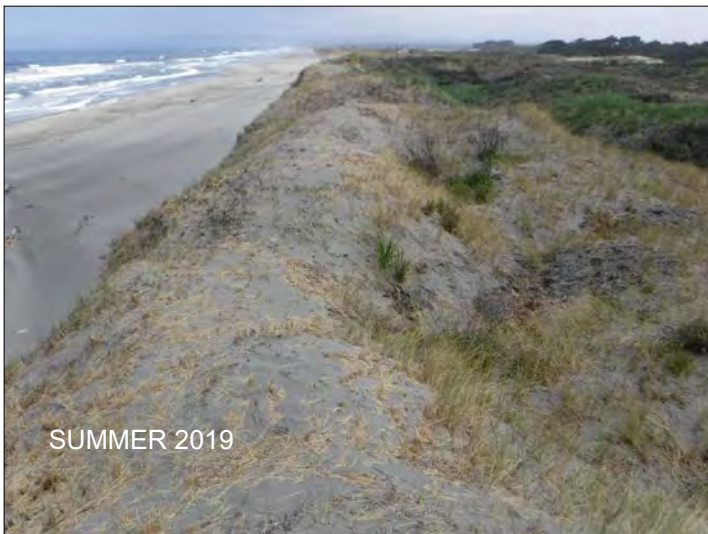
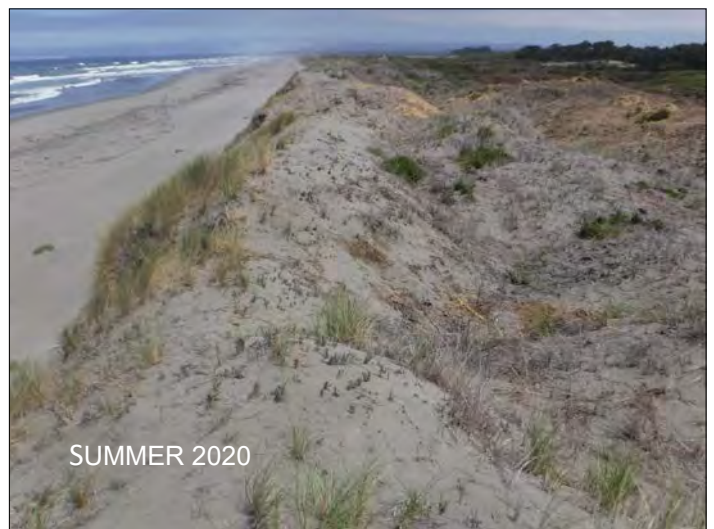
# Bair Transect 16

Notes: The foredune crest elevation of this steep, peaked *Ammophila* foredune is 12.7 m NAVD 88. Low scarping occurred at the base of the foredune in winter 2016 prior to the survey, and from then until winter 2017 the upper beach built up slightly and a scarp-fill ramp formed. Soon after the winter 2017 survey a high water event scarped the base of the foredune, causing retreat of up to 6 m horizontally and lowering the beach 0.5 m vertically. By summer 2017 the base of the scarp had slumped and the beach had increased in elevation, contributing to the formation of a scarp-fill ramp. By summer 2018 the ramp was still present but erosion had lowered the elevation of both the ramp and the upper beach, ending with an elevation similar to winter 2016. The foredune saw additional scarping in winter 2019. In summer 2019 a burn treatment occurred on the foredune, as is visible in the 2019 and 2020 photos. Over the course of the study, the foredune stoss slope steepened from scarping, the seaward toe retreated by approximately 10 m, and the crest remained stable .

View north at 154 m (foredune crest)

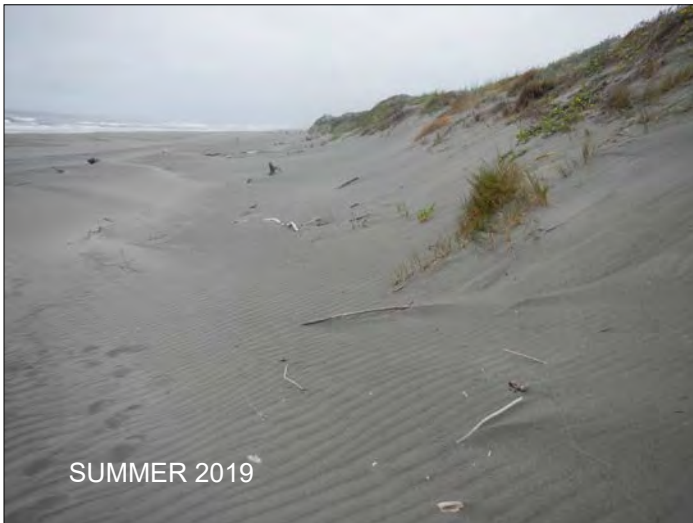
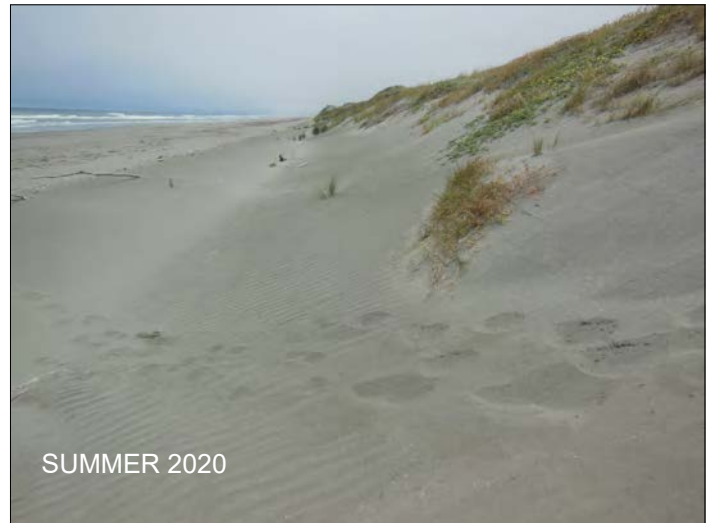
## Bair Transect 17

Notes: Between 2012 and 2016 there was deposition of 0.5 m on the stoss slope of the foredune. Significant scarping of the established foredune and lowering of the beach occurred in 2016 prior to the winter 2016 survey (no incipient foredune was present). By summer 2016 a combination of slumping and ramping had smoothed the foredune slope. By the time of the winter 2017 survey the upper beach had scarped and lowered 1.0 m, and shortly after a large highwater event scarped the foredune back 10.0 m horizontally. By summer 2017 the beach had accreted 0.5 m vertically, but the ramp was only just reaching the base of the scarp. Therefore, sand transport from the beach to the foredune was limited during this season. Between summer 2017 and summer 2018 the foredune toe had regained elevation and the ramp was fully formed, allowing sand transport from the beach to the foredune. This transect is located in the Lanphere Adaptation Site, where *Ammophila* was removed from the foredune in winter 2016, and native species planted in winter 2017. Post vegetation removal, the first foredune crest deflated approximately 0.2 m, with sand deposited in the swale between the two foredune crests. As vegetation became established there was little change in this area from summer 2017 to summer 2018. The foredune base and ramp changed little between 2018 and 2019. Over the course of the study, and in response to restoration treatments, the foredune broadened with net deposition on both the upper stoss and lee slopes and steepening of the lower stoss face, but with limited change in position and elevation of the crest.

View north at 119 m (left, showing scarp) and 105 m (right, and below showing ramp)

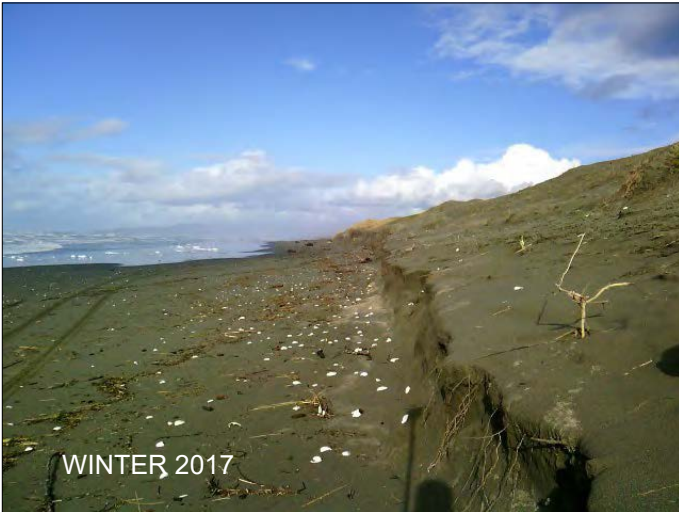
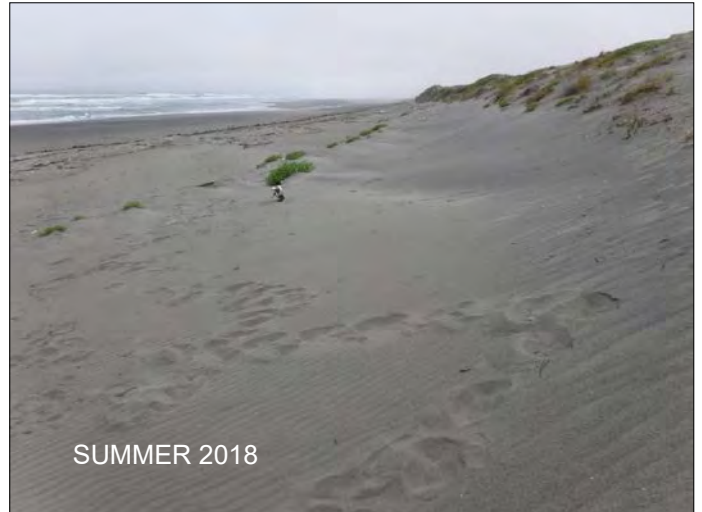
## Bair Transect 18

View north at 120 m (left, showing scarp) and 110 m (right, showing ramp)

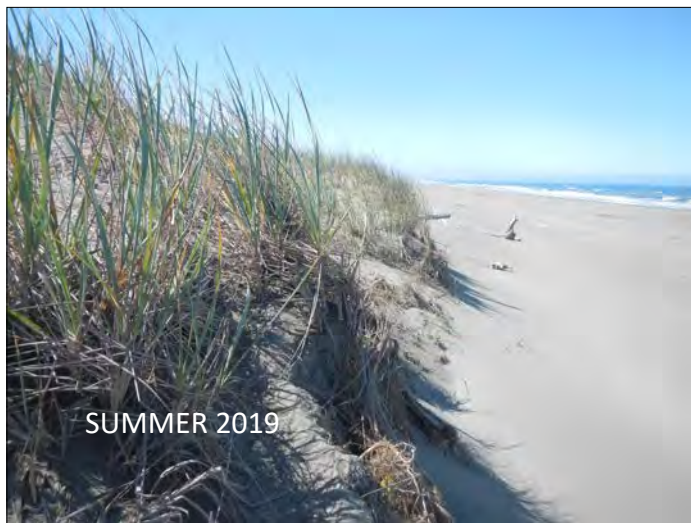
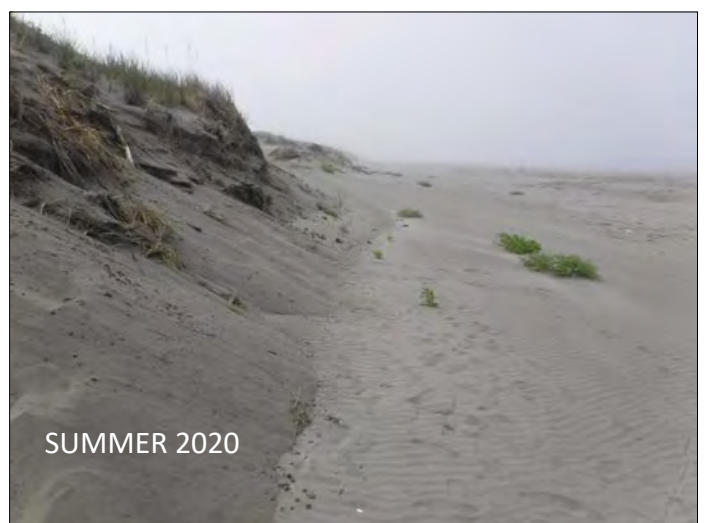
# Lanphere Dunes Transect 19

Notes: The transect describes a high, broad foredune vegetated by native species. Between 2012 and 2016 up to 1.0 m of accretion occurred on the stoss face and crest of the foredune. Significant scarping after the winter 2016 survey shows up in the summer 2016 profile, having removed 2.6 m vertically including the small narrow incipient foredune. By winter 2017 a scarp-fill ramp was forming and the upper beach had regained 2.0 m of elevation, although the lower beach had not recovered. However by summer 2017 the ramp was continuous and becoming vegetated and the beach had recovered to winter 2016 elevations. From 2017 to 2018 erosion of the upper beach and foredune toe returned this portion of the transect to conditions similar to summer 2016. There was little change to the profile between 2018 and 2019, with its relatively mild winter, although the position of the offshore bar shifted. Between winter and summer 2020 the lower stoss face of the foredune was scarped back 5.0 m. Over the course of the study the profile lost its incipient foredune, with the base of the foredune retreating 10.0 m. Since 2012 there has been deposition of 0.5 m on the crest of the foredune.

View south at 179 m (foredune crest)

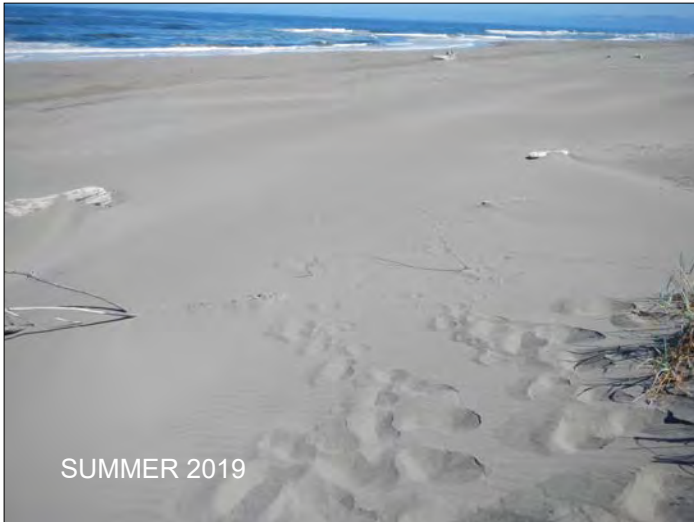
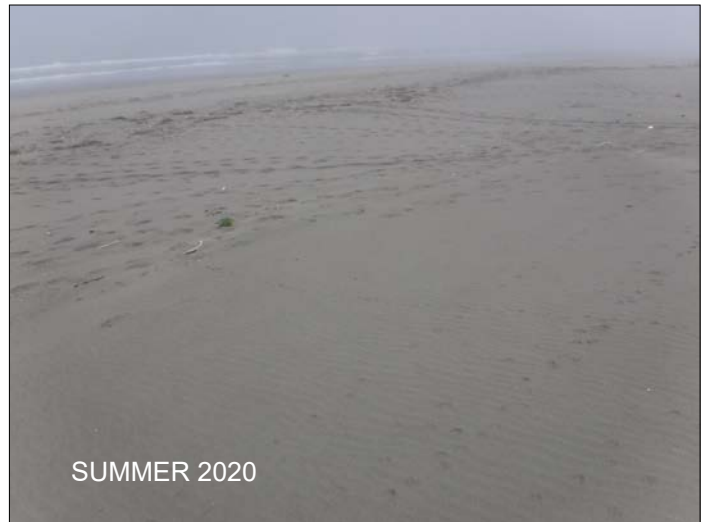
# Lanphere Dunes Transect 20

Notes: Between 2012 and 2016 an incipient foredune formed and the depositional lobe of a blowout behind the foredune increased in height by 1.0 m. The established, native foredune was relatively stable between 2016 and 2020, with minor deposition on the landward peak where the transect crosses the depositional lobe of an old stabilizing blowout. The incipient foredune was scarped between the winter 2017 and summer 2017 surveys, and continued eroding, with upper beach lowering, through summer 2018. Between winter 2019 and summer 2019 the incipient foredune eroded away completely. At elevation 13.1 NAVD 88, this transect represented one of the highest foredune crests surveyed in the study area. Over the course of both studies an incipient foredune formed and then eroded over 20 m horizontally, and the depositional lobe on the lee side of the foredune increased in height.

View NW from incipient foredune crest at 193 m

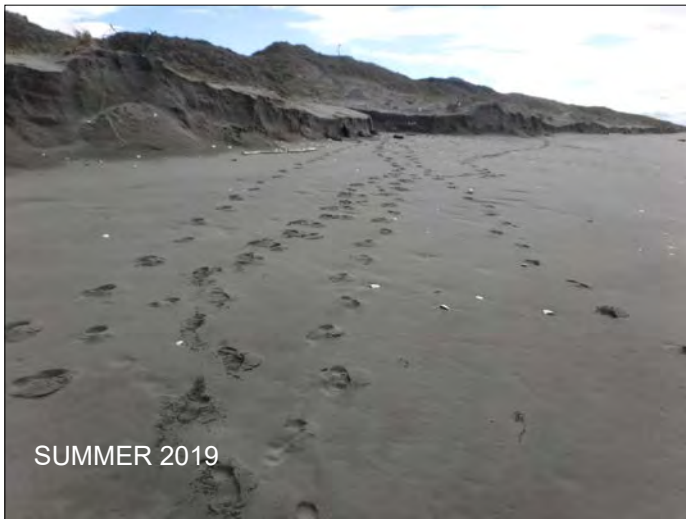
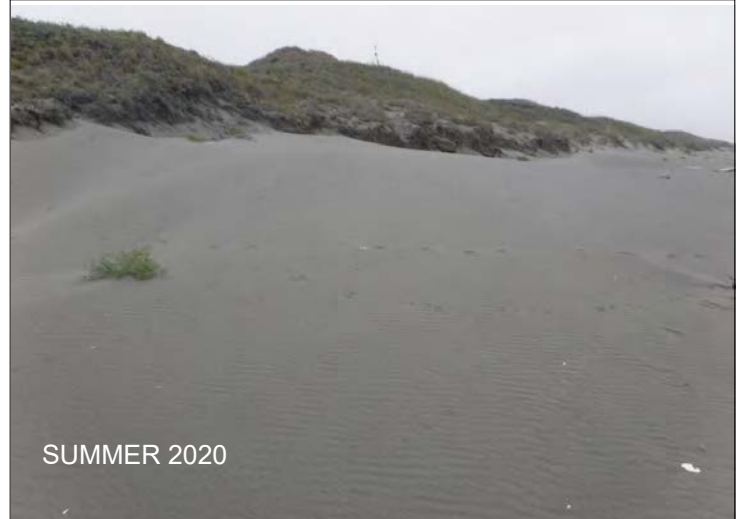
# Lanphere Dunes Transect 21

Notes: The transect extends up an old, now-stabilized blowout, causing a peaked foredune topography vegetated with native species. Between 2012 and 2016 an incipient foredune formed. Following the winter 2017 survey the incipient foredune was severely scarped, losing up to 2.0 m vertically and 20 m horizontally, as seen in the summer 2017 profile. By the summer 2017 survey a scarp-fill ramp had formed and by summer 2018 the incipient foredune increased in elevation by 0.8 m (see photos below taken SE along the transect). In winter 2019 the incipient foredune scarped, and between winter and summer 2019 further scarping occurred, removing the incipient foredune completely. By summer 2020 a ramp was forming (see photo). The crest of the foredune, at 13.2 m NAVD 88, was the highest crest elevation measured along any of the transects in the study area. Over the course of both studies the foredune remained quite stable with some deposition on the stoss face and crest, however the incipient foredune formed and then eroded over 30 m horizontally.

View southeast at 199 m (incipient foredune)

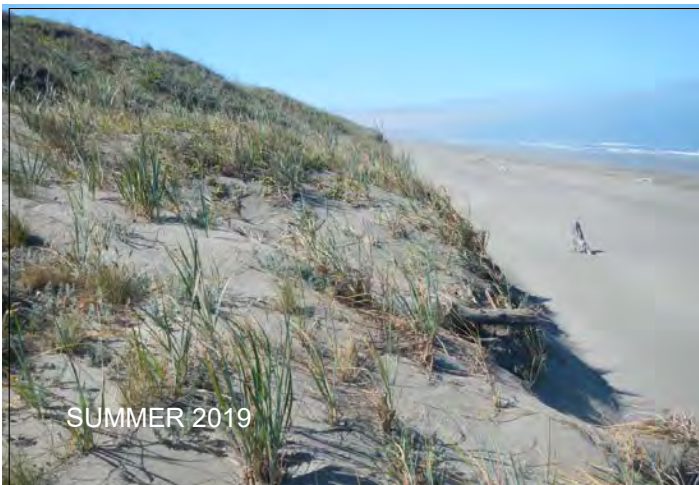
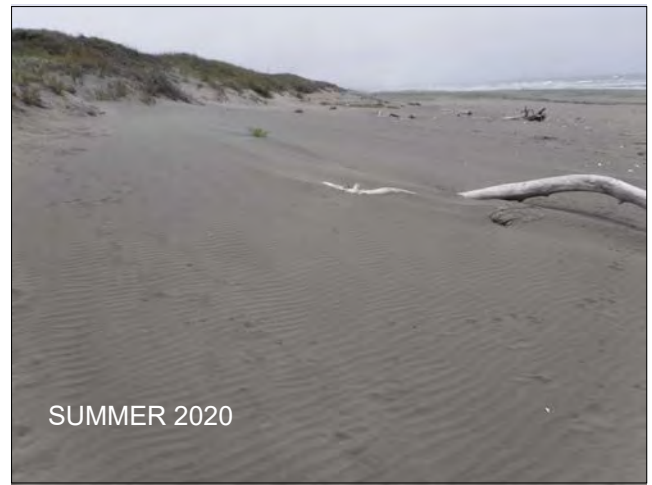
## Lanphere Dunes Transect 22

Notes: The transect depicts a high, stable, established foredune with a more dynamic incipient foredune. Vegetation is native. Between 2012 and 2016 an incipient foredune formed and there was deposition on the stoss face of the foredune. The incipient foredune increased in elevation 0.5 m between winter 2016 and summer 2017, remaining stable until the winter 2017 survey. However, scarping in winter 2017 (after the survey) resulted in narrowing and translation of the incipient foredune inland by summer 2017. By summer 2018 the incipient foredune had begun to weld onto the established foredune (see photograph taken at base of established foredune). The foredune crest elevation is high, at 13.0 NAVD 88. Between winter 2018 and summer 2019 the incipient foredune scarped and was completely removed. Over the course of both studies there was deposition on the stoss face of the foredune and formation of followed by complete removal of the incipient foredune, which eroded 30.0 m horizontally.

View south at 187 m (incipient foredune)

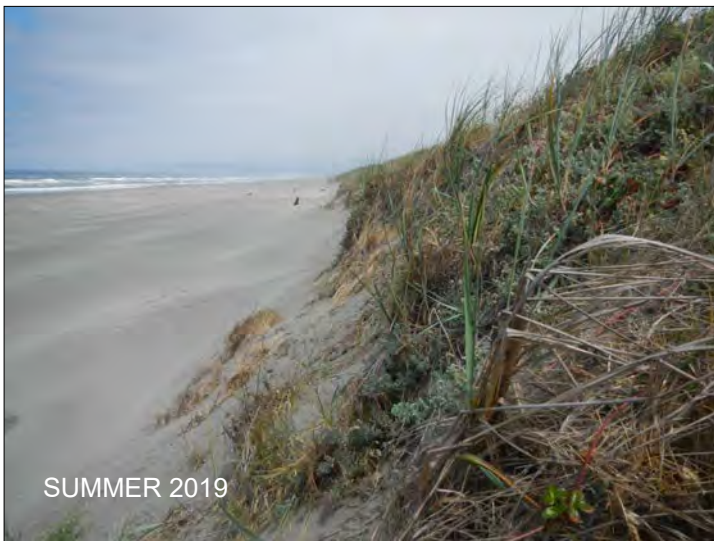
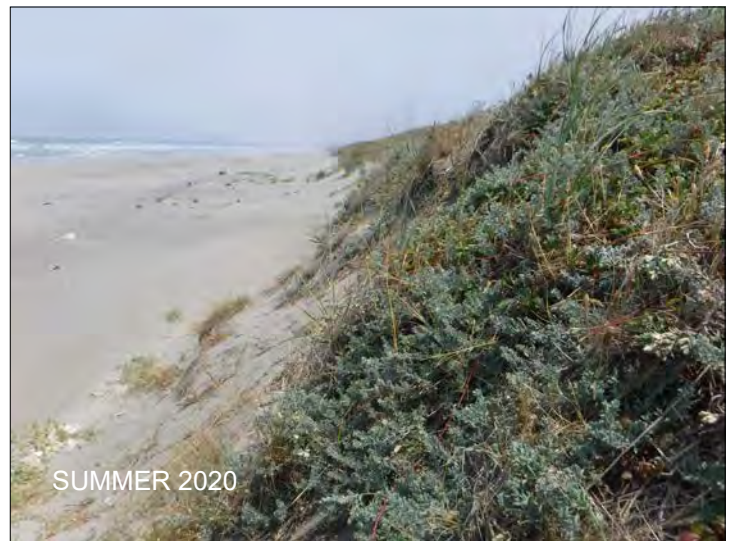
# Lanphere Dunes Transect 23

Notes: This is a high (12.0 m NAVD 88), native, established foredune with a dynamic incipient foredune. The incipient foredune formed between 2012 and 2016, and was stable for the first year while the beach underwent seasonal changes. In winter 2017, prior to the survey, the incipient foredune was entirely removed through a dramatic 2.0 m vertical scarping event that resulted in 20 m of retreat. By summer 2018, the beach had recovered some of its elevation especially on the backshore. Between winter and summer 2019 the established foredune scarped, retreating 8 m at its base. By 2020 a ramp was forming, and there was deposition on the stoss face of the foredune. Over the course of both studies the incipient foredune was formed and then eroded, retreating over 30.0 m, and the upper stoss face accreted.

View north at 165 m (foredune base)

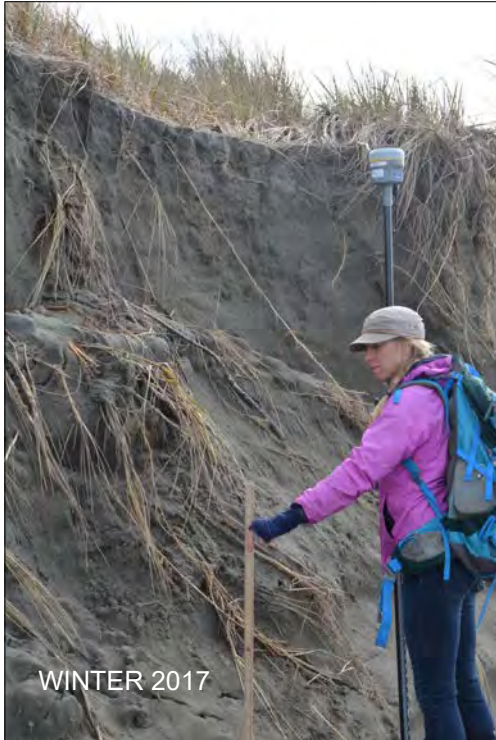
## Lanphere Dunes Transect 24

Notes: The incipient foredune was formed between 2012 and 2016, and was entirely removed in winter 2017 prior to the survey. High water events led to a 2.0 m vertical elevation loss, and 17 m of retreat. By 2018 ramping had occurred at the base of the foredune. In winter 2019 the established foredune scarped back 10 m, although by summer 2019 deposition of +1 m had occurred on the upper beach. By 2020 a ramp was forming on the scarp (see photo). Over the course of both studies the incipient foredune was formed and then removed, retreating over 20.0 m, and the established foredune eroded on its stoss face, but was showing signs of recovery through scarp-fill ramping.

View southeast of scarp at 183 m.

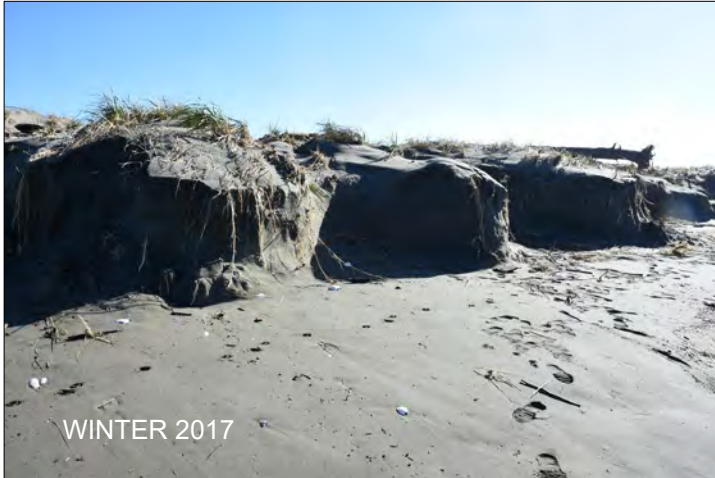
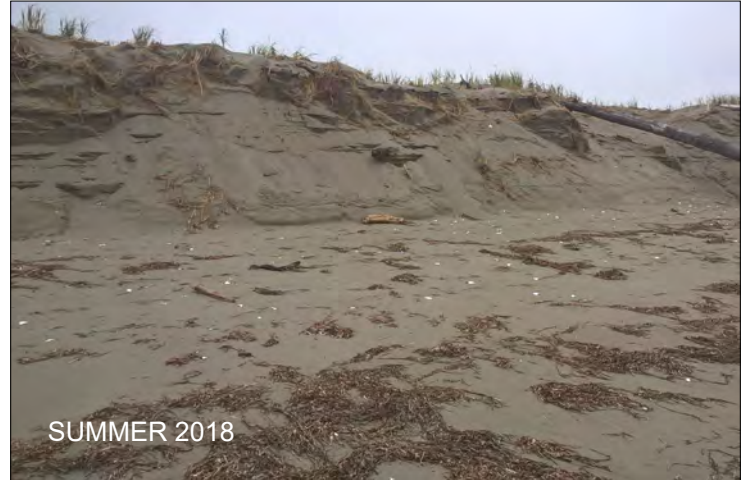
# Ma-le'I North Transect 25

Notes: The profile describes a sparsely vegetated to unvegetated parabolic dune. From 2012 through 2016 a foredune began forming. In winter 2017 the foredune was severely scarping with a loss of 1.6 m vertically. Additional scarping and beach lowering occurred by summer 2017 due to the narrow width of beach resulting from a persistent rip current. Some slumping but no ramping of the scarp had occurred by summer. Between the winter 2018 and summer 2018 surveys a high water event eroded the foredune back another 12.0 m horizontally, removing the cusped edge. The beach was lowered by 0.5 m. Note the low beach and unusually high water line in the summer 2018 photo. By summer 2020 deposition on the upper beach and formation of a ramp allowed for some recovery of the developing foredune, the crest of which was now 20.0 m to the east. Over the course of the two studies the slipface of the dune migrated inland 10.0 m, with the foredune crest broadening and increasing in elevation, and the back of the blowout lowering in elevation 10 m.

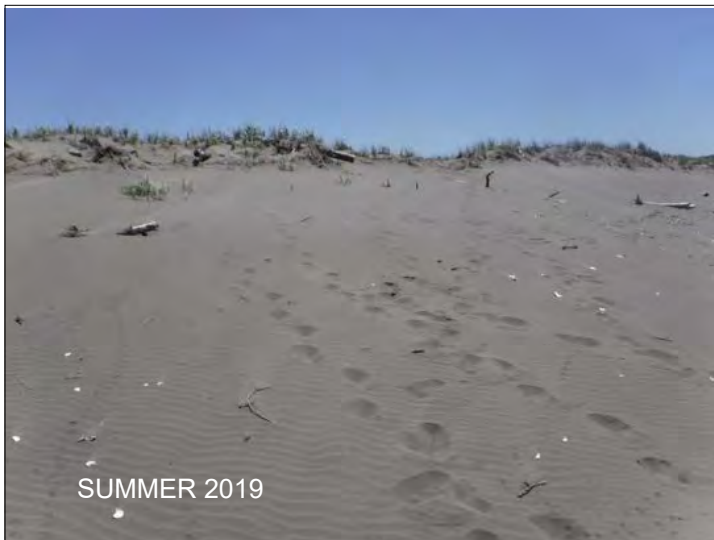
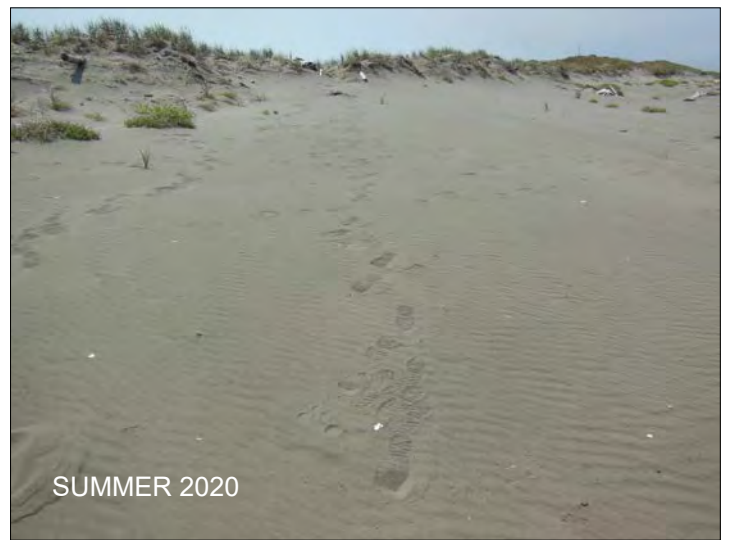
## View southeast at 207 m (upper beach)

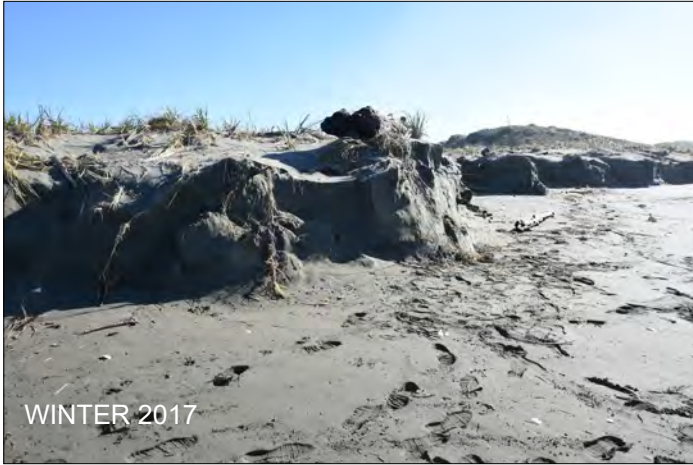
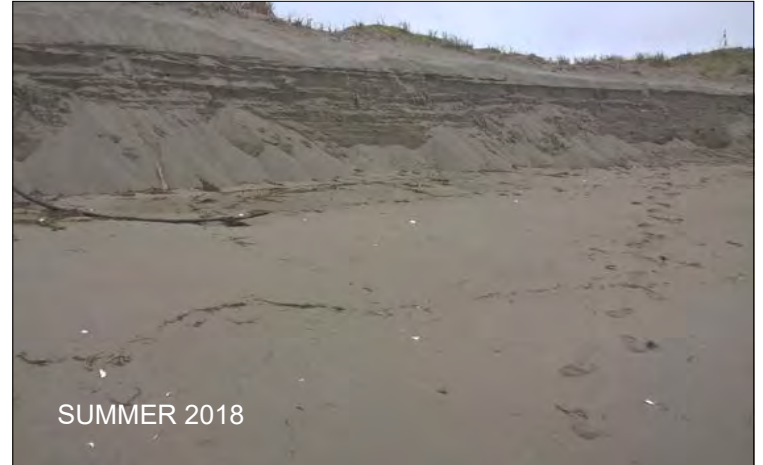
Ma-le'I North Transect 26

Notes: Adjacent to and similar to Transect 25 although this parabolic dune is shorter and its terminal slipface higher and steeper. Between 2012 and 2016 a foredune began to develop, and the slipface of the dune migrated 0.5 m eastward and lost elevation of up to 1.5 m. In winter 2017 the developing foredune was scarped, losing 1.5 m of elevation, and the backshore was lowered by 0.8 m. By summer 2017 an additional 20.0 m of retreat had occurred from renewed scarping due to the narrow width of beach resulting from a persistent rip current. Slumping had occurred along with some ramping. Between the winter and summer 2018 surveys the upper beach eroded up to 1.4 m, removing the ramp. In 2019 deposition on the upper beach rebuilt the ramp. At its eastern edge the parabolic dune has migrated, with the slipface steepening through winter 2018 as a result of the relatively static position of its base, which was anchored by *Salix* growing in a deflation basin. Over the course of the two studies the foredune translated eastward but gained over 1.0 m in elevation.

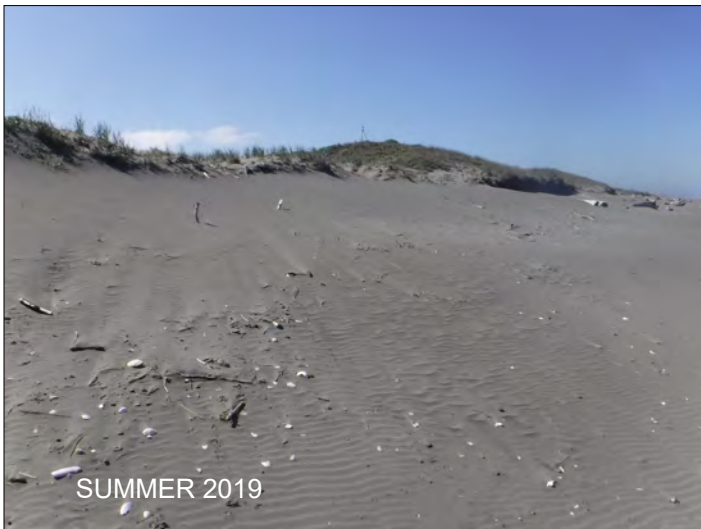
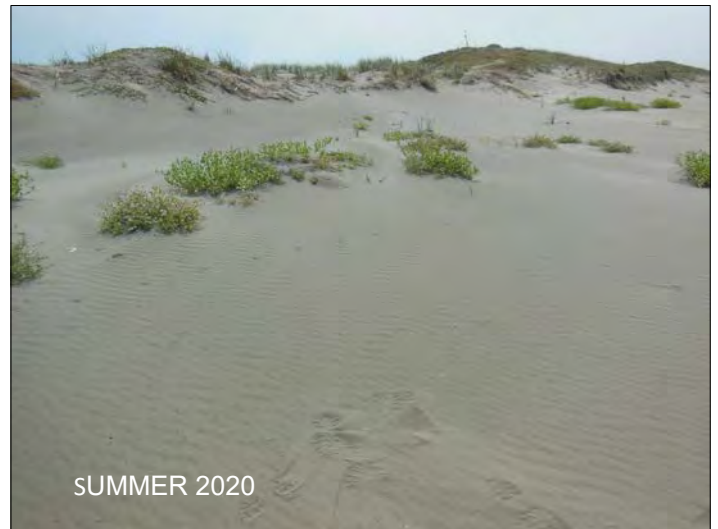
View southeast at 191 m (upper beach)

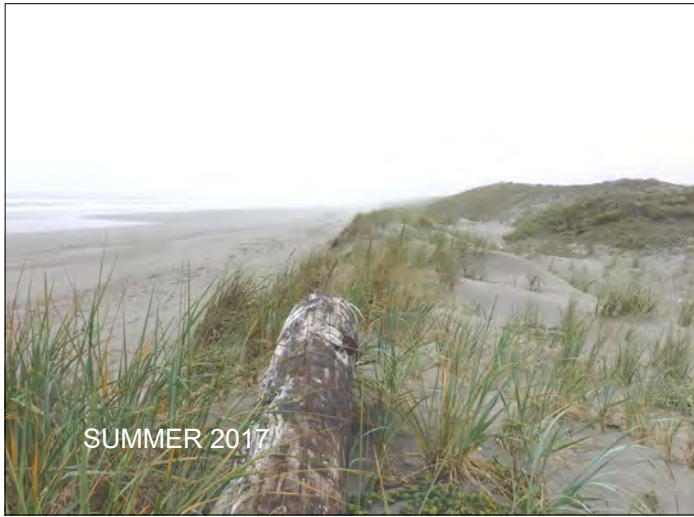
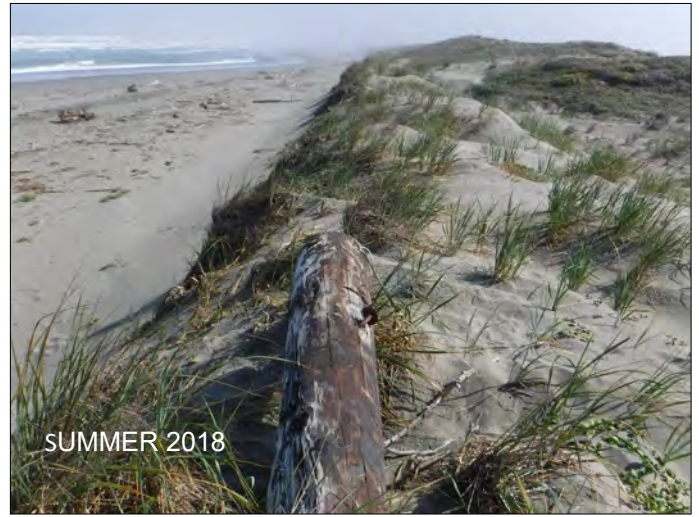
Ma-le'i North Transect 27

Notes: Between 2012 and 2016 (prior to the current study), an incipient foredune developed. Scarping of the incipient foredune occurred in winter 2016, followed by scarp-fill ramping in summer 2016. The incipient foredune was then rescarped in winter 2017 during the high water event that emplaced the wood pictured in the photo below. Although little ramping occurred in summer 2017, the upper beach gained in elevation. Scarping resulted in mobilization of sand on the crest of the incipient foredune, similar to the slipfaces that can be seen to the north in the photograph. In 2019 additional scarping of the incipient foredune occurred, leaving only a small remnant. By summer 2019 there was no incipient foredune. Over the course of both studies the incipient foredune formed and then eroded.

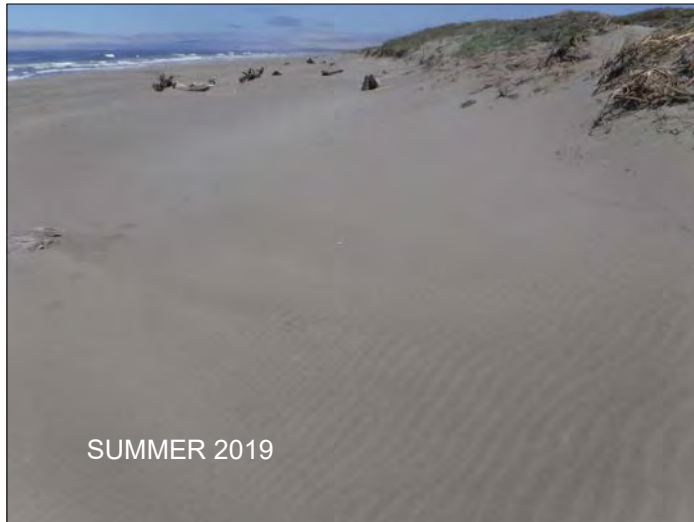
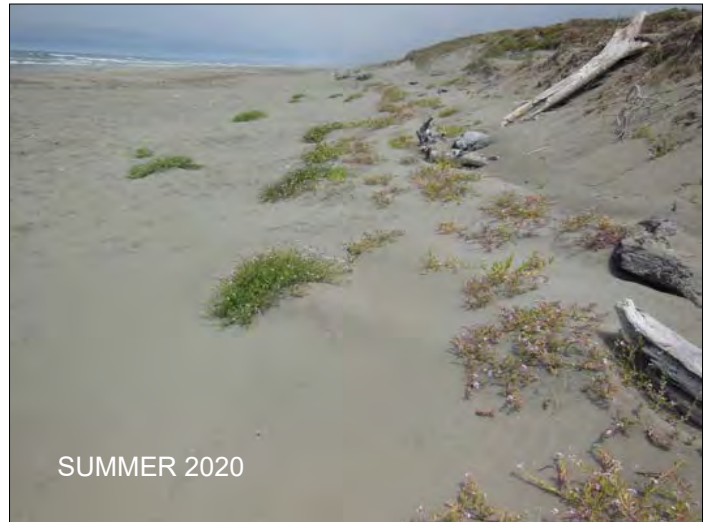
View north at 171 m (incipient foredune)

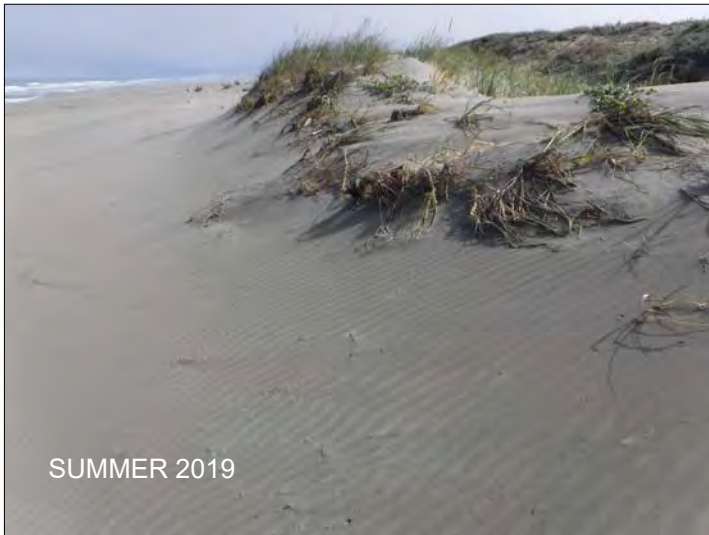
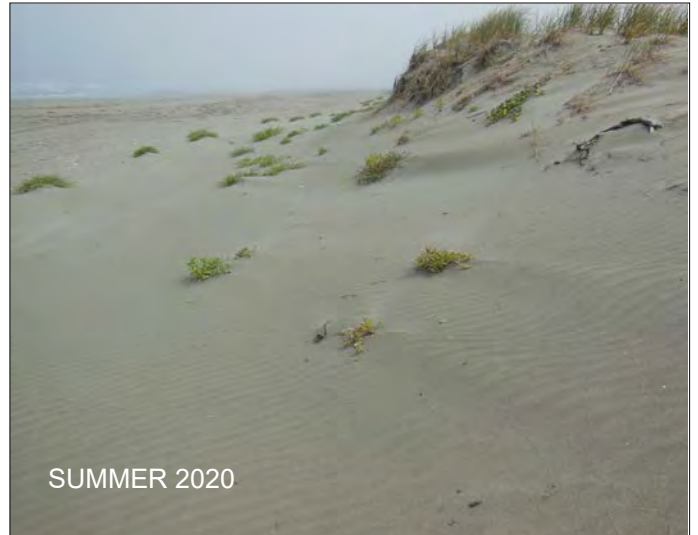
View north at 177 m (incipient foredune)

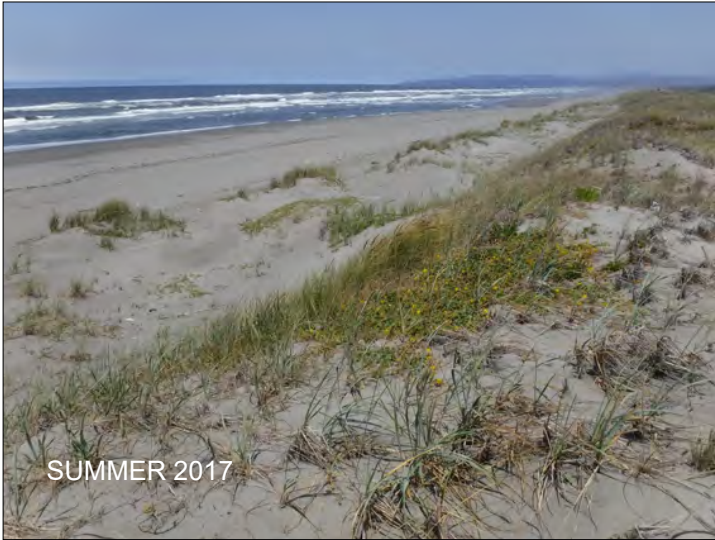
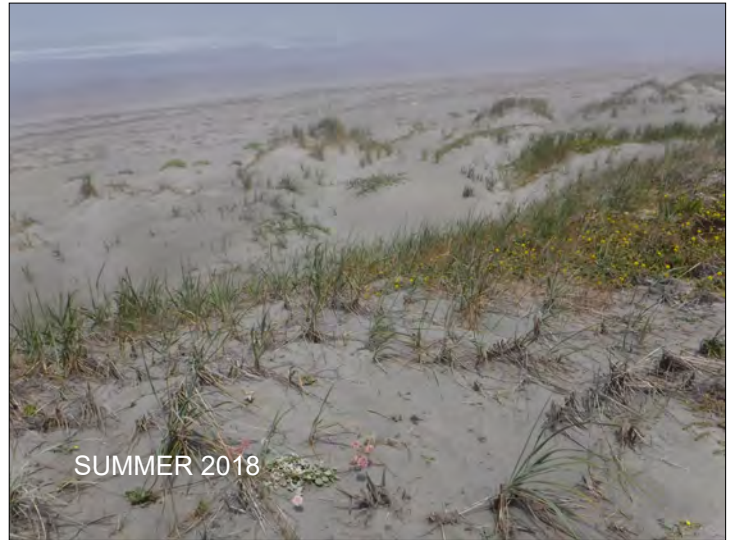
Ma-le'i North Transect 29

Notes: Between 2012 and 2016 an incipient foredune formed. Scarping of the incipient *Elymus* foredune occurred in winter 2016 with additional erosion of the upper beach occurring before the summer 2016 survey, which shows scarp-fill ramp formation. In the high water events of winter 2017 the incipient foredune retreated an additional 10.0 m, leaving a 2.5 m scarp. In summer 2017 the mobilized sand on the incipient foredune crest formed a slipface, and by summer 2018 additional deposition had filled the incipient foredune swale (see photos below). In 2019 –2020 the incipient foredune had translated and become incorporated in the established foredune. Over the course of the two studies the incipient foredune first formed, and then was removed. The established foredune underwent deposition on the stoss face and foredune crest.

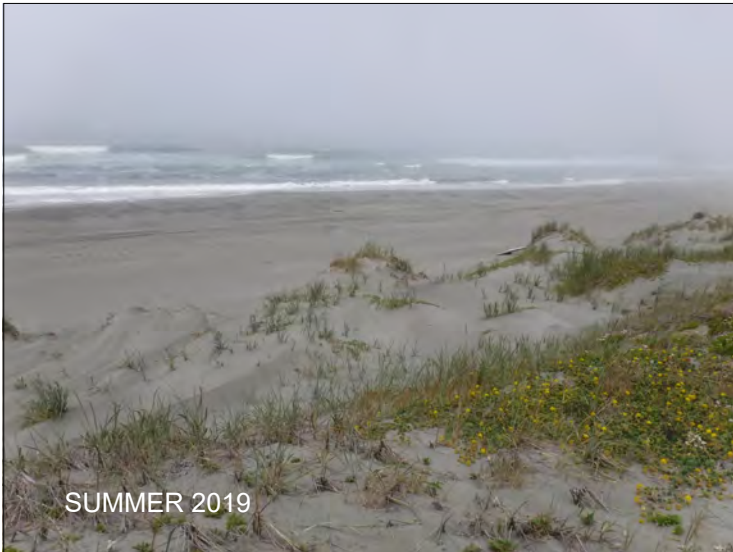
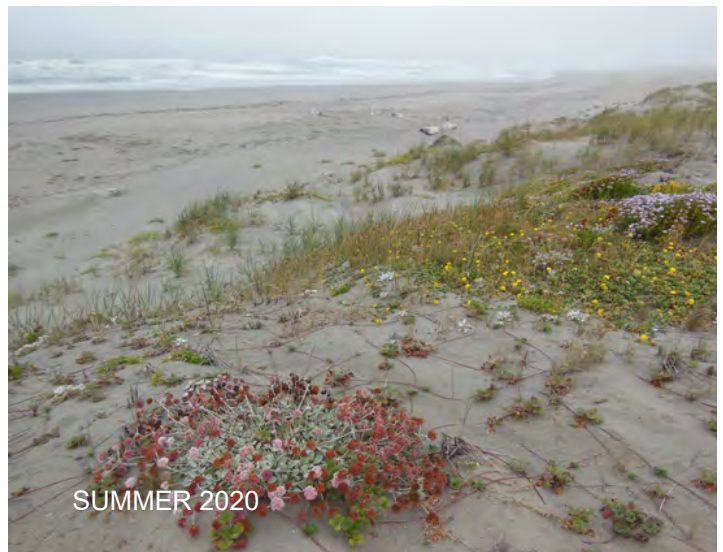
View northwest along transect at 147 m (foredune crest)

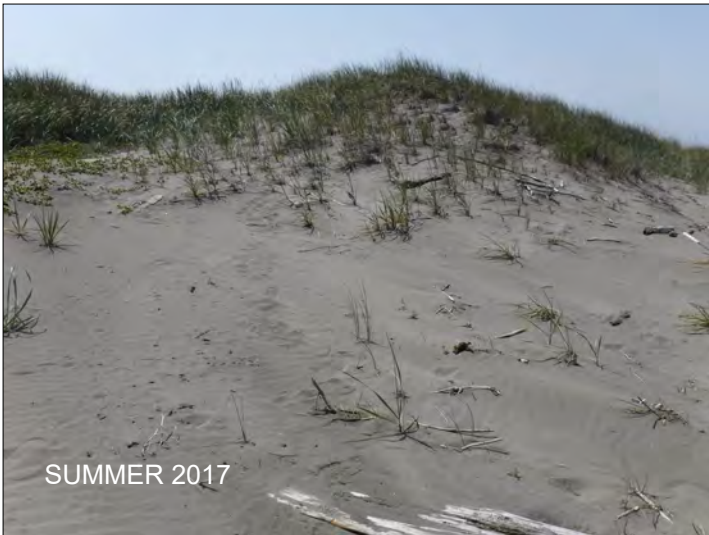
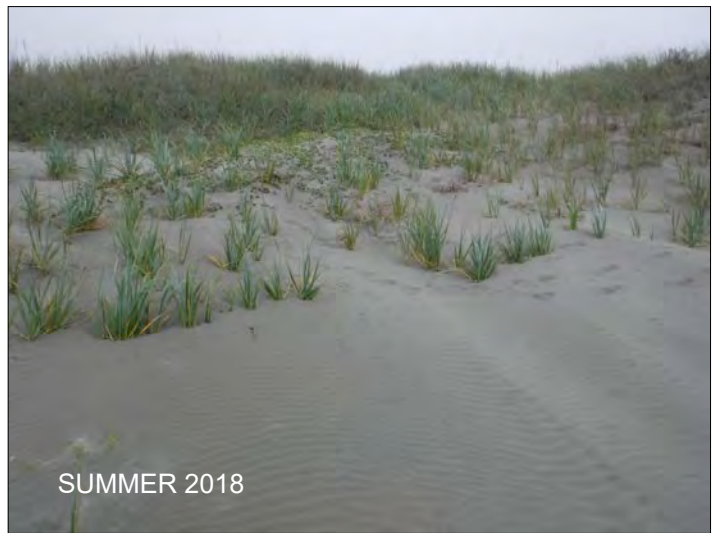
## Ma-le'l North Transect 30

Notes: Between 2012 and 2016 an incipient foredune formed. The incipient *Elymus* foredune scarped dramatically in winter 2017, losing 2.0 m vertically and lowering the beach. By summer 2017 the beach had regained the lost elevation and the incipient foredune slope was smoothed by erosion and ramping. The small peak at 109 m midway up the stoss face of the established foredune in winter 2016 is the relict of a knoll that eroded during the previous 3 years. The sand from the knoll moved up the face of the established foredune. By summer 2018 the incipient foredune was no longer a distinct feature, having welded on to the stoss face of the established foredune. By 2019 this feature had migrated up the foredune. Over the course of both studies the incipient foredune formed and then eroded/translated causing deposition of up to 1 m on the stoss slope of the foredune.

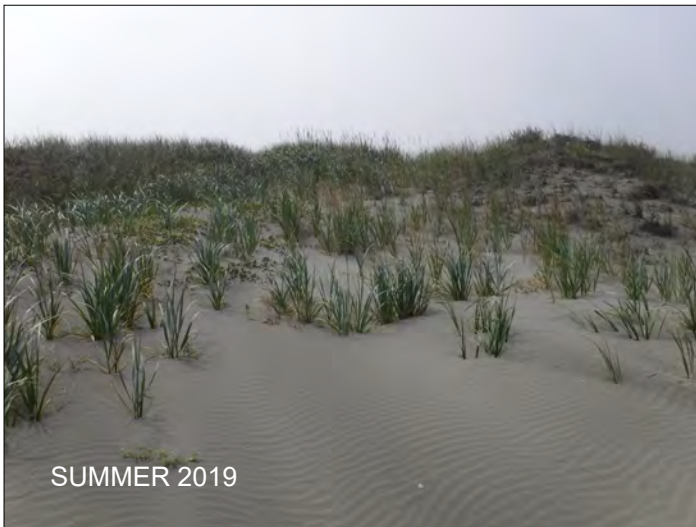
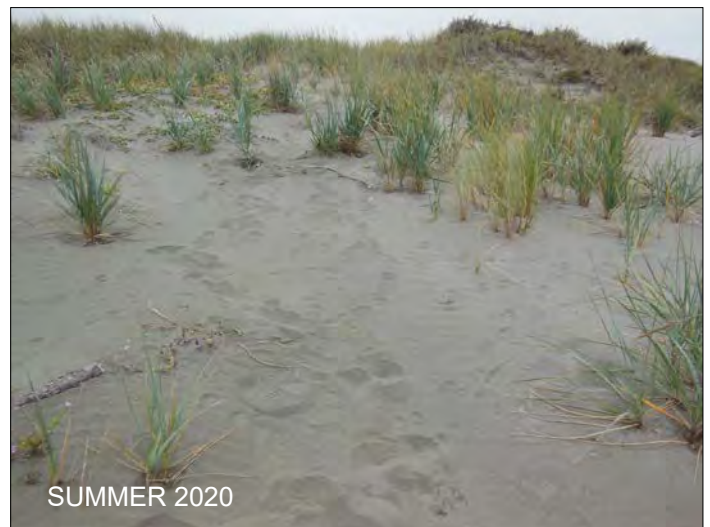
View southeast along transect at 117 m foredune base showing deposition on stoss face

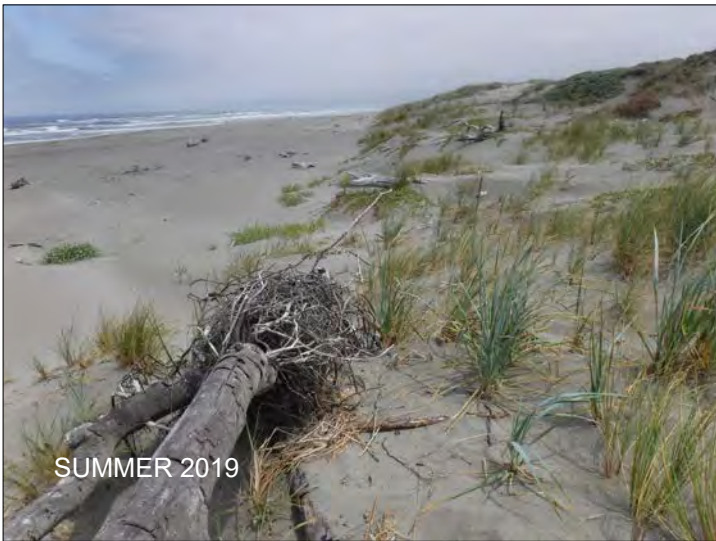
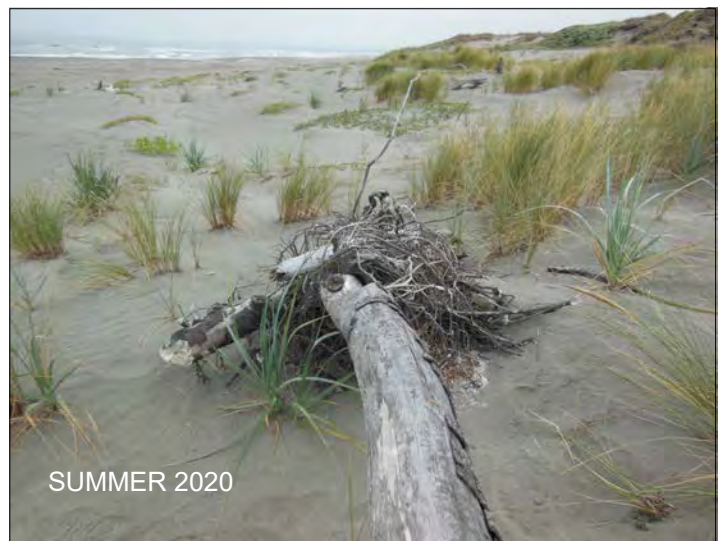
View north at 156 m (incipient foredune)

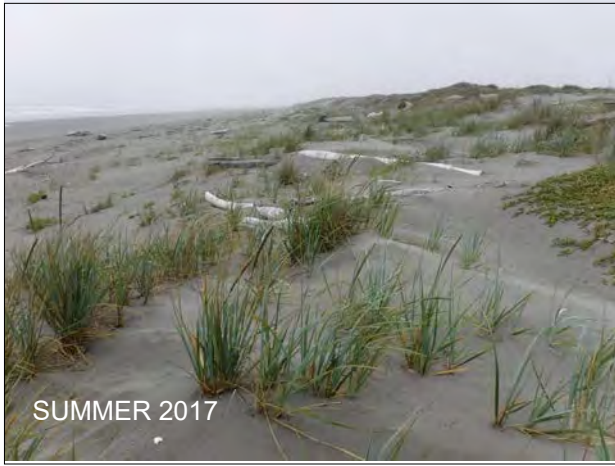
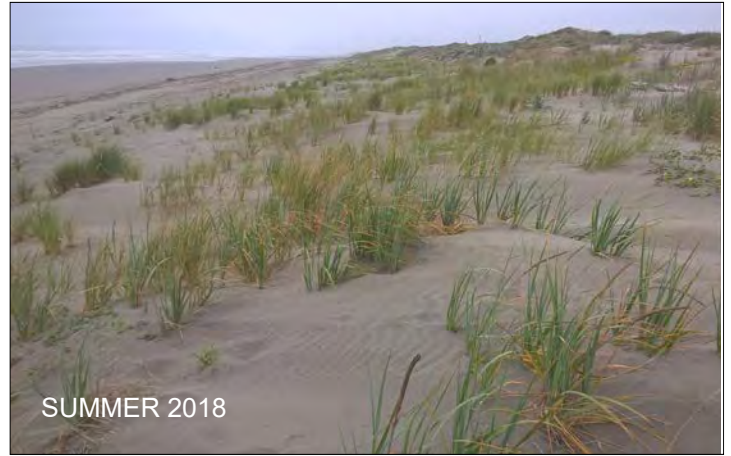
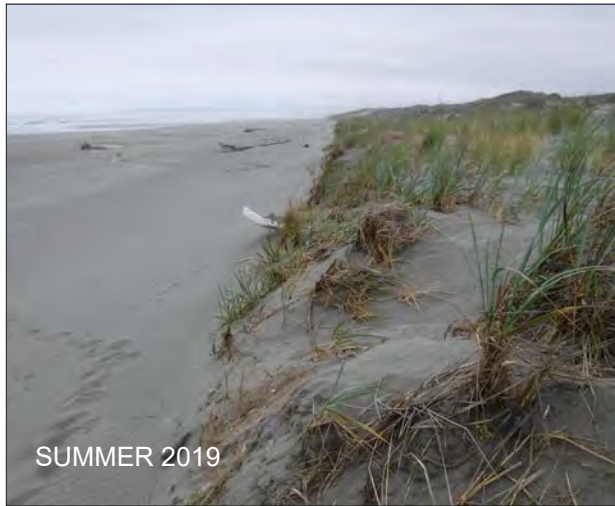
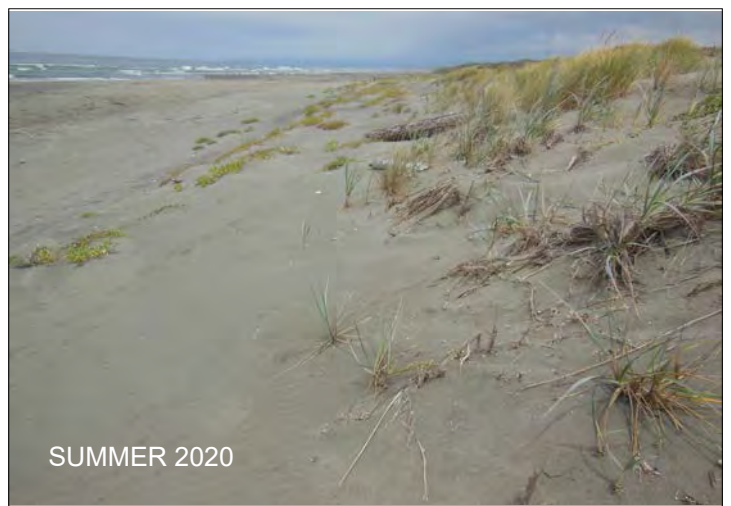
## Ma-le'ī South Transect 32

Notes: The broad, bench-like incipient foredune (similar to the previous transect) was scarped in winter 2016 and a steep beach slope resulted. In summer 2016 mobilized sand at the crest of the incipient foredune migrated into the incipient foredune swale and there was 0.5 m of deposition as the result of scarp-fill ramping. In winter 2017 the upper beach scarped and eroded. By summer 2017 sand had filled the scarp and deposition occurred on the incipient foredune. Additional deposition on the incipient foredune occurred by summer 2018, although erosion occurred on the upper beach. In 2019 the incipient foredune and upper beach were substantially scarped, as is visible in the photo below. By Summer 2020 a ramp had formed filling the scarp. Over the course of the study the incipient foredune was removed, retreating 20.0 m, but deposition occurred on the upper stoss face of the established foredune. There was also erosion at the crest.

View north at 144 m (incipient foredune)

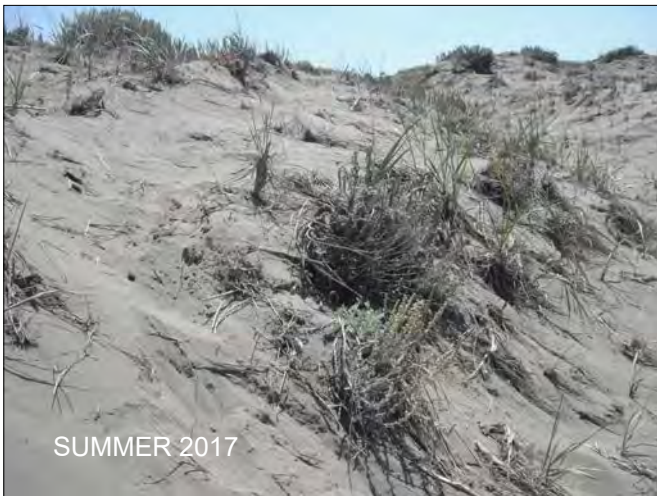
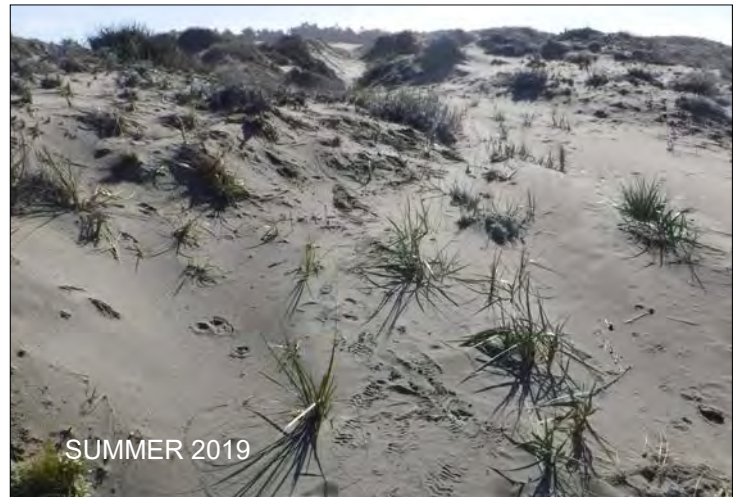
## Ma-le'i South Transect 33

Notes: A 2.0 m vertical scarp formed in the incipient *Elymus* foredune during high water events in winter 2017. By summer 2017 0.4 m deposition occurred on the upper beach, but the vertical scarp remained, although sediment was mobilized on its crest. By summer 2018 a scarp-fill ramp had formed and sediment had translated inland and filled the incipient foredune swale (see photos below). The established native foredune is eroded into hummocks and erosion occurred in the blowout between the peaks at 230 and 270 m. In 2019 the upperbeach was eroded and the fore-dune troughs were filled. By summer 2020 the peaks had coalesced into a more typical foredune. This profile extends further inland than most in order to capture the Humboldt Bay Municipal Water District pipelines in an area that has been vulnerable to erosion and exposure in the past. This area is actively managed, with sand placed over an exposed portion of the pipeline in 2015. Erosion is occurring on both sides of the knoll that sits on top of the pipeline. Note that the profile to the immediate west of the pipeline is stable, and the migration of the dunes at and east of the pipeline is unconnected to processes at the beach and foredune. Over the course of the study the foredune retreated 10.0 m.

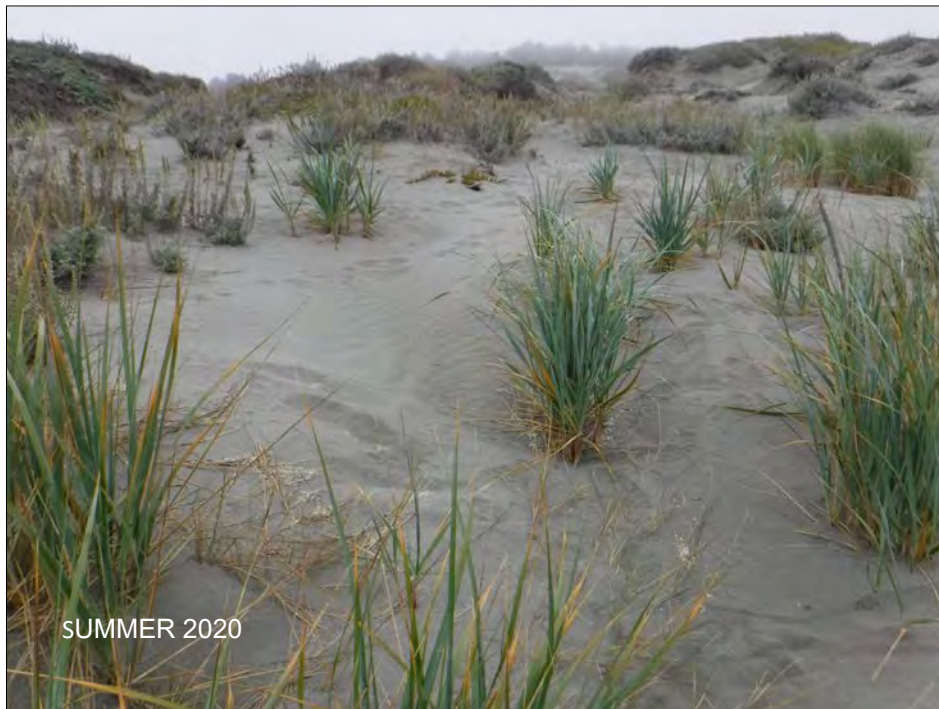
View southeast at 298 m (foredune base)
