HUMBOLDT COASTAL RESILIENCY PROJECT  
AND  
CLIMATE READY PROJECT

SUMMARY DATA FOR CROSS-SHORE TRANSECTS  
WINTER 2016-SUMMER 2020

Andrea Pickart and Candace Reynolds, U.S. Fish and Wildlife Service,  
and Ian Walker, U.C. Santa Barbara

July 2021

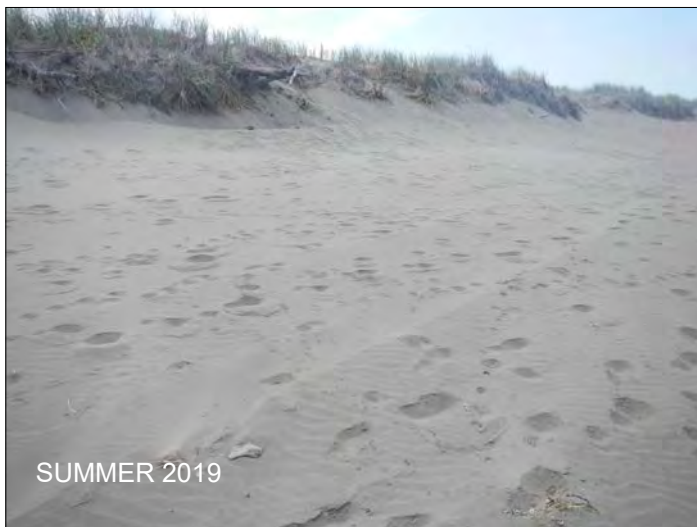
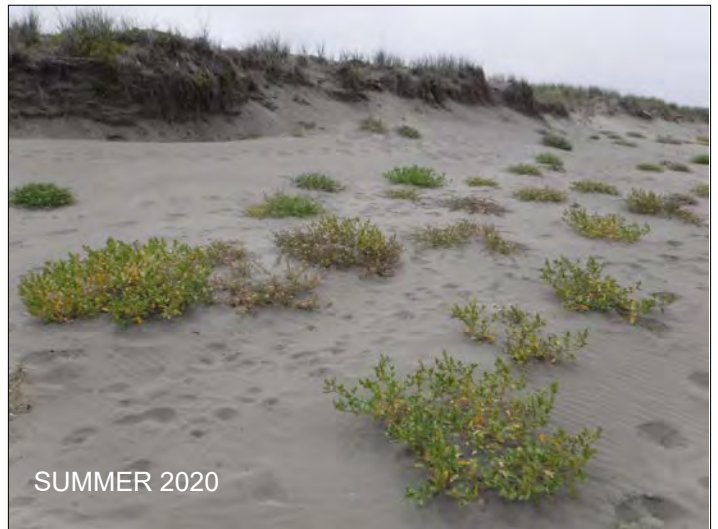
View southeast along transect from upper beach at 196 m

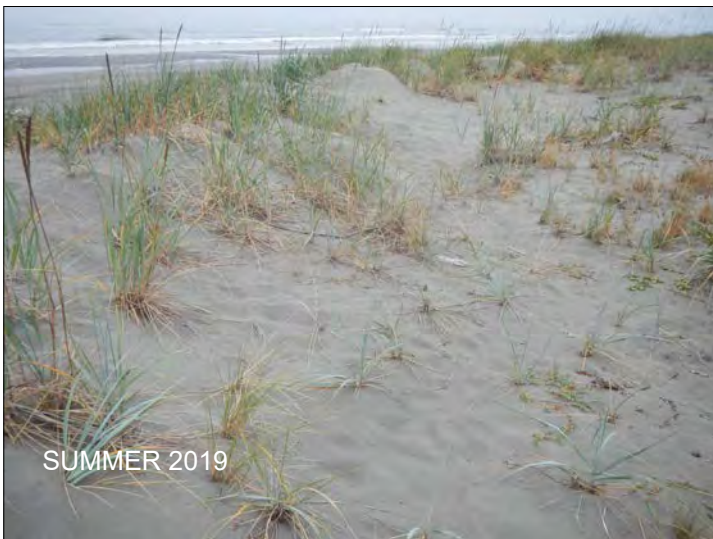
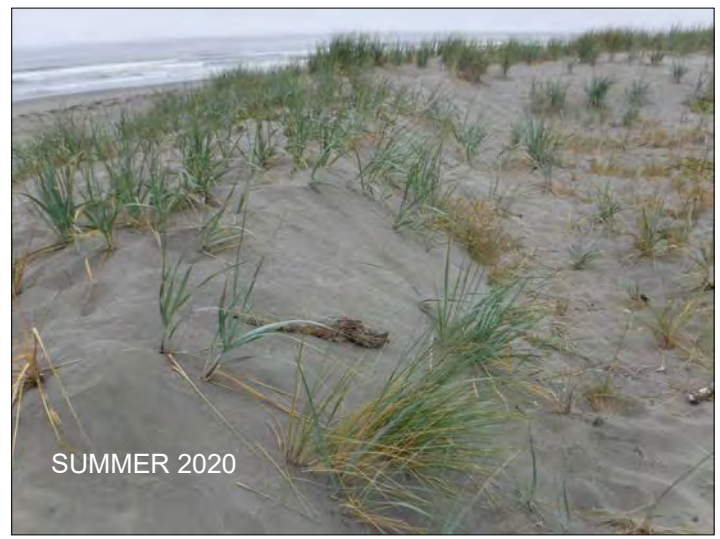
View northwest at 104 m (incipient foredune)

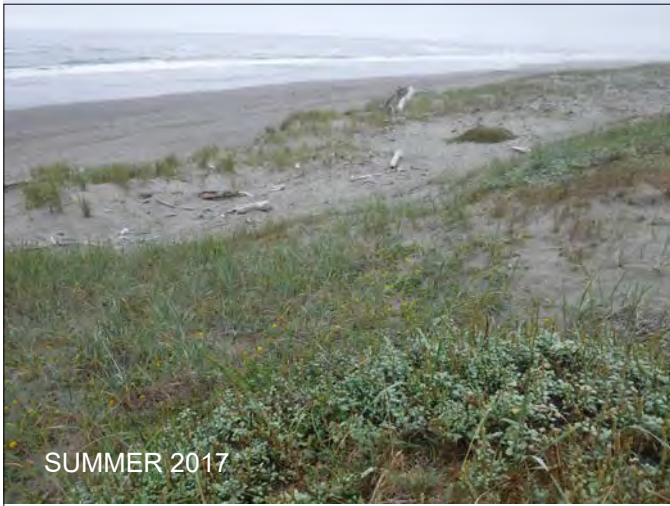
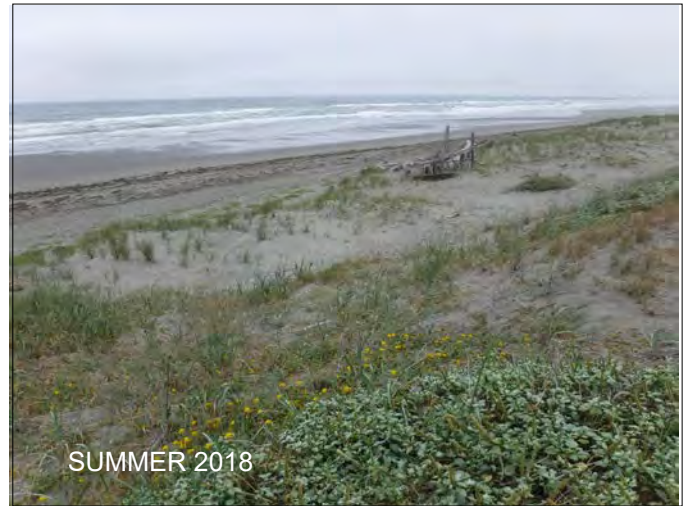
## Ma-le'l South Transect 37

View southeast along transect from foredune crest at 136 m

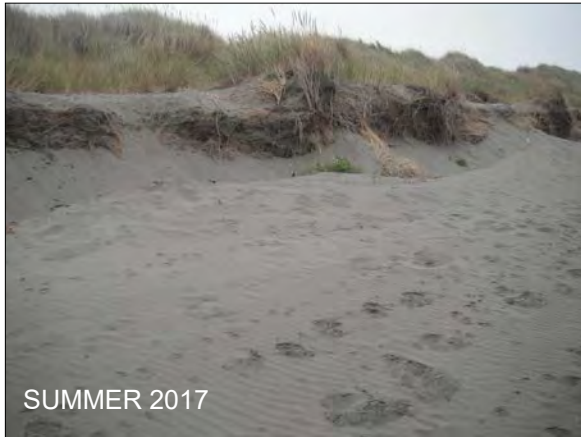
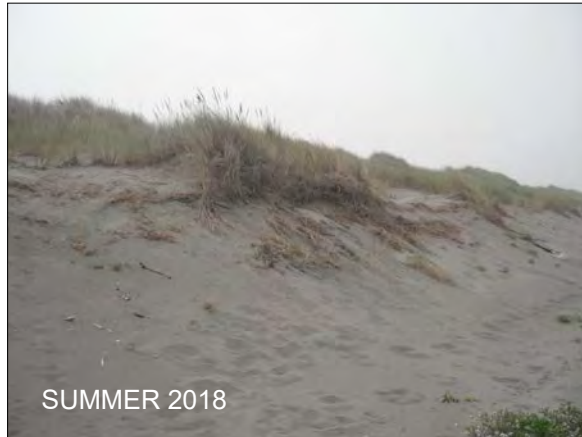
FOD Transect 38

Notes: The profile describes a stable, peaked *Ammophila* foredune seaward of an older, formerly native foredune, with a dynamic incipient foredune. Data are not available for winter 2016 but summer 2016 shows a well developed incipient *Ammophila* foredune that was significantly scarped (2.0 m elevation loss and 20 m horizontal retreat) in winter 2017, effectively removing the incipient foredune. Beach deposition occurred in summer 2017 but no scarp-fill ramping occurred, just minor slumping. By summer 2018 a loss of 0.5 m vertically had occurred on the upper beach at the toe of the incipient foredune (see photos above). Additional erosion of the upper beach occurred in 2019. Over the course of the study the incipient foredune completely eroded, retreating 15.0 m, while the established foredune was stable.

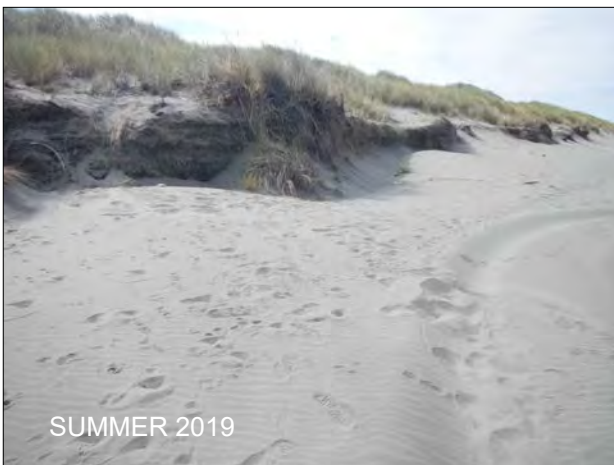
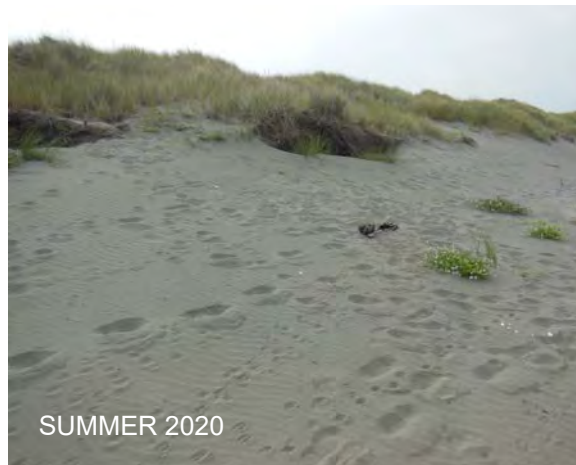
View southeast along transect at 180 m from upper beach showing scarp ed incipient foredune

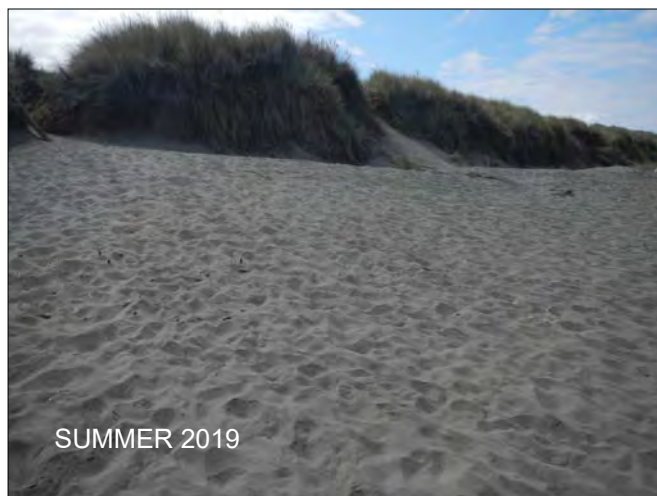
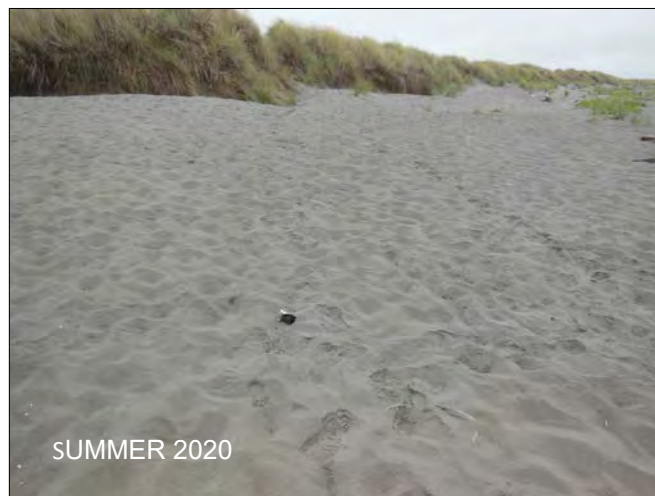
View southeast along transect at 114 m (upper beach) with view of scarped established foredune

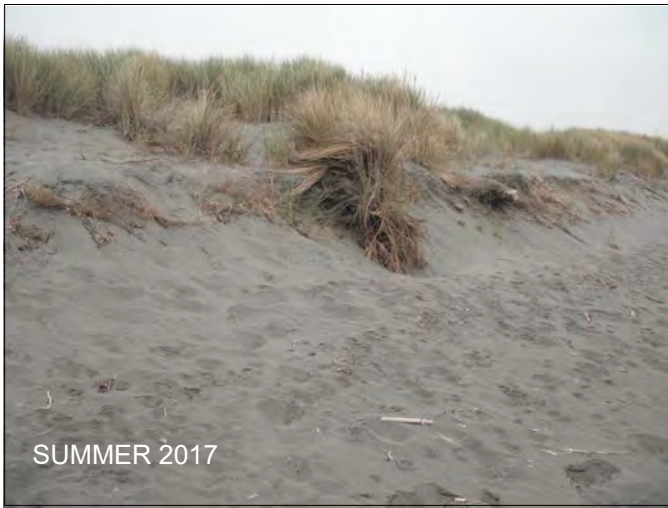
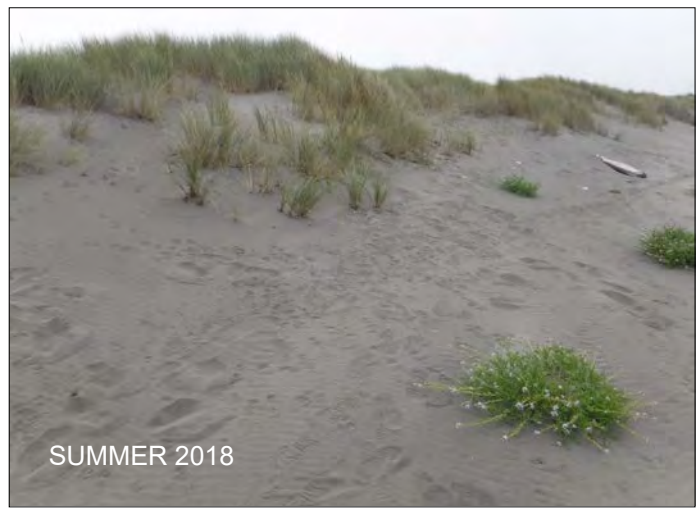
## FOD Transect 40

Notes: The profile depicts multiple incipient and established foredunes built by *Ammophila*, although the area behind the first persistent incipient foredune (crest at 115 m) has undergone *Ammophila* removal. Between winter 2016 and summer 2016 deposition of 0.5 m occurred on the upper beach, creating a new sparsely vegetated *Ammophila* incipient foredune (crest at 125 m). This incipient foredune was then scarped in winter 2017 and the beach eroded, emphasizing the incipient foredune topography although its crest elevation was unchanged. Some slumping had occurred by summer 2017 (see left photograph looking inland along transect from upper beach) but the incipient foredune profile did not change. By summer 2018 a scarp-fill ramp had formed (top right photo). The feature was again scarped in winter 2019, with some recovery in summer 2019. By summer 2020 a scarp fill ramp had formed. Over the course of the study the outer incipient foredune was eroded, retreating 2.0m, and the more inland incipient foredune increased in breadth (prograding 2.5 m) due to ramp formation.

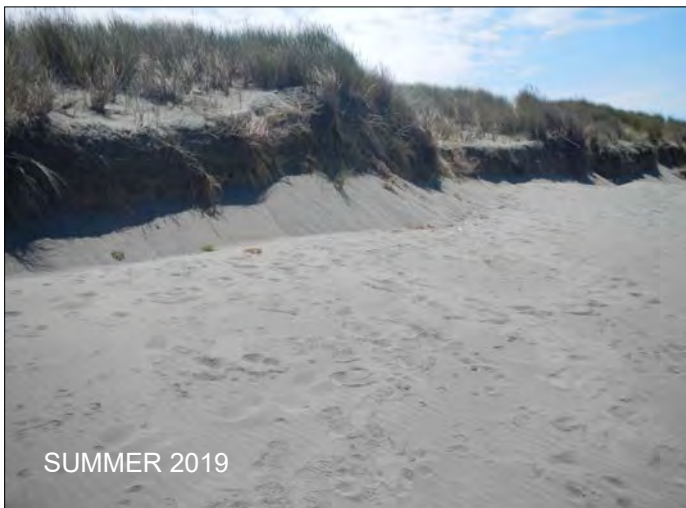
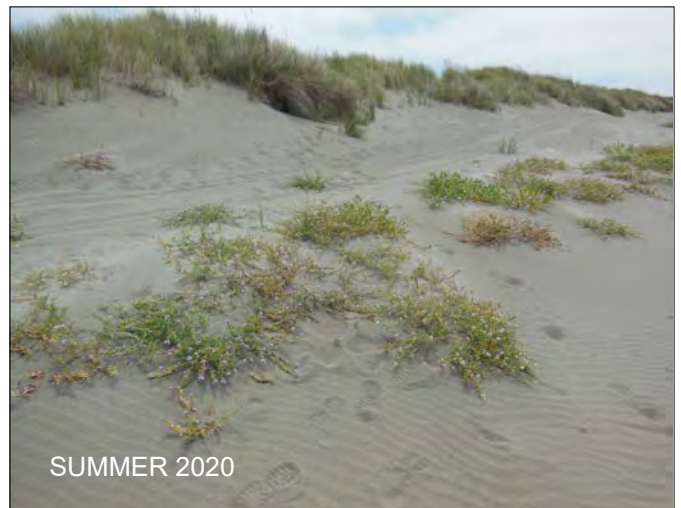
View southeast from upper beach showing incipient foredune

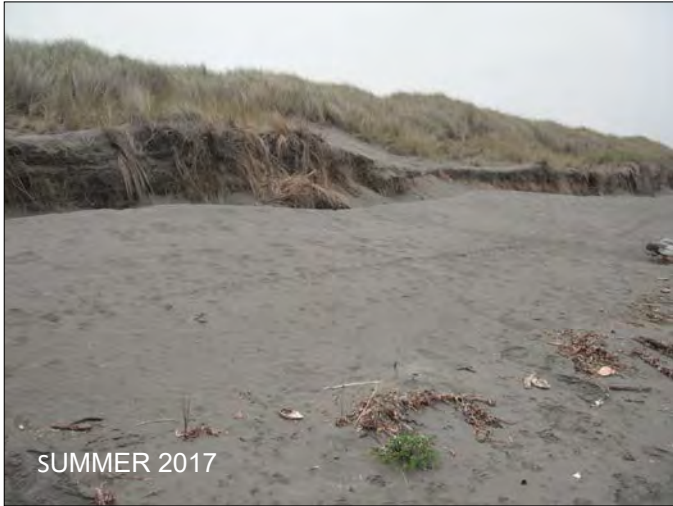
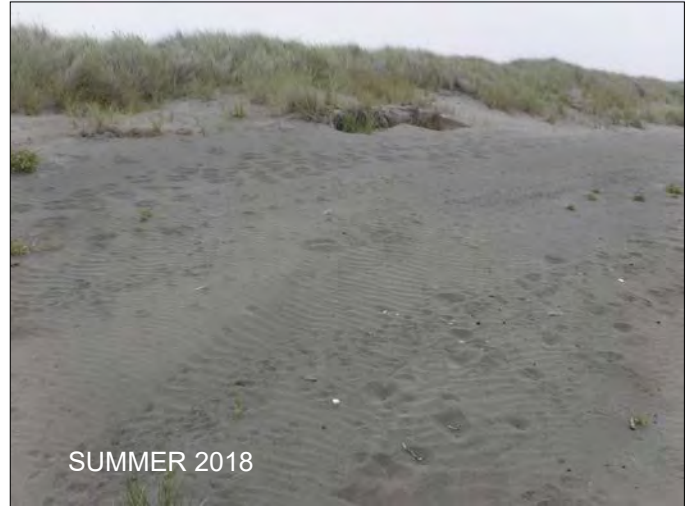
MCSO Transect 41

Notes: The transect is located in an unrestored portion of property owned by the Manila Community Services District. The profile depicts a dynamic incipient foredune and a stable peaked *Ammophila* foredune fronting a backdune area stabilized by *Ammophila* and *Carpobrotus*. The incipient *Ammophila* foredune saw deposition of up to 0.6 m between winter and summer 2016. It was then almost entirely scarped in winter 2017 (loss of 2.4 m vertically and 24.0 m horizontally). By summer 2017 there was minimal recovery, although some upper beach deposition occurred, as can be seen in the photograph taken at the upperbeach looking southeast. Between winter 2018 and summer 2018 a scarp fill ramp formed, with deposition of up to 0.7 m on the upper beach. By summer 2019 vegetation was colonizing the upper beach. Over the course of the study, the incipient foredune was completely removed, re-creating 20.0 m, and there was deposition of the stoss face of the foredune.

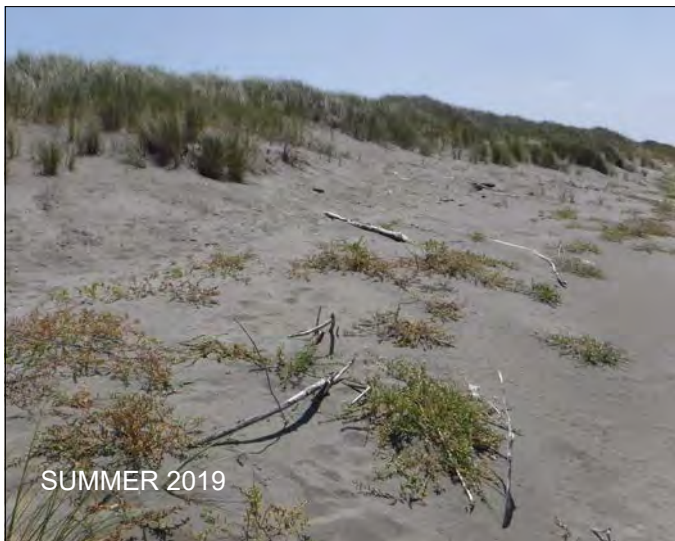
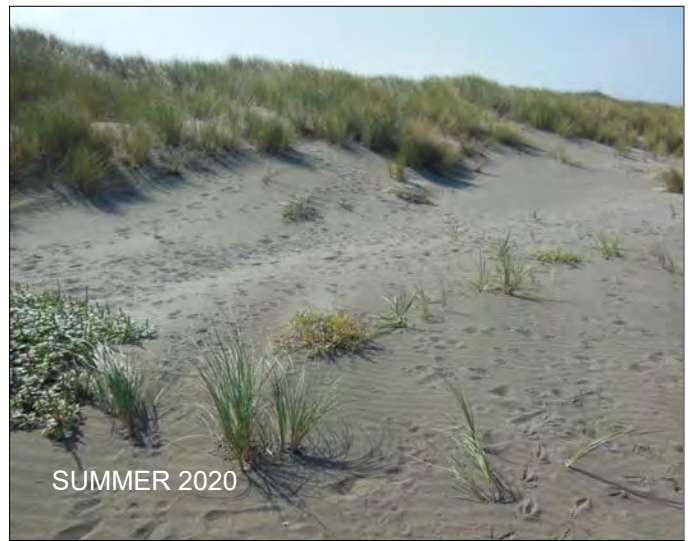
View southeast along transect at 152 m, showing incipient foredune from upper beach.

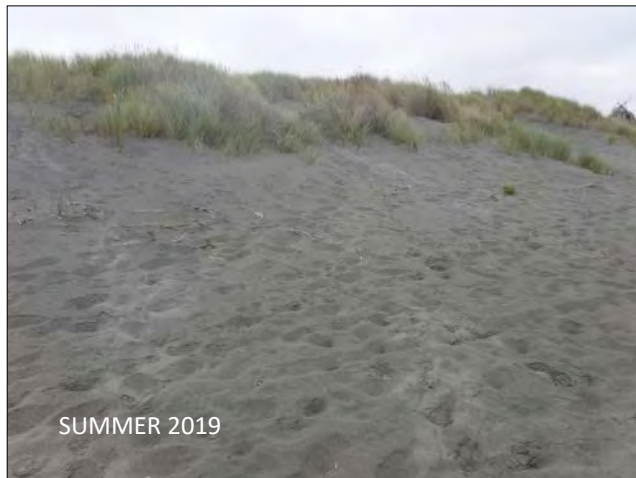
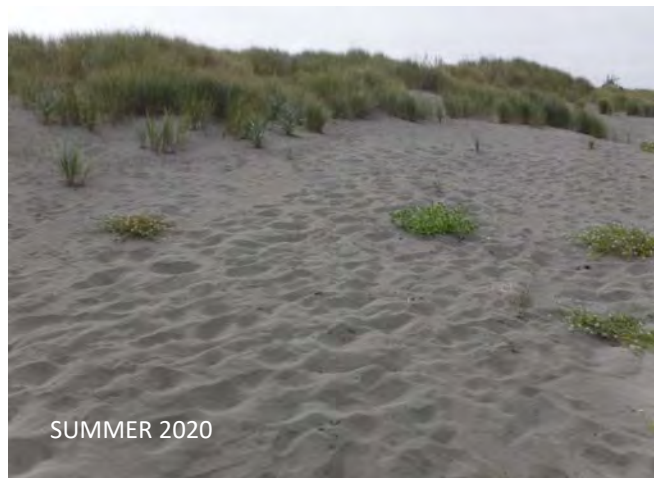
View southeast along transect at 156 m (upper beach) showing beach scarp

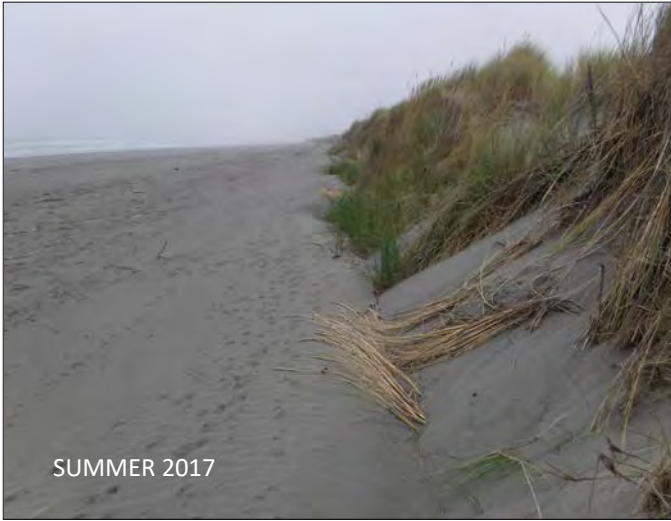
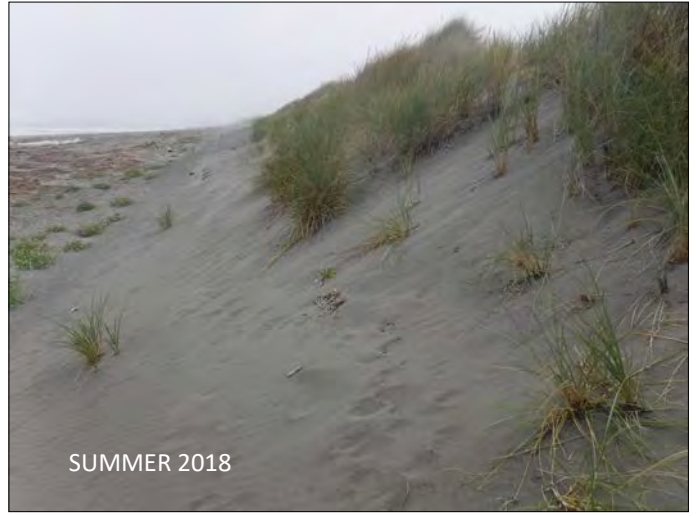
# MCS D Transect 43

Notes: The transect is located in the Manila Dunes Recreation Area. The area was restored in the 1990s-2000s, but was not maintained, and *Ammophila* has invaded the foredune zone. The profile describes an incipient *Ammophila* foredune fronting a higher native foredune. The incipient *Ammophila* foredune was scarped 1.4 m vertically in winter 2017, retreating 16 m along the transect. By the summer 2017 survey, a scarp-fill ramp had formed and partially filled the scarp. Between the winter 2018 and summer 2018 surveys the ramp was eroded and the beach lowered. By summer 2019 a scarp-fill ramp had reformed. The ramp attached to the incipient foredune by summer 2020. Over the course of the study the incipient foredune evolved from a lower more gently sloping feature to a more peaked feature due to repeated scarping. The incipient foredune retreated 6.0 m horizontally.

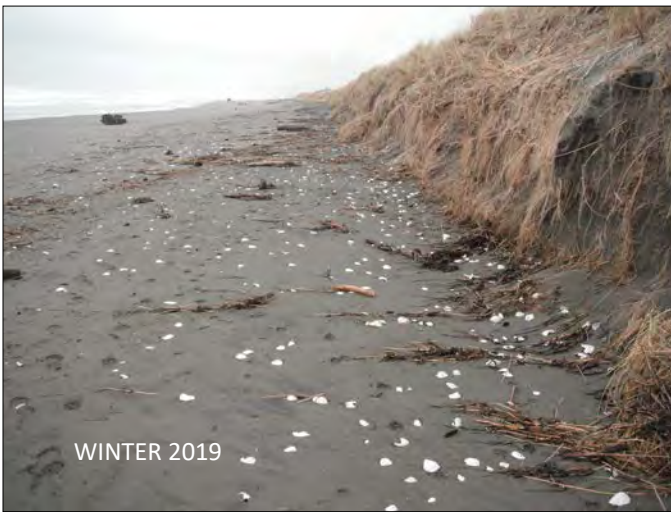
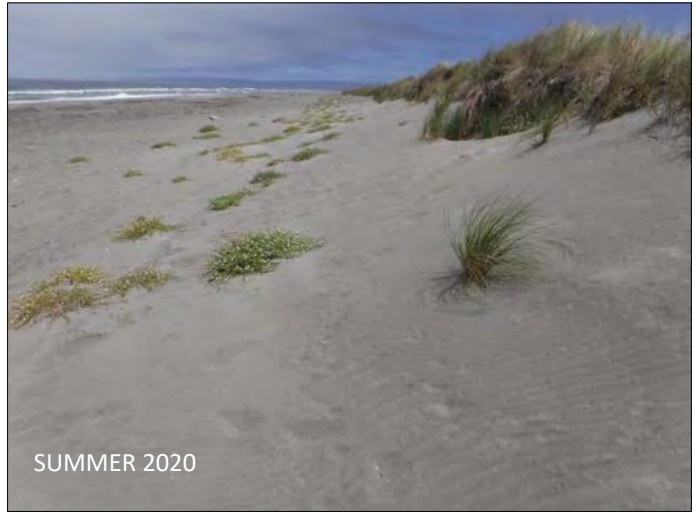
View north at 172m at foredune base

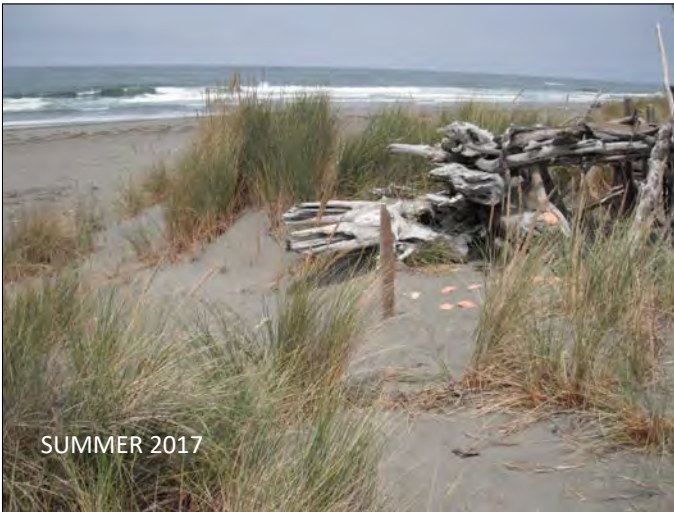
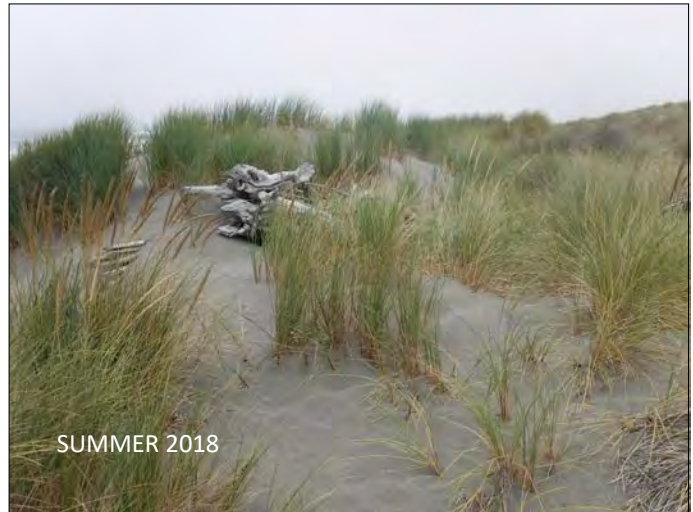
# MCS D Transect 44

Notes: The transect is located in the Manila Dunes Recreation Area. The area was restored in the 1990s-2000s, but was not maintained, and *Ammophila* has reinvaded the foredune zone. The profile describes a dynamic incipient *Ammophila* foredune in front of a broad, restored (but reinvading) stable, established foredune that slopes down to the deflation plain. The backshore and incipient *Ammophila* foredune was scarped (approximately 0.8 m vertical loss and 15 m horizontal loss along the transect) during high water events in winter 2017. By the summer 2017 survey, a scarp-fill ramp had formed, raising the backshore elevation and partially filling the scarp. In addition, new deposition (0.5 m) occurred at the crest of the incipient foredune following scarping. Between summer 2017 and summer 2018 the incipient foredune grew in elevation by an additional 0.5 m (see photos below, note burial of wood by sand deposition on left photo). In summer 2019 the incipient foredune increased in height by 0.5 m. There was additional minor deposition in summer 2020. Over the course of the study, the incipient foredune first eroded and then eventually built in elevation by 1.5 m.

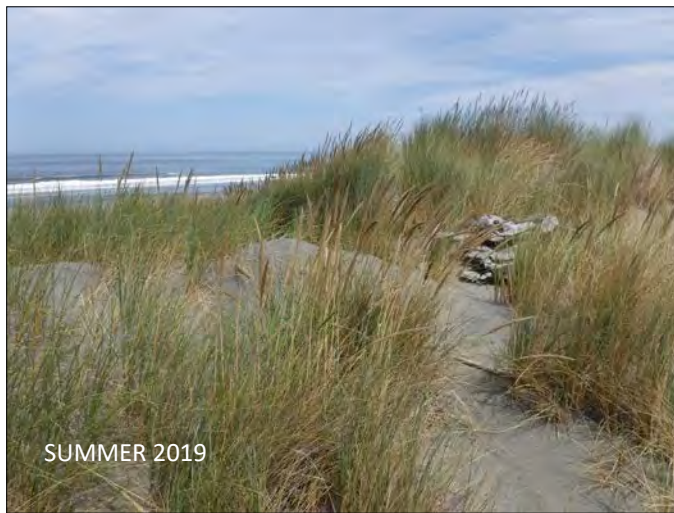
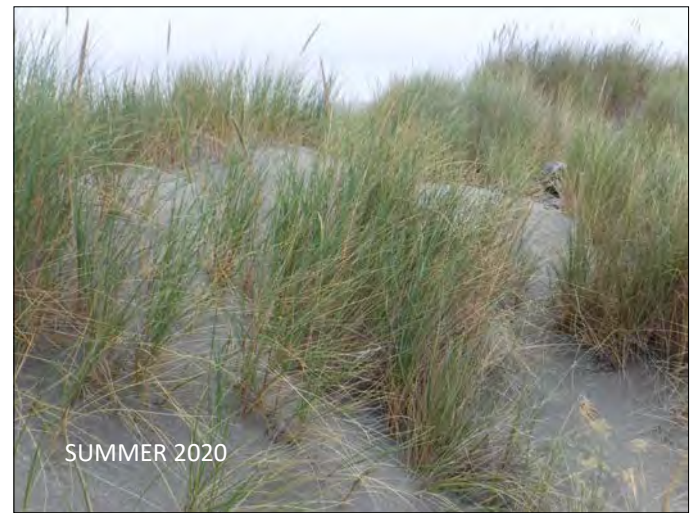
View northwest along transect taken at foredune base (140 m) showing incipient foredune

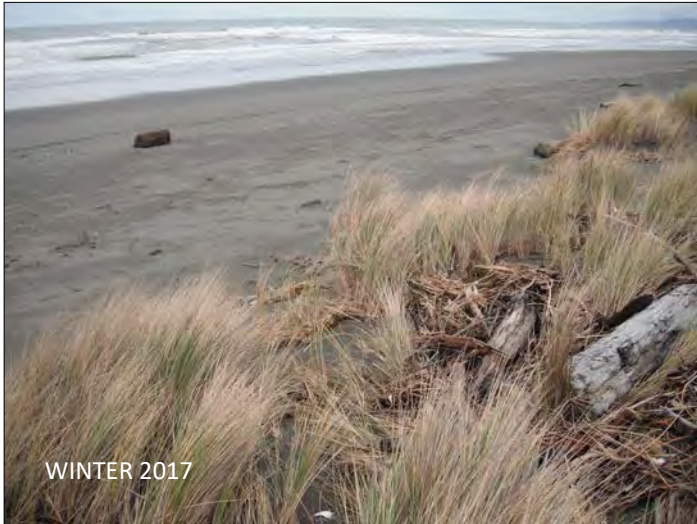
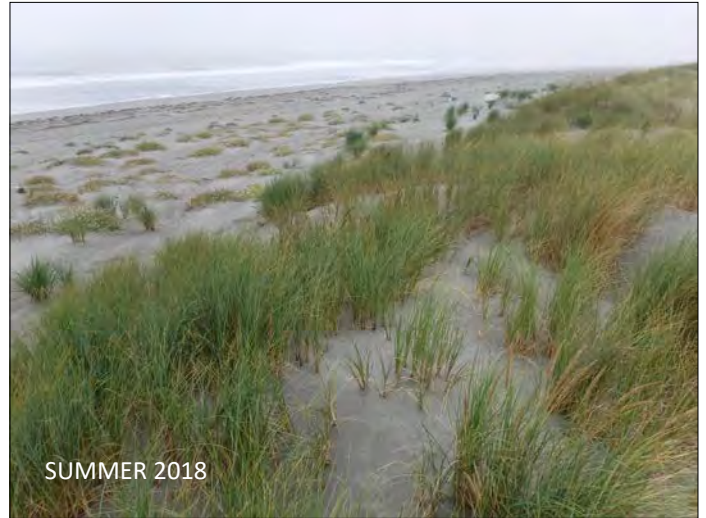
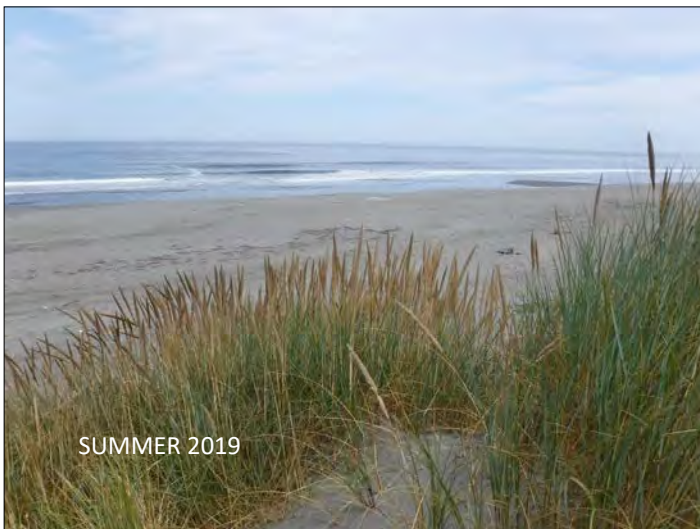
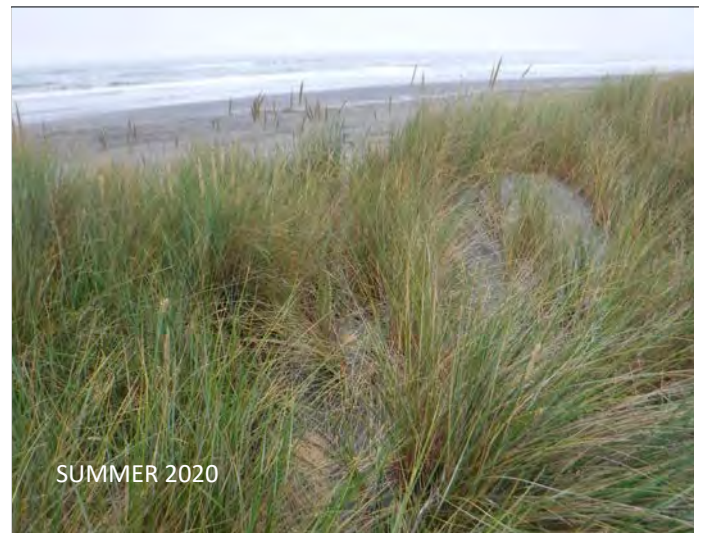
## MCSO Transect 45

View north west at 144 m (incipient foredune)

Notes: The transect is located in the Manila Dunes Recreation Area. The area was restored in the 1990s-2000s, but was not maintained, and *Ammophila* has reinvaded the foredune zone. The profile describes a dynamic incipient *Ammophila* foredune (crest 130 m) in front of an older, now established *Ammophila* foredune (crest 110 m). Behind that are relict native foredune peaks at 94 and 60 m. The incipient foredune scarped in winter 2016 prior to the survey, creating a more defined incipient foredune topography in summer 2016. By the following winter a scarp-fill ramp had filled the scarp, creating a gently sloping backshore. From winter 2017 to summer 2017, sand mobilized by the scarp deposited 0.5 m on the incipient foredune crest. Between summer 2017 and summer 2018 the incipient foredune increased in elevation by an additional 0.5 m. Deposition occurred on the upper beach in winter 2019. This profile began with scarping followed by steadily increasing volumes in the backshore and incipient foredune over the four year monitoring period. *Ammophila* is now establishing on the backshore below the incipient foredune, as can be seen in the photograph taken on the incipient foredune looking north-west along the transect.

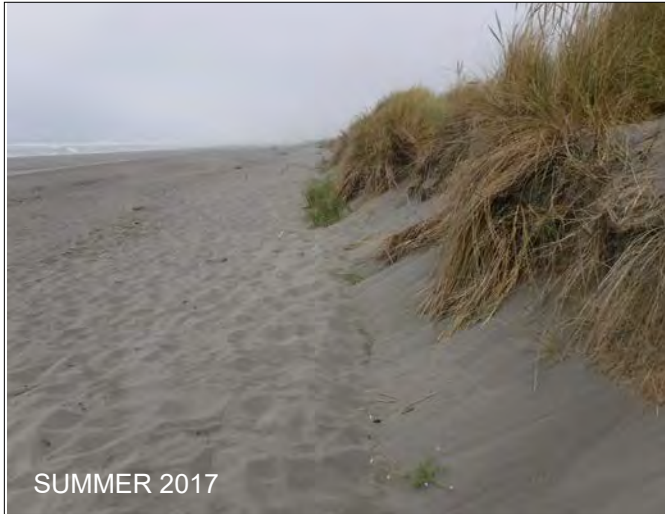
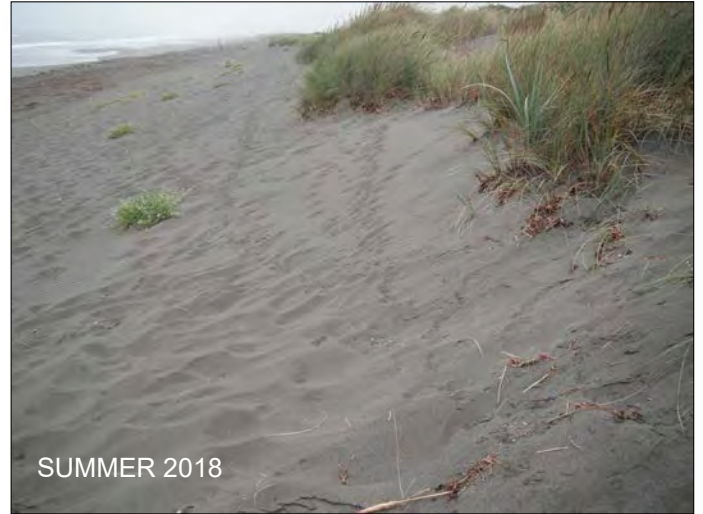
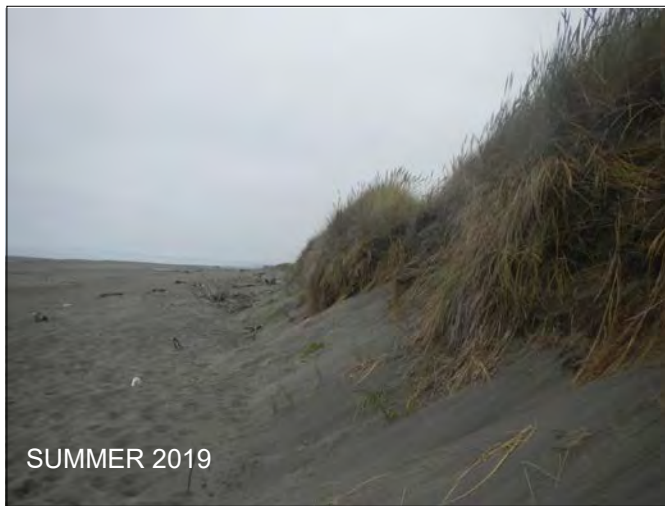
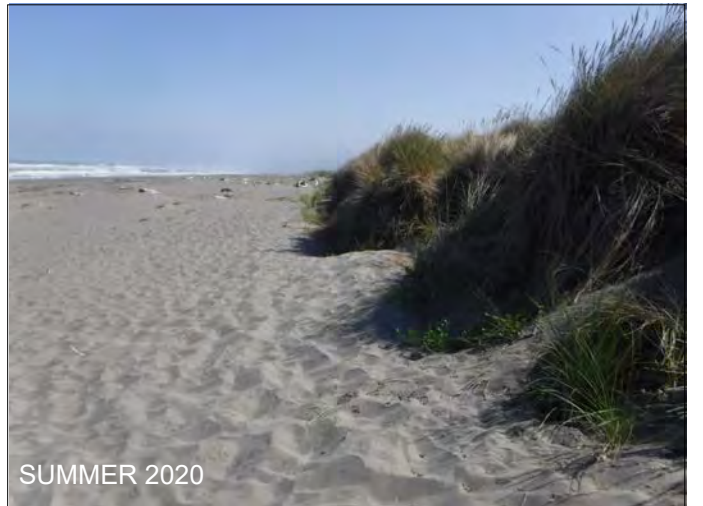
## Samoa Pacific Transect 46

View north at 126 m (foredune base)

Notes: The transect describes a steep *Ammophila* foredune (crest 106 m) with a relict native (now invaded) foredune at 76 m. The base of the foredune was scarped between the winter and summer 2016 surveys, resulting in beach lowering of 1.5 - 2.0 m. In winter 2017 the foredune was further scarped, retreating 10 m horizontally and removing 2.2 m vertically. From winter to summer 2017 there was upper beach deposition, with a scarp-fill ramp beginning to form, and minor deposition at the crest of the scarp. By summer 2018 the stoss face was completely ramped and had recovered the foredune morphology present in 2016. In 2019 and 2020 additional scarping occurred in winters, resulting in a steep foredune stoss face. Over the course of the study the foredune stoss face retreated 5.0 m but the beach gained in elevation. There is a pattern of winter scarping and summer beach deposition and ramp formation.

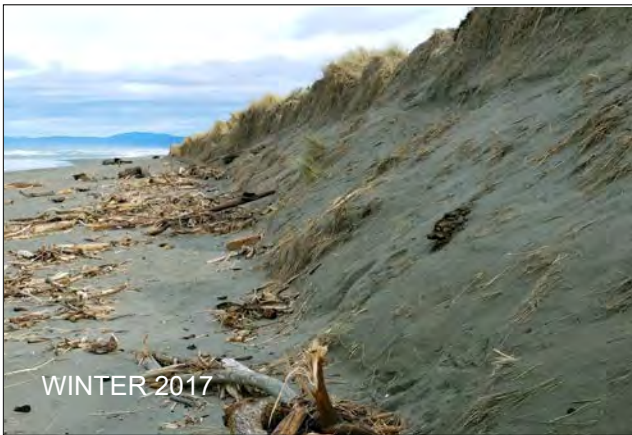
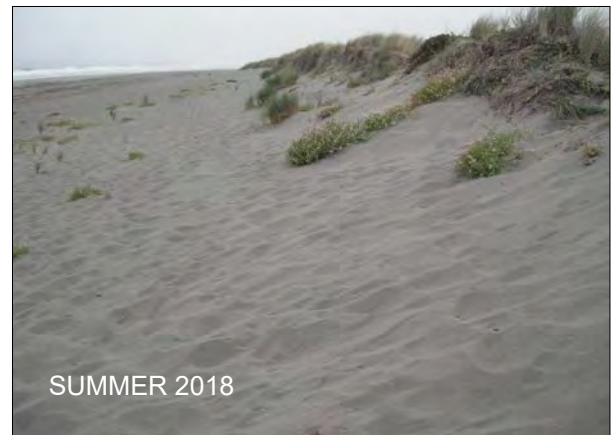
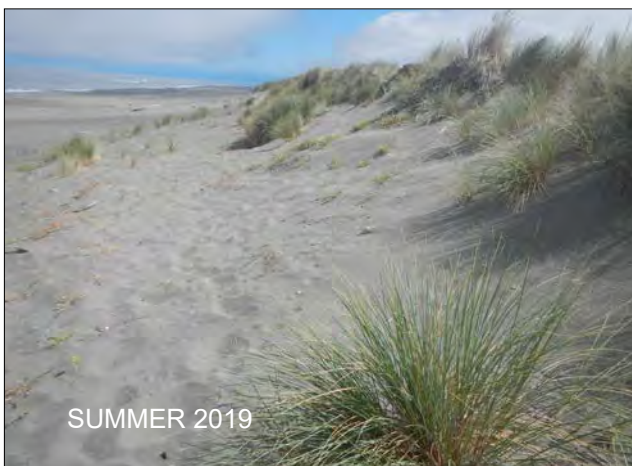
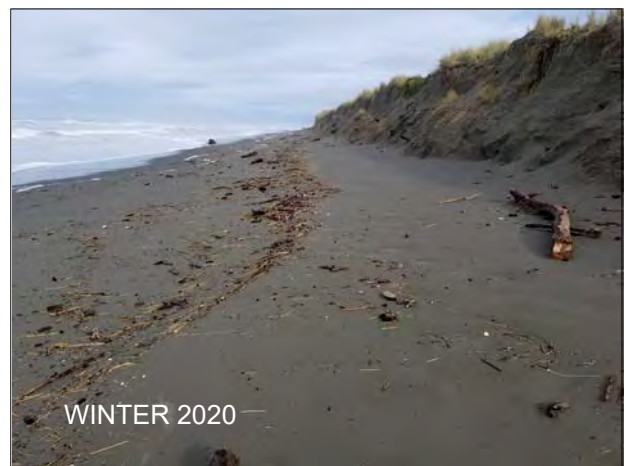
## Samoa-Pacific Transect 47

View north showing scarp at 78 m (left) and scarp-fill ramp at 72 m (right and below)

Notes: The transect is composed entirely of dunes that formed since 1939 and under the influence of *Ammophila* rather than native vegetation. The established *Ammophila* foredune was severely scarped prior to the winter 2016 survey, leaving a 5.0-m vertical scarp and presumably lowering the beach. The beach gradually recovered 2+ m of elevation. By summer 2018 a scarp-fill ramp had formed, and was present in similar proportions in summer 2019. In winter 2019 the foredune was scarped again and retreated 15 m., lowering the beach. In summer 2020 the beach gained some in elevation. Over the course of the study the foredune retreated 15 m.

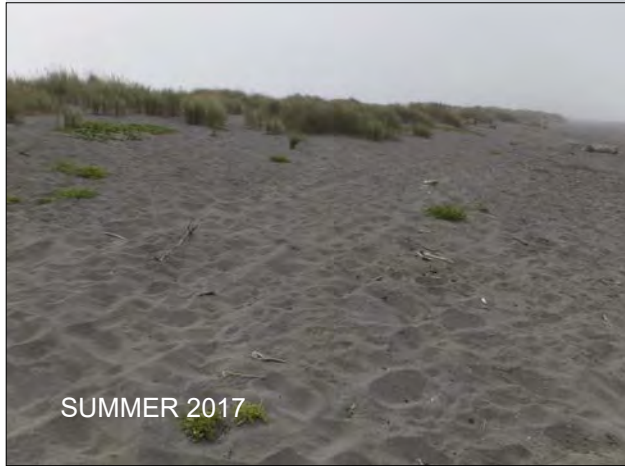
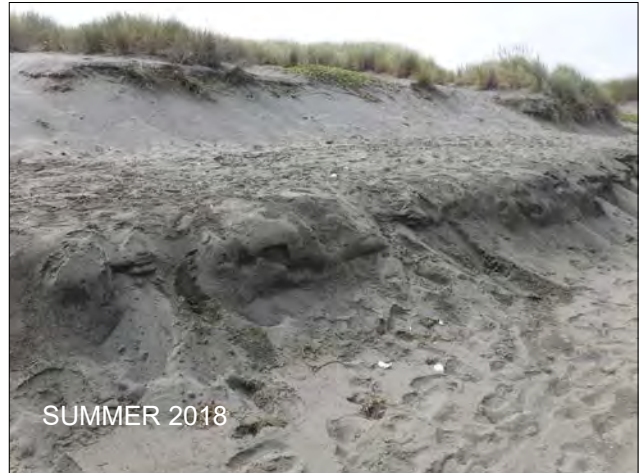
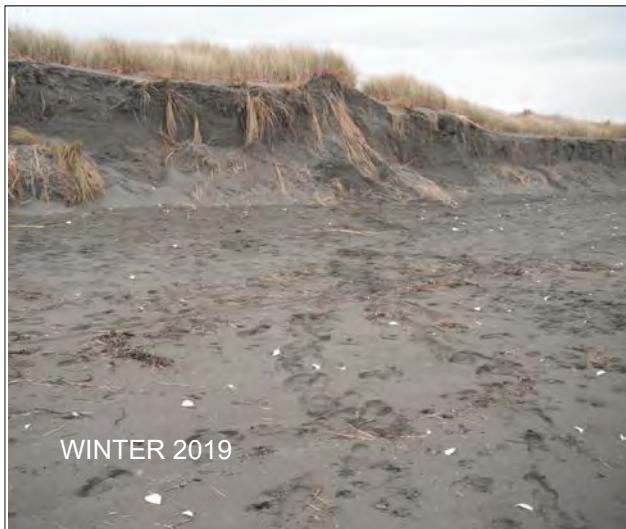
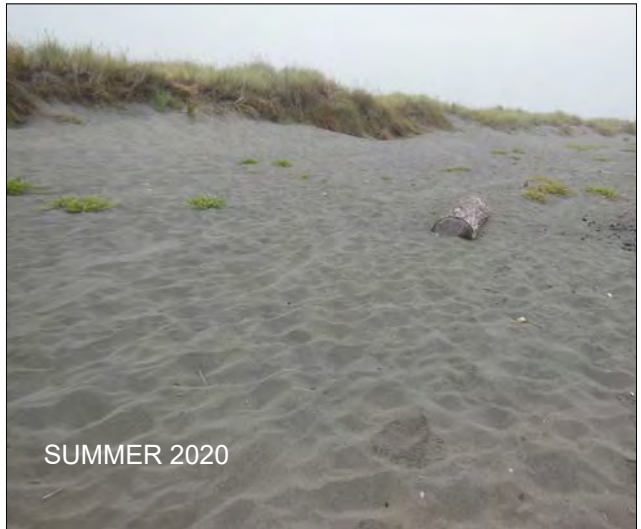
## Cal Redwoods Transect 48

View southeast along transect at 148 m (backshore) looking towards foredune.

Notes: The profile describes a low *Ammophila* foredune in front of a lower backdune area. Deposition of 0.4 m occurred on the backshore in summer 2016 suggesting the start of an incipient foredune, along with up to 1.0 m seasonal deposition on the beach at 184 m. Erosion in winter 2017 removed substantial sediment from the beach (2.2 m at 184 m), creating a steeply sloping beach. However, some deposition occurred on the incipient foredune zone. In summer 2017 the beach did not increase in elevation, but there was 0.8 m deposition on the crest of the incipient foredune, essentially merging it with the established foredune. In winter 2017 scarping removed 2.0 m of vertical sediment from the backshore (see photo below right) and very little change occurred between winter and summer 2018 other than deposition in the foreshore. In winter 2019 additional scarping occurred. By summer 2020 ramping/slumping had occurred but the top portion of the foredune was still scarped. Over the course of the study the foredune broadened, with 0.7 m of deposition on the crest, but assumed a scarped morphology.

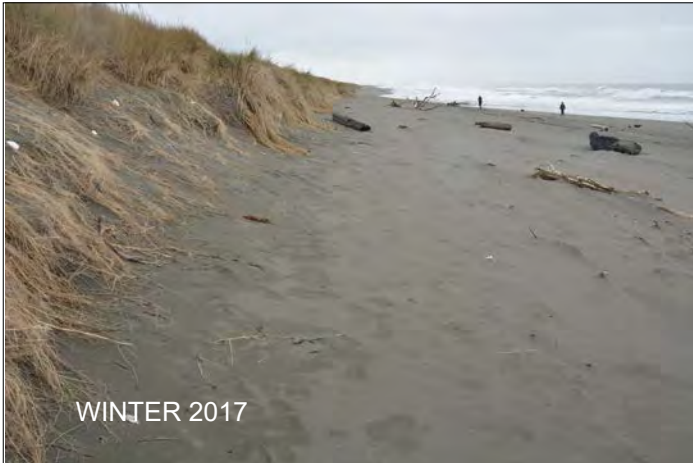
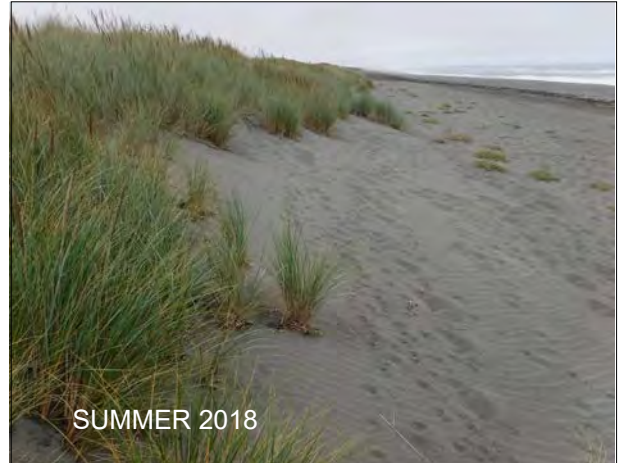
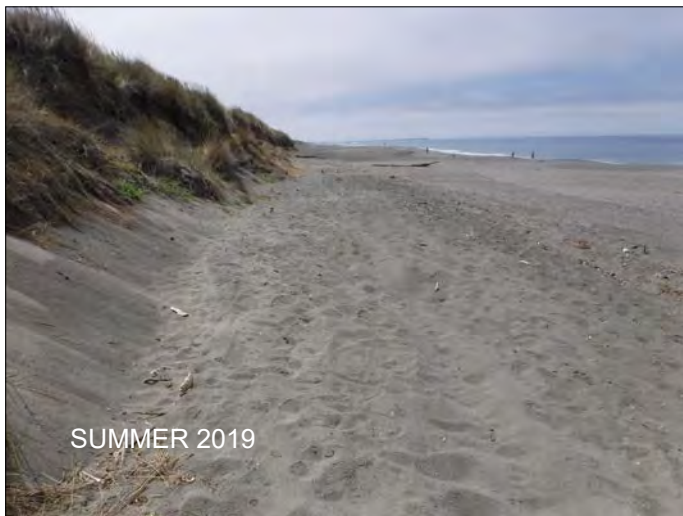
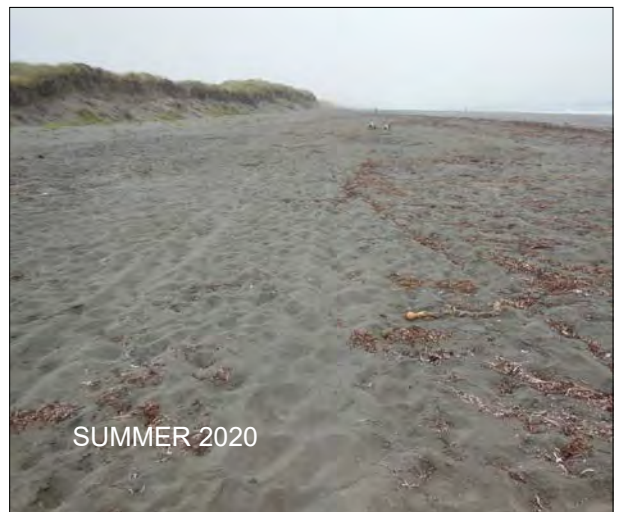
## Fairhaven Power Transect 49

View south at 100 m (foredune base and scarp)

Notes: The established *Ammophila* foredune was severely eroded in winter 2016 prior to the survey, resulting in a 2.0 m vertical scarp. The beach steadily regained elevation in the following two years, and by summer 2017 a scarp-fill ramp had almost completely welded to the former crest of the foredune as can be seen to the south in the photograph below. By summer 2018 deposition was occurring on the stoss face of the foredune (photo below). However, between winter and summer 2019 major scarping occurred, eroding the foredune 5.0 m horizontally. In winter a major erosional event eroded the foredune completely, causing a retreat of 35.0 m. In summer 2020 deposition on the foreshore reduced the height of the scarp. Over the course of the study, this site was severely erosional, with complete loss of the foredune and retreat of 30.0 m.

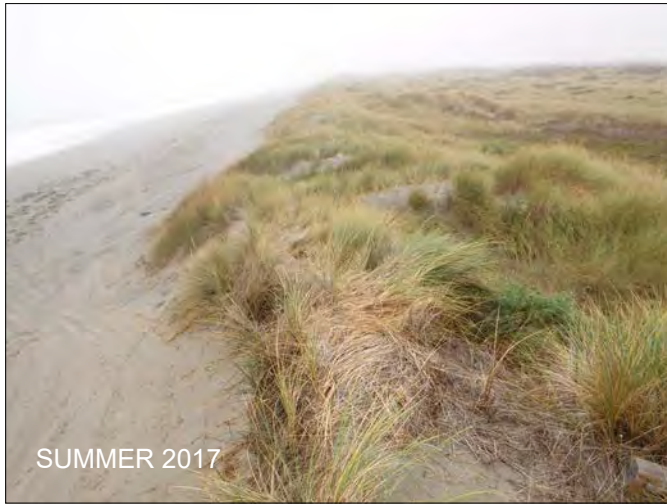
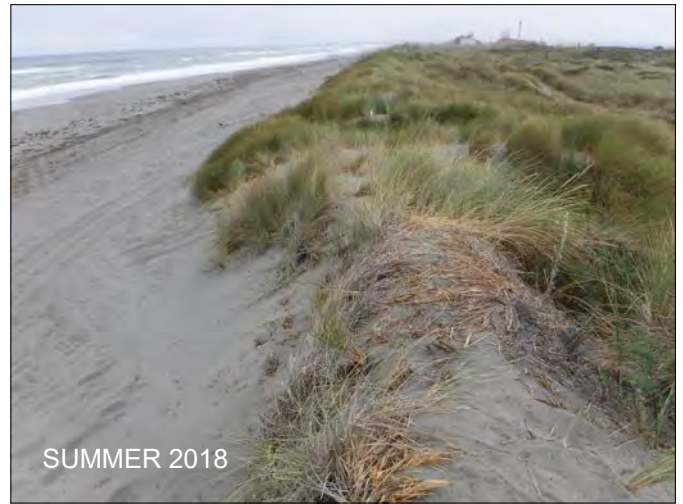
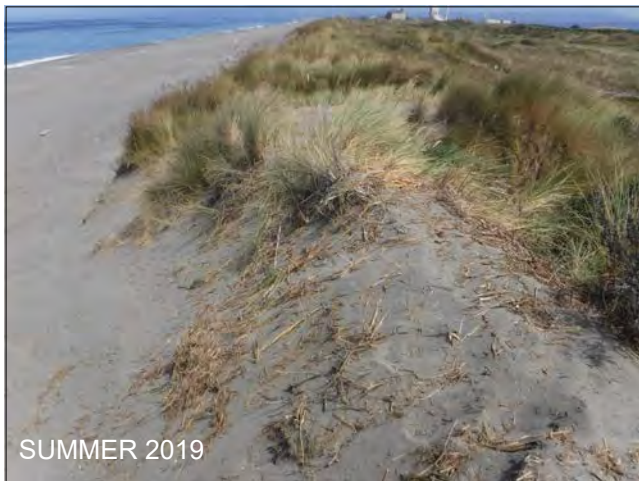
## City of Eureka Transect 50

View north at 120 m (foredune crest)

Note, the summer 2020 photo could not be taken because the photopoint had eroded away.

Notes: The transect is located near the City of Eureka’s Samoa airstrip, and depicts a peaked *Ammophila* foredune backed by a low *Ammophila*-stabilized backdune area. The backshore was relatively stable during 2016, with the foreshore exhibiting typical seasonal changes. In winter 2017 the backshore was scarped and lowered by 1.0 m vertically. By summer 2017 the backshore was still low, and the steep beach is visible in the photo taken at the crest of the foredune looking north. Between summer 2017 and summer 2018 deposition occurred in the foreshore and additional deposition occurred behind the foredune crest (see photos below). Between 2018 and 2019 the backshore lost up to 1.0 m in elevation and the foredune base was eroded. In winter 2020 the foredune scarped, retreating up to 10m. Over the course of the study the foredune lost almost half its breadth (10.0 m).

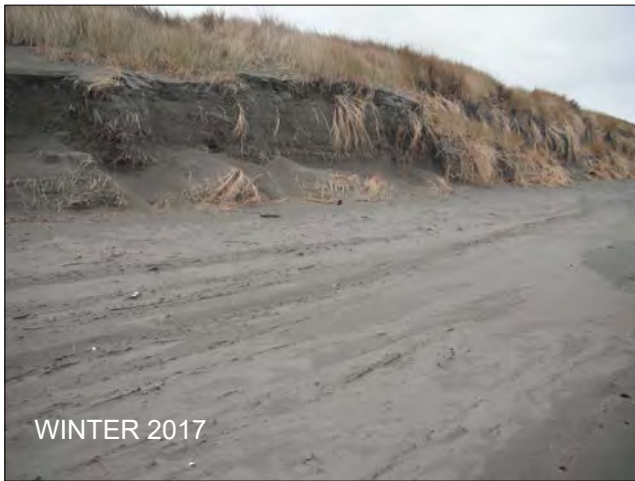
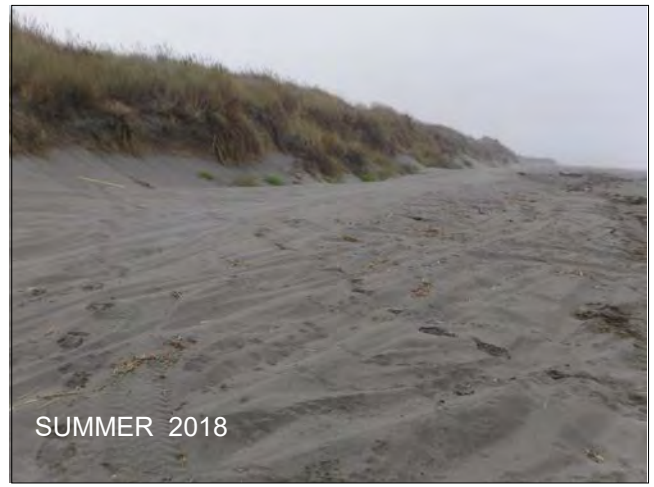
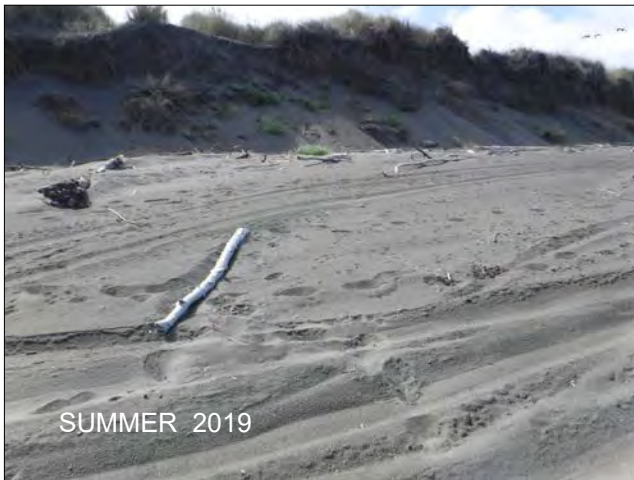
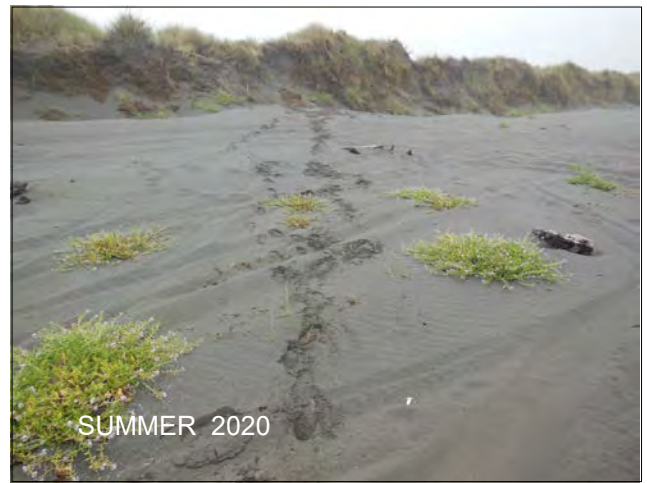
## City of Eureka Transect 51

View southeast along transect at 154 m (upper beach) looking towards foredune

Notes: The transect extends through an *Ammophila* dominated area that includes ATV trails in the extended area of the Samoa Dunes Recreation Area. The foredune was severely scarped in the winter of 2017, with approximately 2.0 m of vertical loss of foredune. By summer 2017, slumping had occurred but the upper beach had regained only 0.5 m of elevation. During 2018 deposition on the upper beach resulted in scarp fill ramping (see photos). However, in 2019 the foredune rescarped, losing up to 5.0 m horizontally. In summer 2020 ramping had occurred, but the upper portion of the scarp remained. The beach was high enough to support *Cakile*. Over the course of the study the foredune retreated 10.0 m.
