HUMBOLDT COASTAL RESILIENCY PROJECT  
AND  
CLIMATE READY PROJECT

SUMMARY DATA FOR CROSS-SHORE TRANSECTS  
WINTER 2016-SUMMER 2020

Andrea Pickart and Candace Reynolds, U.S. Fish and Wildlife Service,  
and Ian Walker, U.C. Santa Barbara

July 2021

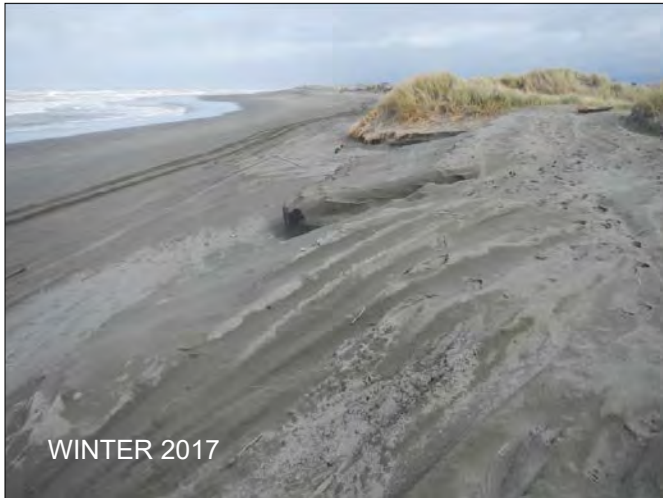
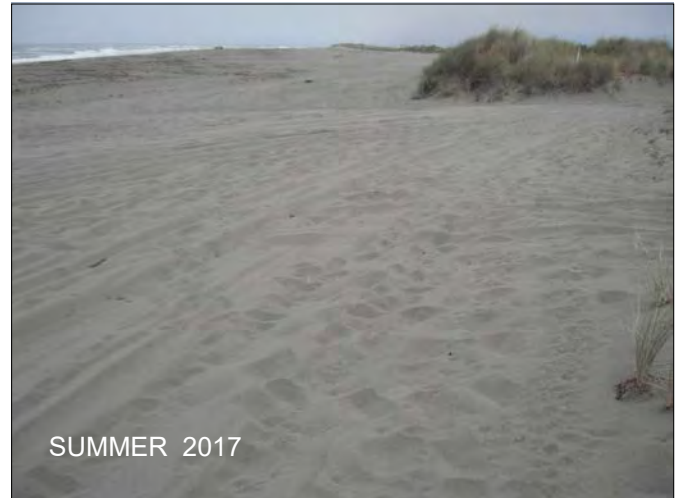
## Samoa Transect 52

View north at 162 m (foredune base)

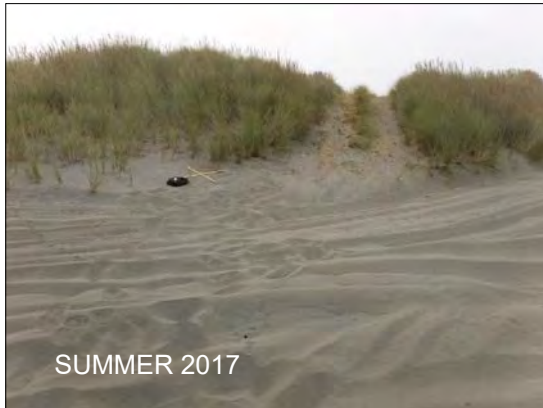
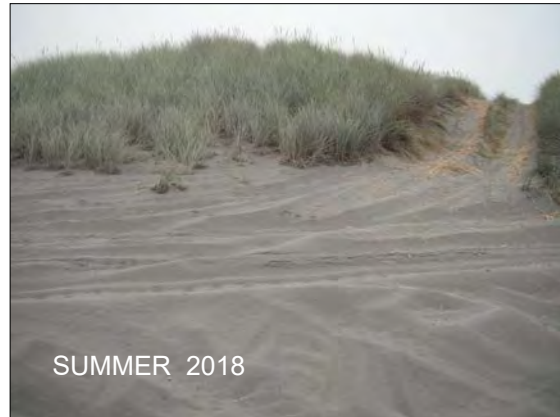
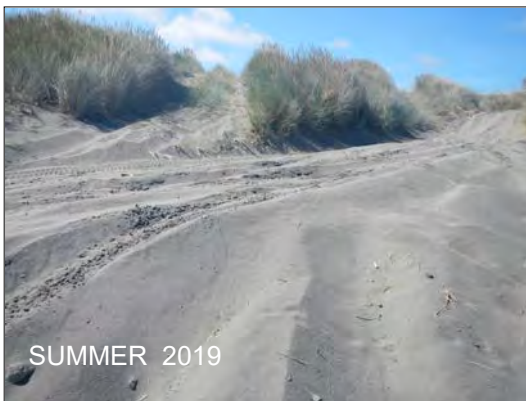
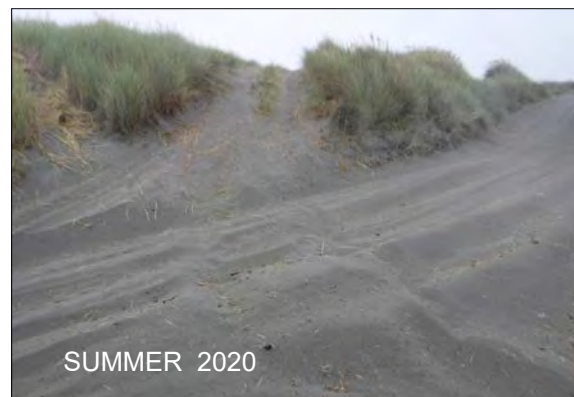
## Samoa\_Transect 53

View southeast at 144 m (upper beach) looking towards foredune

Notes: The transect is within the Samoa Dunes Recreation area and crosses several ATV trails that bisect an area stabilized by *Ammophila*. This is also an area of continuing high erosion since at least the 1930s, influenced by its proximity to the north jetty. The foreshore lost 1.0 m of elevation between 2016 and 2017, but the backshore gained 0.4 m and there was deposition on the foredune, especially on the lee slope where an ATV trail crosses the transect at 116 m. Between summer 2017 and summer 2018 up to 1.2 m eroded vertically from the upper beach, and there was additional deposition on the lee slope. In winter 2019 10+ m was eroded vertically from the backshore, which stayed at that elevation through summer 2019. Over the course of the study the backshore gained in elevation while the foreshore decreased in elevation. The foredune saw deposition both on the stoss and lee, the result of a vehicle trail that formed a slipface on the lee side.

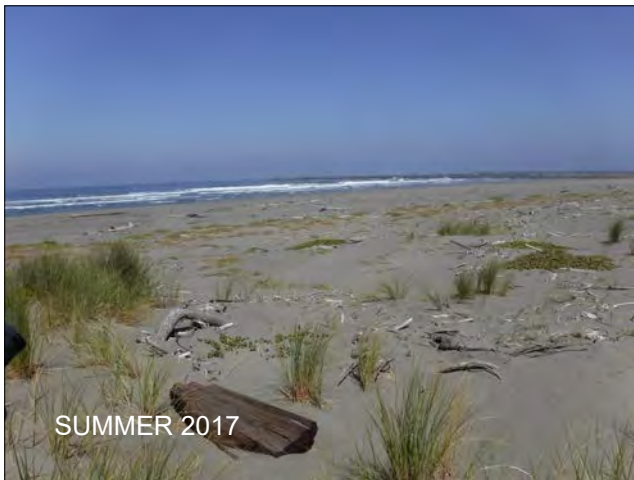
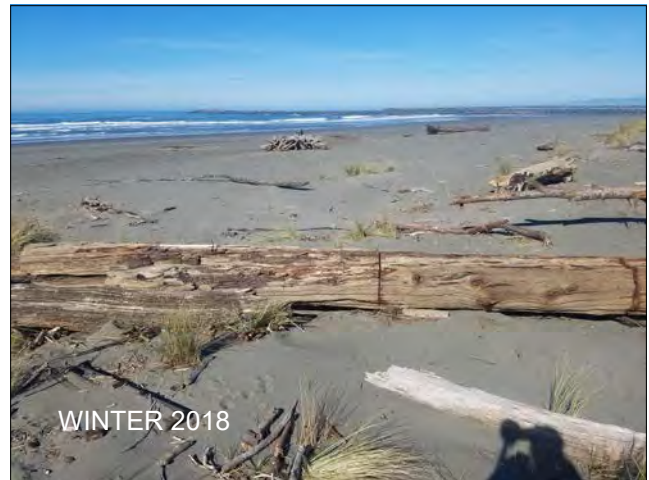
## South Spit Transect 54

View northwest along transect at 322 m (incipient foredune)

Notes: This transect intersects the South Spit at its widest point, in an area that vegetation is not managed. The profile demonstrates multiple, relict *Am-mophila* foredune ridges from shoreline accretion. Data are not available for winter 2016. From summer 2016 through summer 2017 the upper beach increased in elevation up to 1 m, becoming colonized by *Cakile* spp. In summer 2017 transverse dunes were migrating inland on the beach below the vegetation line, visible as ridges in the profile. The upper beach also gained in elevation up to 0.5 m between summer 2016 and summer 2017. Between summer 2017 and summer 2019 the upper beach assumed incipient foredune morphology. Between summer 2019 and summer 2020 there was significant erosion of the backshore. Over the course of the study an incipient foredune formed, but retreated 10.0 m, while the backshore eroded.

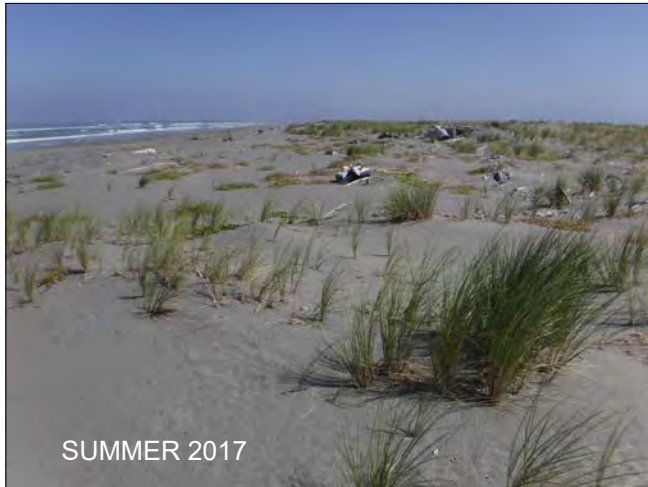
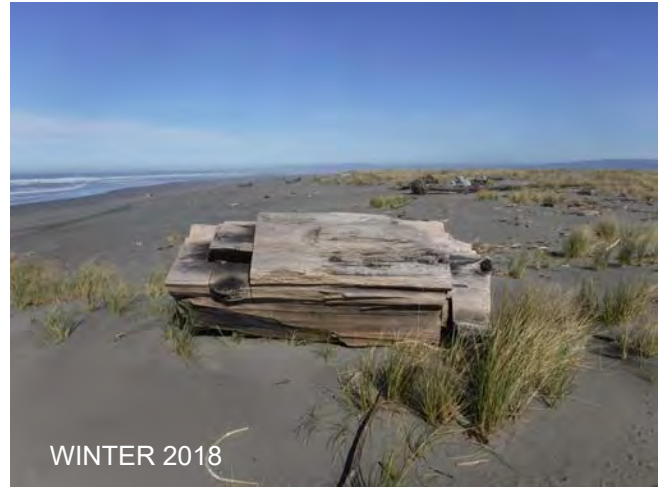
## South Spit Transect 55

## View north at 480 m (foredune base)

Notes: This transect intersects the BLM's Western Snowy Plover Management Area, which was bulldozed to decrease vegetation cover and is maintained through dozing and/or disking annually. As a result, there is no distinct foredune feature, and the profile in the managed area shows shifting sand, as can be seen in the photographs taken near the vegetation line looking north. In winter 2016 the backshore was steep, but the summer 2016 profile shows backshore deposition of 0.4 m landward of offshore bars. In summer 2017 the backshore gained an additional 0.5 m of elevation. By summer 2018 there was additional minor deposition on parts of the backshore. In winter 2019 the upper beach scarped. The topographic rise at approximately 330 m is the east edge of the restoration area, where dense *Ammophila* causes deposition. Over the course of the study the eastern boundary of the bulldozed area increased in height, while the backshore lowered. The flattened foredune maintained its elevation over the course of the study.

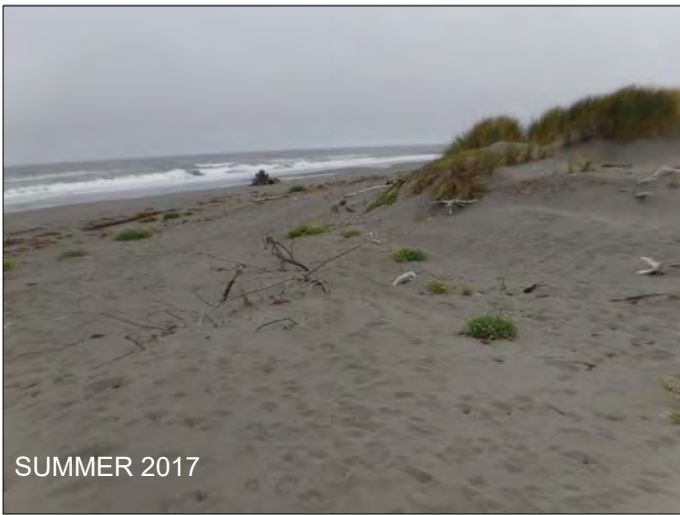
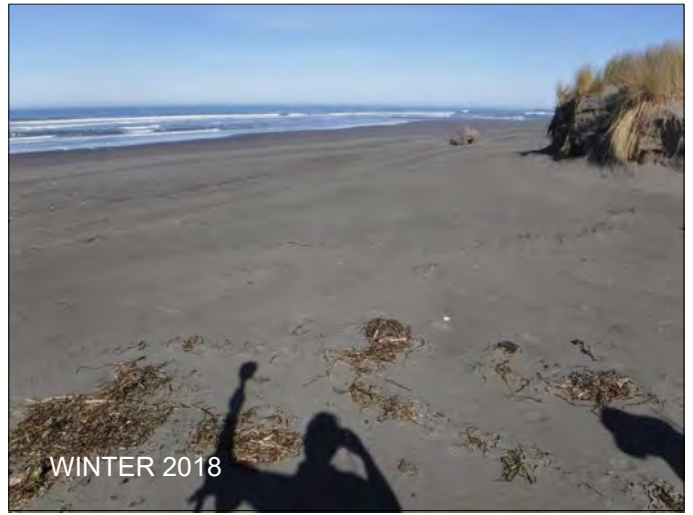
South Spit Transect 56

View northwest along transect at 406 m (foredune)

Notes: Similar to Transect 55, Transect 56 intersects the BLM's Western Snowy Plover management area. There was more of a foredune in this profile (with a similar feature visible to the north in the photograph which is taken northwest along the transect from the base of the ridge). This feature originated as a wave cut escarpment in winter 2017, and managers did not grade it in 2017. Aeolian deposition occurred on its crest in summer 2017. There was only minor filling of the scarp in summer 2017 and by summer 2018 those sediments had eroded. By summer 2020 the foredune feature had eroded. Similar to T55, there was deposition in summers 2017-2019 at the east end of the management area where dense, unmanaged *Ammophila* begins. In winter 2018 there was erosion on the upper beach and in summer 2019 there was erosion throughout the managed area, which might have been the result of grading. Over the course of the study, the flattened foredune retreated 40.0 m.

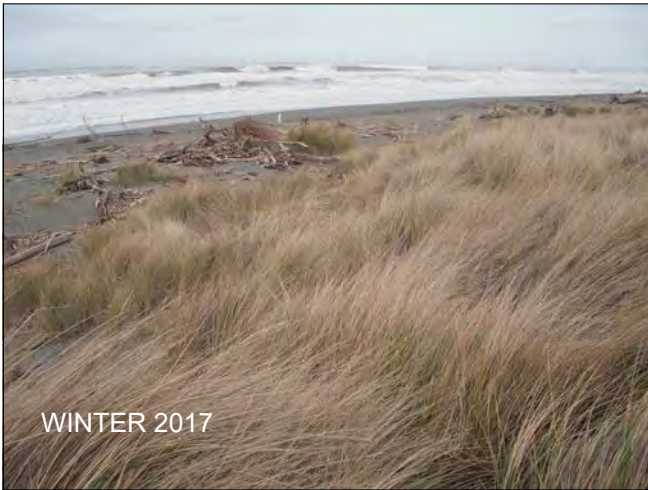
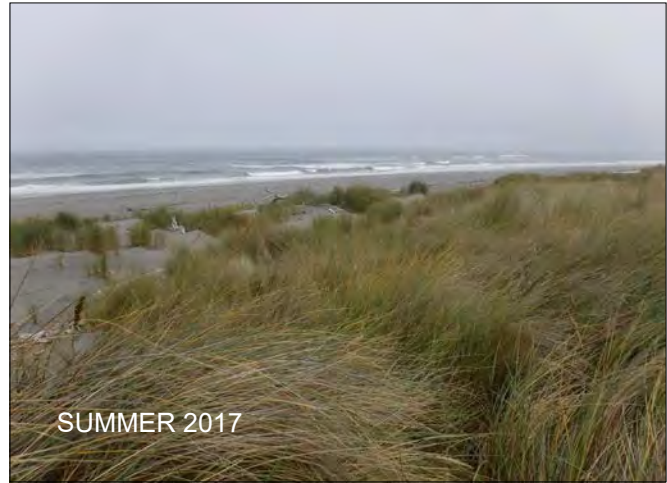
## South Spit Transect 57

View northwest along transect at 352 m (foredune crest)

Notes: There are no data available from winter 2016, but the upper beach was relatively steep in summer 2017, and underwent significant deposition by winter 2017. By summer 2017 deposition had also occurred on the incipient foredune, visible in the upper left of the 2017 photograph below (taken from the foredune crest northwest along the transect) and in summer 2018 up to 0.4 m was added to the incipient foredune. In summer 2019 and summer 2020 the incipient foredune was built up even further. The profile is located in an unmanaged portion of the spit, and two relict *Ammophila* foredunes can be seen east of the present day foredune in the profile. The third ridge to the east is a relict native foredune. This transect spans the entire width of the spit. Over the course of the study, the area east of the incipient foredune was stable. The incipient foredune was formed over the 4-year period, with deposition of 1.2 m. No retreat or progradation occurred.

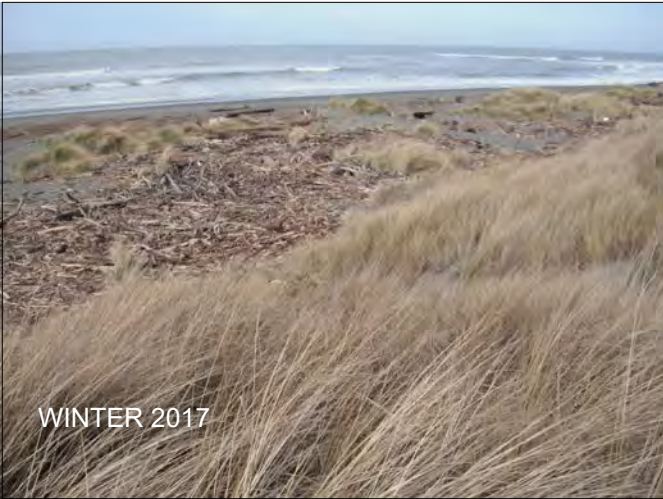
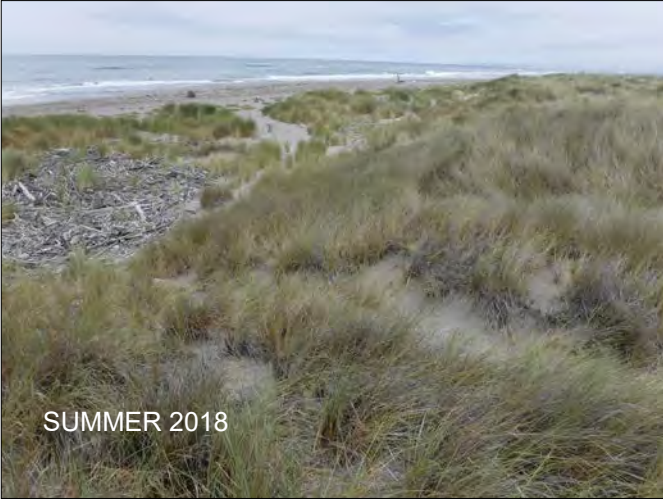
South Spit Transect 58

View northwest along transect at 216 m (foredune crest)

Notes: There are no data available from winter 2016. The transect is located in a portion of the South Spit in which vegetation is not managed and *Ammophila* is dominant. An incipient foredune topography was forming and was scarped during high water events in winter 2017. The scarp emphasized the incipient foredune morphology, and a driftwood deposit was placed in the swale of the incipient foredune, remaining through summer 2019 and visible in the photographs below taken from the crest of the foredune and looking northwest along the transect. In summer 2017 the upper beach and incipient foredune did not change significantly but by summer 2018 additional deposition had occurred on the incipient foredune, with the morphology shifting in summer 2019 into transverse dunes climbing up the incipient foredune. By summer 2020 the incipient foredune was well developed. Over the course of the study the area east of the incipient foredune remained stable, and change was restricted to formation of the incipient foredune and beach. The incipient foredune resulted in deposition of 1.0 m, but the upper beach was eroded by 1.0 m and retreated landward.

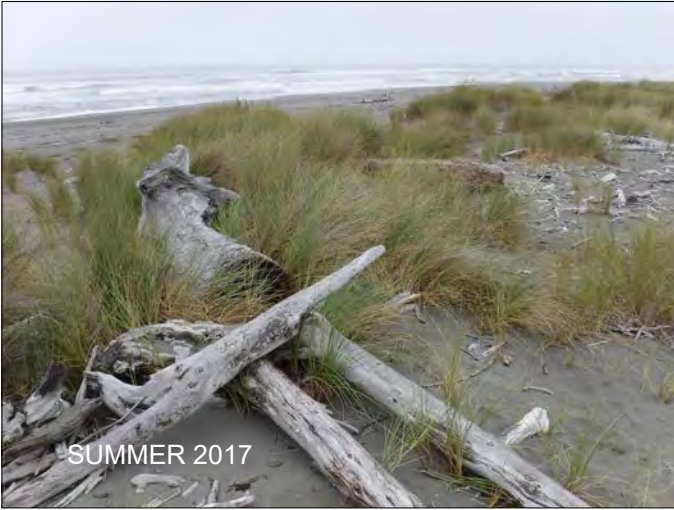
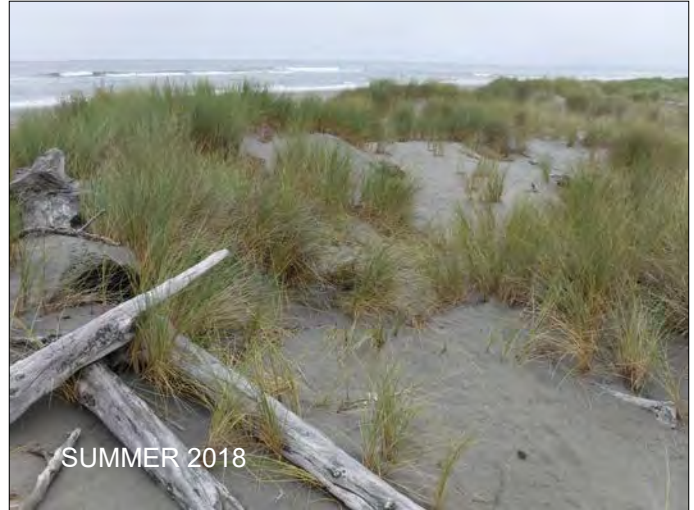
# South Spit Transect 59

View northwest along transect at 170 m taken at foredune base

Notes: There are no data available from winter 2016. The profile is located on a portion of the South Spit that did not receive vegetation management until 2020. Multiple relict *Ammophila* foredunes are present resulting from accretion events. Between summer 2016 and winter 2017 the western edge of the incipient foredune scarped, but by summer 2017 a scarp-fill ramp had formed as can be seen in the photograph below looking north-west along the transect from the incipient foredune towards the backshore. The beach regained elevation levels present in summer 2016. In winter 2019 the incipient foredune scarped, emphasizing its morphology. By summer 2019 the incipient foredune had gained in elevation and breadth (deposition can be seen in right rear of summer 2019 photograph below). During 2020 *Ammophila* was removed in this area, piles are visible in the photograph below. Over the course of the study an incipient foredune formed on the upper beach, resulting in deposition of 0.5 m, but causing retreat of 15.0 m.

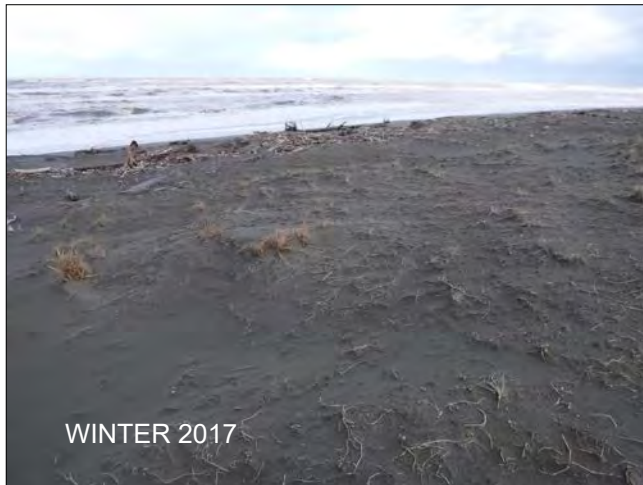
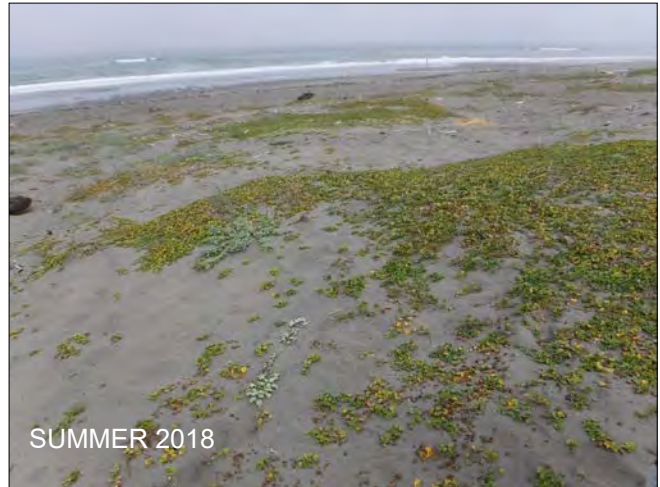
## South Spit Transect 60

View northwest along transect at 138 m (foredune crest)

Notes: This portion of the South Spit has been restored by the manual removal of *Am-mophila* and vegetation is native. The profile exhibited normal seasonal changes from winter 2016 through summer 2017 with a relatively stable vegetated backshore and established foredune. The high spot at 180 m was a large stump. In winter 2017 the backshore was eroded up to the base of the established foredune resulting in a vertical loss of up to 1.2 m. By summer 2018 there was only minimal rebuilding. Further scarping occurred in winter 2019. Over the four year period, there was some sediment movement on the established foredune, with 0.4 m of deposition at 126 m. There was no retreat or progradation.

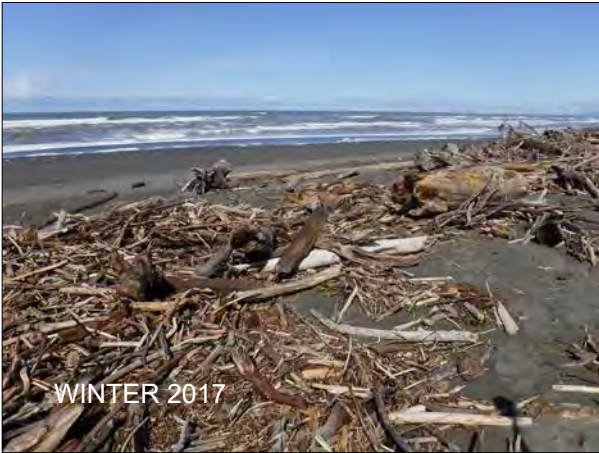
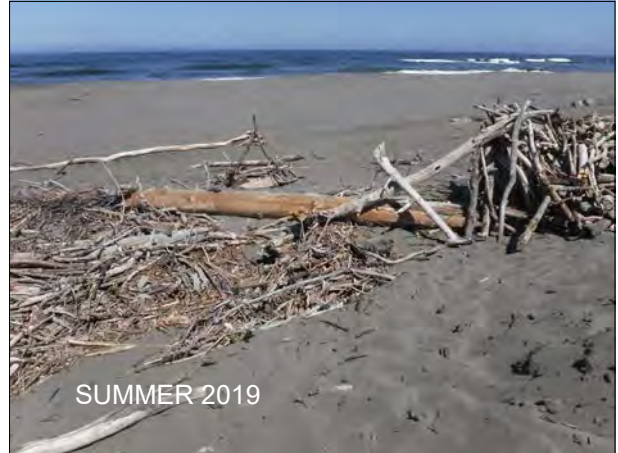
## Table Bluff Transect 61

View northwest at 100 m (base of berm)

Notes: This transect is located where the dune system narrows at the base of Table Bluff and restoration to native dune mat has occurred. Topography is low and no foredune is present. In winter 2019 the berm above the backshore was scaped, losing 1.0 m vertically. The vegetated backshore west of 76 m experienced deposition but later eroded to its present elevation. Large wood was deposited in this area in winter 2017. Between 2019 and 2020 there was additional erosion and much of the large wood washed out although some remains buried. Over the course of the study the foredune retreated 20.0 m.

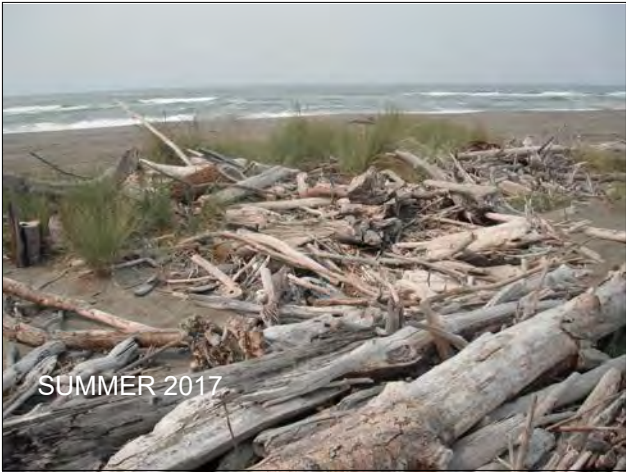
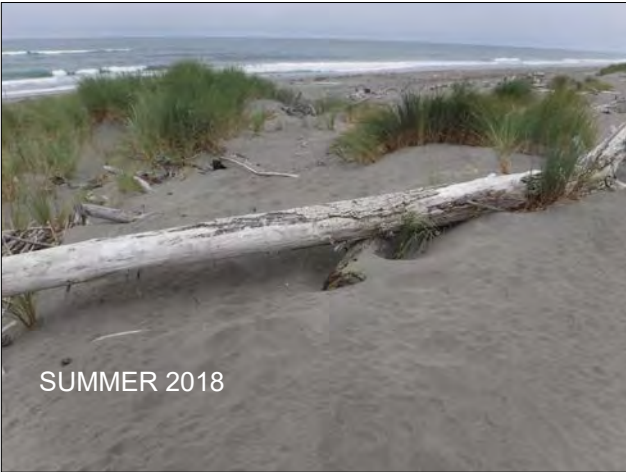
Eel River Wildlife Area Transect 62

View northwest at 246 m (foredune base) looking towards incipient foredune

Notes: The transect is located on the north barrier of the Eel River in an unrestored system stabilized by *Ammophila*. The backshore had been scarped at 276 m prior to the winter 2016 survey. By the summer 2016 survey, scarp-fill ramping had occurred. In winter 2017 high water events deposited a large amount of wood on the backshore. All points from 258-268 m were taken on wood and create the peaks in the graph. In Summer 2017 sand had been deposited among the wood and *Ammophila* was increasing, creating something of a wood incipient foredune. By summer 2018 most of the wood had been buried by sand, although the elevation had increased by only approximately 0.2 m. In winter 2019 additional wood was deposited and by summer deposition had occurred. The photograph is taken from the base of the established foredune looking northwest along the transect, showing the new incipient foredune. Over the course of the study an incipient foredune formed, with a large wood component, but there was no retreat or progradation.

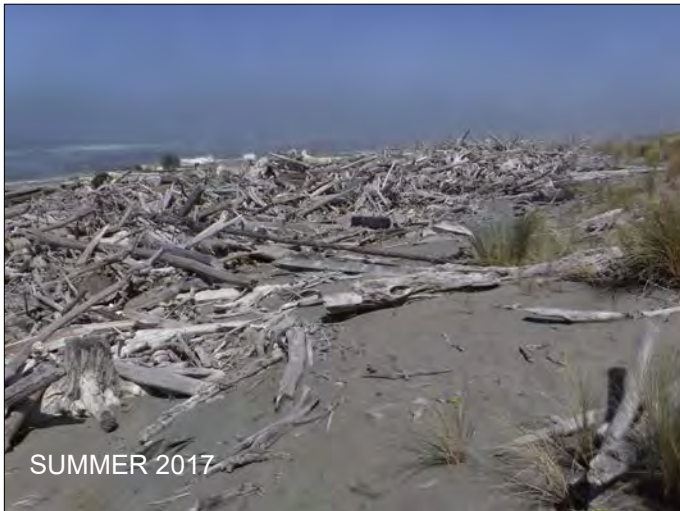
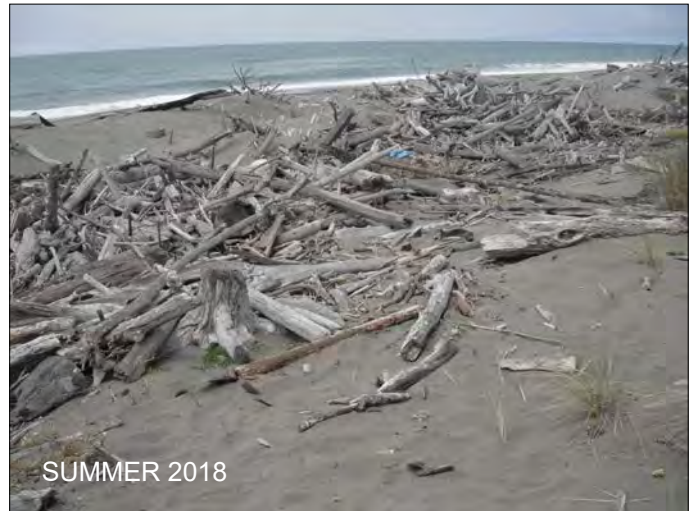
Eel River Wildlife Area Transect 63

View northwest at 242 m (foredune base) looking towards incipient foredune

Notes: The transect is located on the north barrier of the Eel River in an unrestored system stabilized by *Ammophila*. Data from winter 2016 are not available. In winter 2017 a large amount of wood was deposited on the upper beach, and all points from 248-270 m were taken on top of wood. In summer 2017 the backshore was virtually unchanged, and the wood deposit can be seen in the photograph below taken from the base of the foredune looking northwest along the transect. By summer 2018 sand had been deposited on the incipient foredune, burying a portion of the wood deposit (see photos below). In winter 2019 a significant scarping event occurred on the upper beach, with some recovery through deposition in summer 2019. The profile is distinctive in having a broad foredune swale between the relict and present day foredunes. Over the course of the study the upper beach underwent significant erosion, and the incipient foredune was removed, retreating at its base 20.0 m. The site is characterized by historic medium accretion.

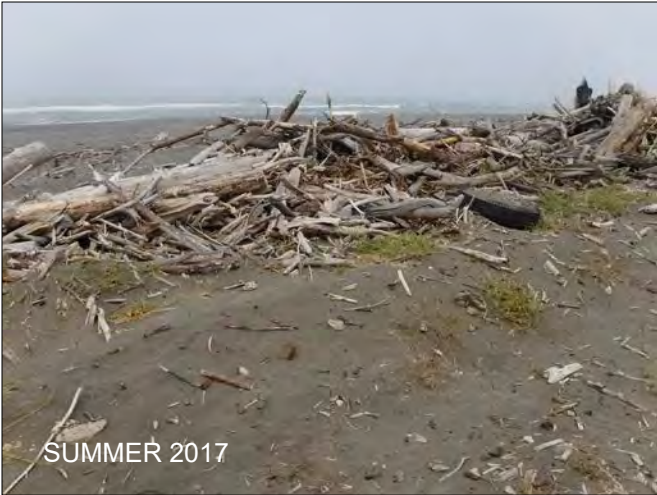
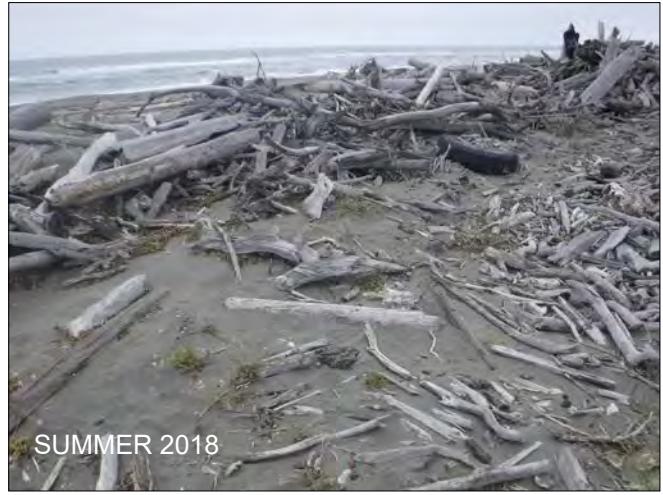
Eel River Wildlife Area Transect 64

Notes: The transect is located on the north barrier of the Eel River in an unrestored system stabilized by *Ammophila*. Data from winter 2016 are not available. In summer 2016 a wood deposit was present in the vicinity of 282 m. In winter 2017 during high water events the beach eroded and a 1+ m vertical loss occurred in that vicinity. At that time a large amount of wood was deposited higher up on the beach up against the base of the foredune. By summer 2017 the wood deposit had moved lower on the beach and was higher in elevation. Points at 236 to 240 m were taken on wood. Sand deposition had occurred within the wood, forming a distinctive incipient foredune, visible in the photograph taken from the base of the foredune and looking northwest along the profile. In winter 2019 there was significant erosion of the upper beach, causing 2.0 m of vertical loss. In summer 2019 approximately half of the elevation was regained and the incipient foredune received deposition that covered much of the wood. In winter 2019 there was another significant deposit of wood. Similar to the previous transect, the profile is distinctive in having a broad foredune swale between the relict and present-day foredunes. Over the course of the study, an incipient foredune with a significant large wood component formed, eventually merging with the foredune. This site is characterized historically by medium accretion.

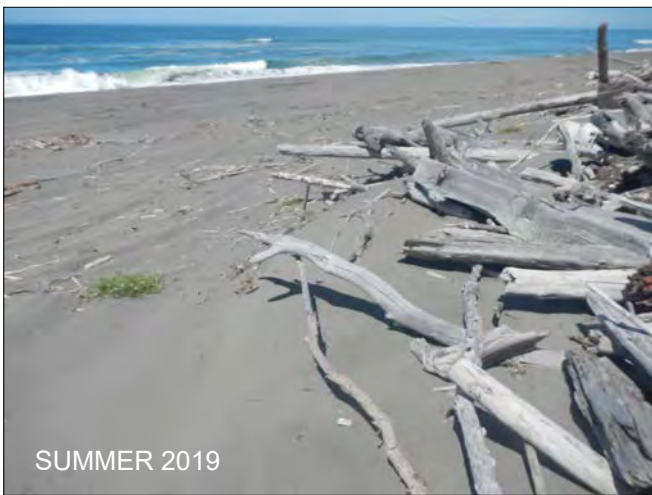
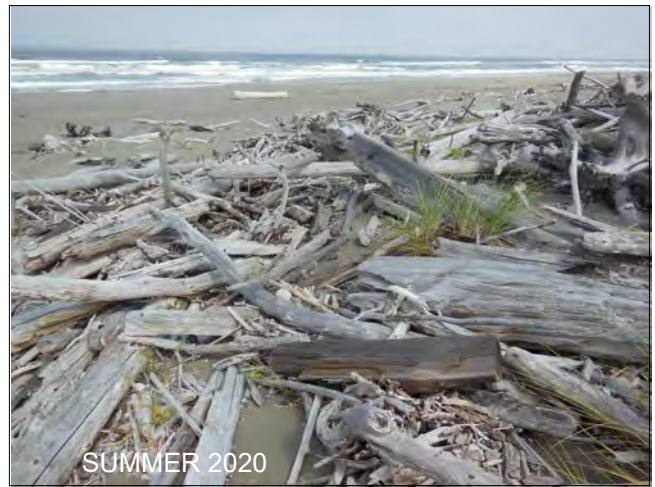
View northwest at 230 m (foredune base) looking towards incipient foredune

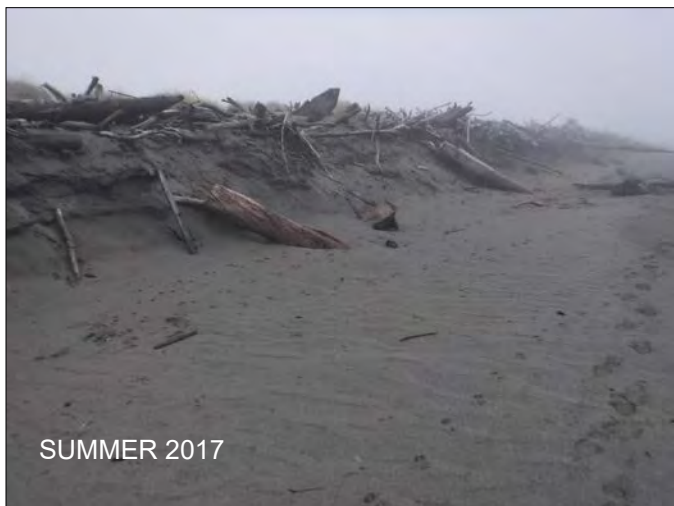
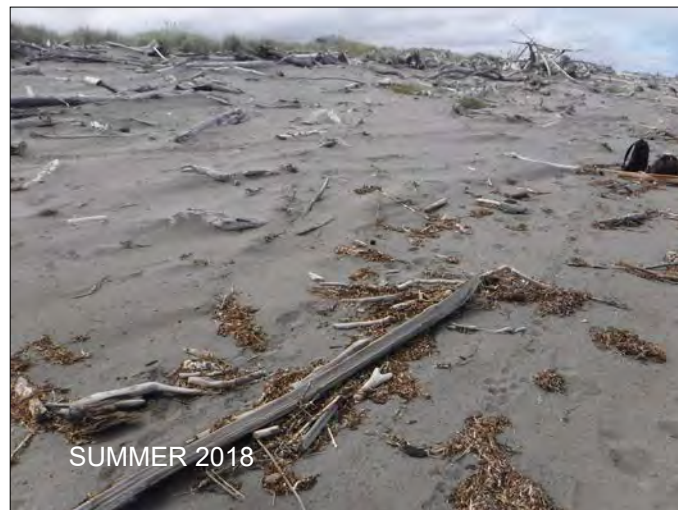
## Eel River Wildlife Area Transect 65

Notes: This transect is located near the dynamic spit at the mouth of the Eel River and exhibits high variability on its seaward side. Topographic data from winter 2016 are not available. The transect passes through a relict foredune scarp associated with mouth migration at 132 m. In summer 2016 the beach was wide. A wood deposit was present from 372-396 m. In winter 2017 during high water events the foreshore was eroded up to 3.0 m vertically, and the backshore retreated landward to 396 m leaving a very steep beach. The wood deposit remained, and sand infilling occurred, forming an incipient foredune morphology, with a net rise in elevation of up to 0.5 m. By summer 2017 further erosion had scarped and removed the western portion of the wood deposit/incipient foredune, as seen in the photo taken from the backshore and looking southeast back along the transect towards the scarp. Between summer 2017 and summer 2018 there was almost 1.0 m of deposition that filled the scarp (see photo below on right). In winter 2019 there was scarping of the upper beach, with infilling the following summer. Over the course of the study the incipient foredune retreated eastward, 110.0 m, beginning to merge with the established foredune.

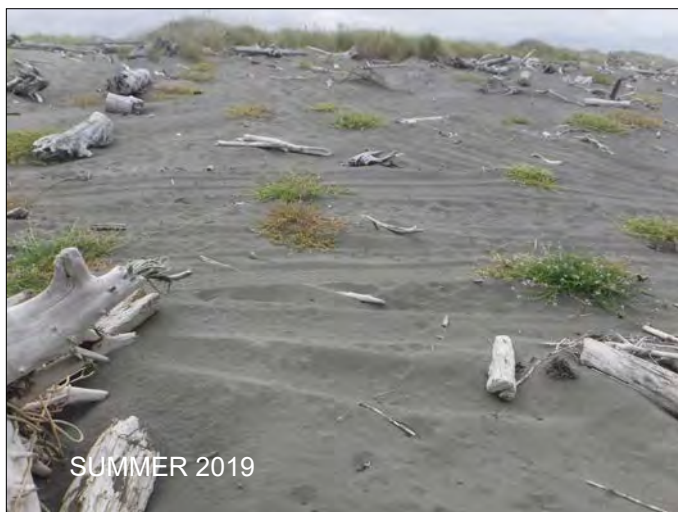
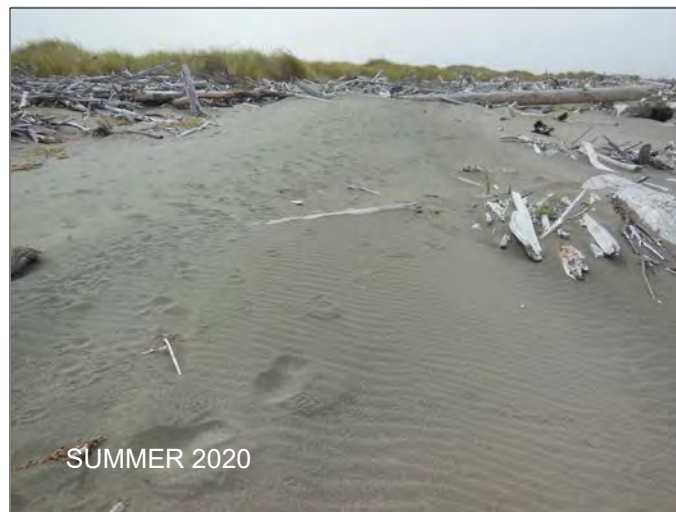
View southeast at 384 m (upper beach) looking towards incipient foredune

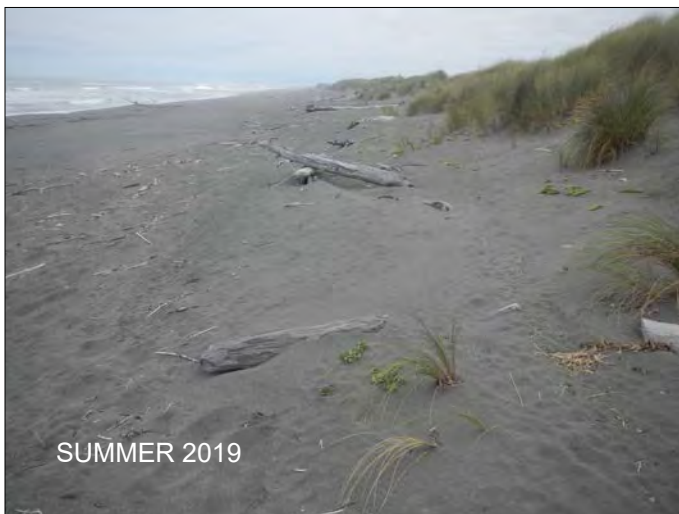
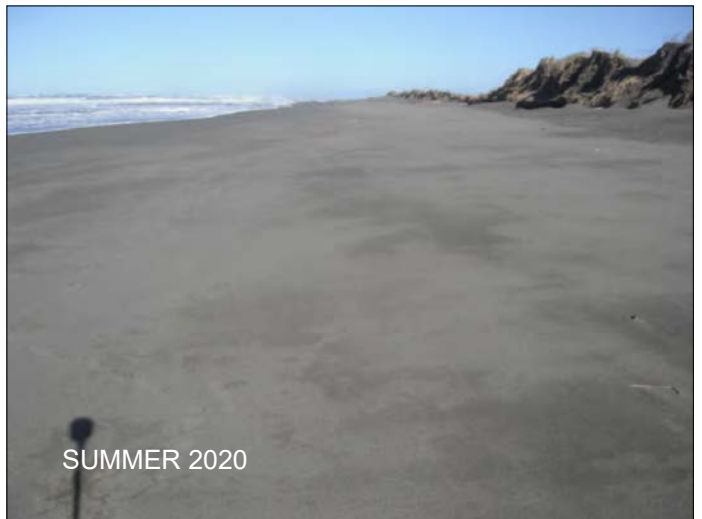
View north at 210 m (foredune base)

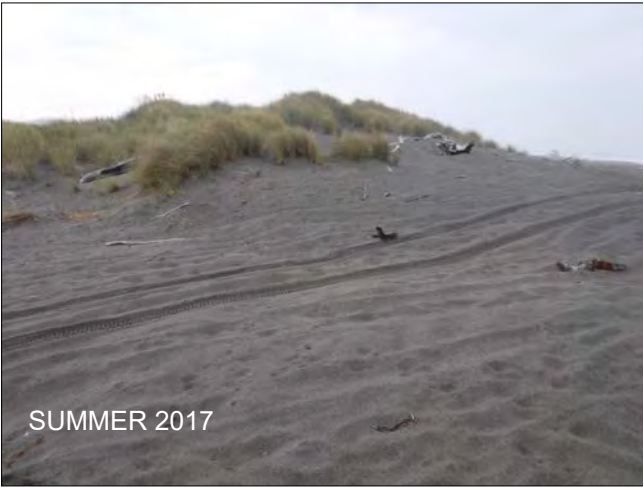
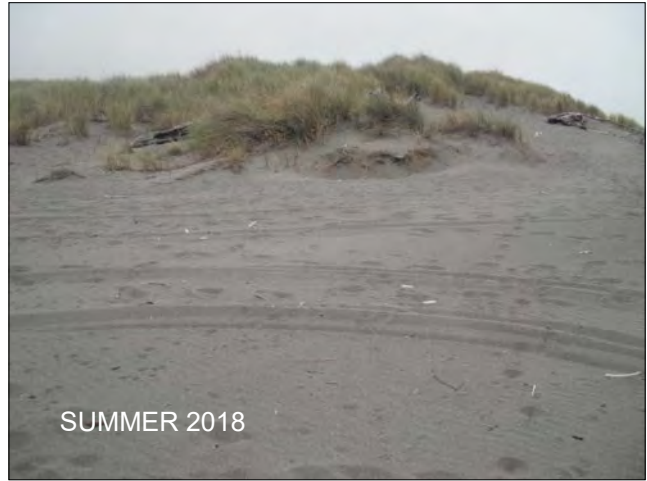
Eel River Estuary Preserve Transect 67

Notes: This transect was placed within a foredune breach that was overwashed during high water events. The transect was placed perpendicular to the shoreline (rather than parallel with predominant wind) in order to include the overwash lobe. The lack of foredune is apparent from the initial low profile. Overwash occurred in winter 2016, but was followed by a large depositional event on the beach which led to aeolian deposition at the position of what would be the foredune in summer 2016. High water events in winter 2017 again eroded 0.6 m of the aeolian deposits through overwashing, but built a 2.0 m beach berm present at the time of the winter survey. Subsequent aeolian deposition recurred in the region of the foredune, but to a lower elevation than the previous year. The abrupt peaks in the profiles at 110 and 116 m represent a large piece of driftwood that moved during winter storms. The winter 2017 beach berm persisted into summer and can be seen on the photograph taken on the foredune crest looking south. There was only minor deposition by the summer 2018 survey. In Fall 2018 the foredune was rebuilt by borrowing sand from the overwash fan and creating a new foredune. There has been no significant erosion of the rebuilt foredune through summer 2020, and the foredune has neither retreated nor prograded.

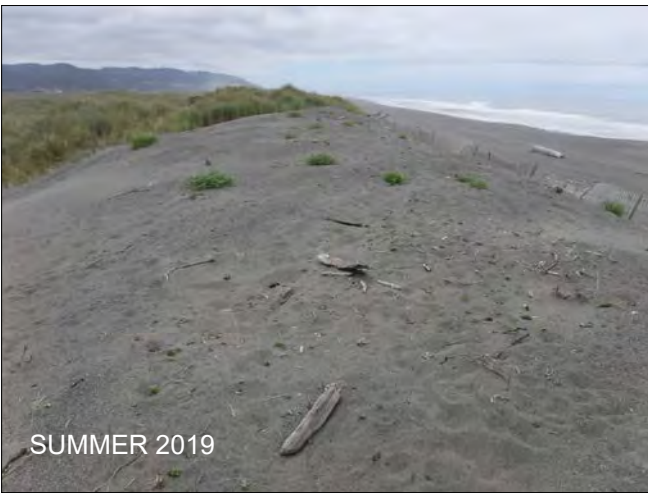
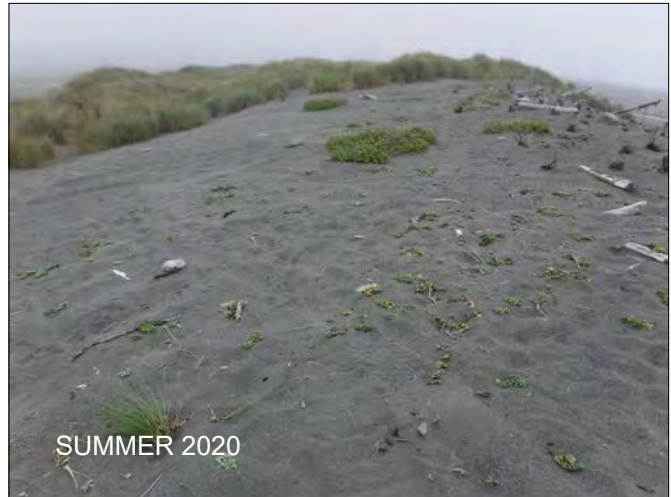
View south at 102 m (foredune crest)

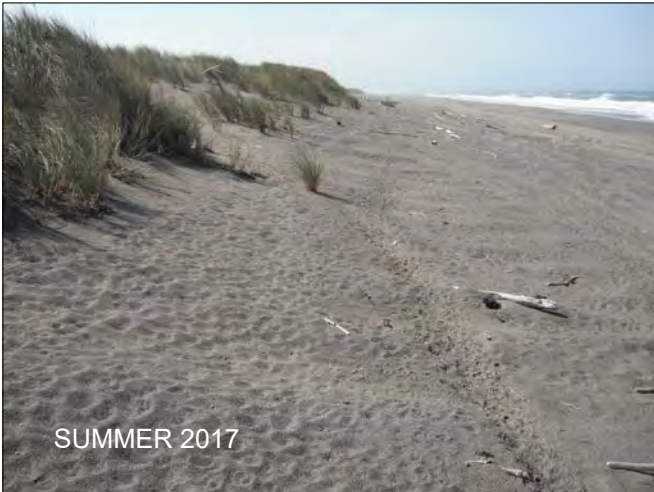
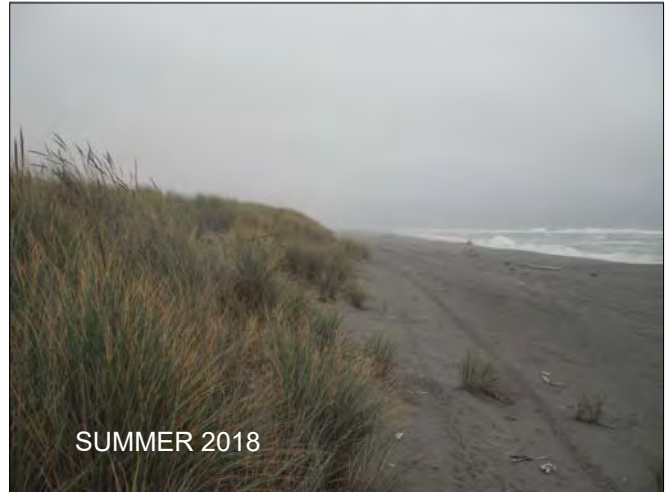
Eel River Estuary Preserve Transect 68

Notes: The transect intersects southern Eel River dune system at one of its widest points, and the profile depicts multiple relict *Ammophila* foredunes. The present-day foredune had been recently scarped, with up to 3.0 m of elevation loss, at the time of the 2016 survey. Between winter 2016 and summer 2017 a scarp-fill ramp gradually reconnected the backshore to the foredune crest. The beach lost 1.0 m of elevation in winter 2017 and regained only part of it in summer 2017, with additional loss of up to 2.0 m by summer 2018. Deposition occurred at the base of the foredune prior to the winter 2018 survey, but had been removed by summer 2018. Scarping of the foredune in winter 2019 resulted in a steep stoss face that persisted into summer 2019. In winter 2020 additional erosion at the base of the foredune lowered the beach by 1.0 m, but by summer 2020 a ramp was forming. Over the course of the study, the foredune was steepened and the base retreated 30.0 m, suggesting low resiliency in keeping with the designation of historic medium erosion for this stretch of shoreline.

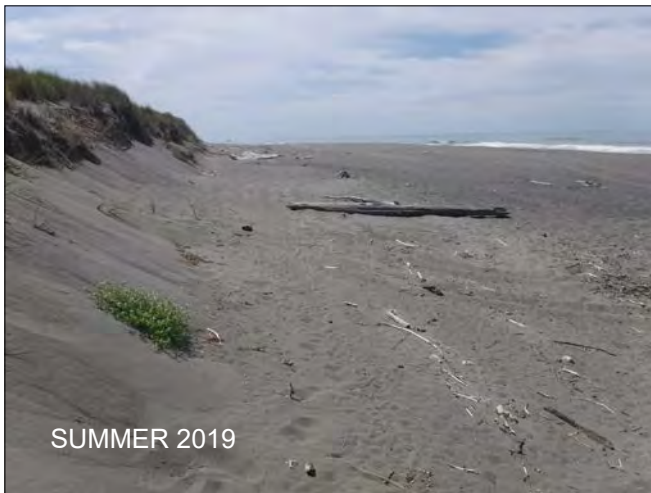
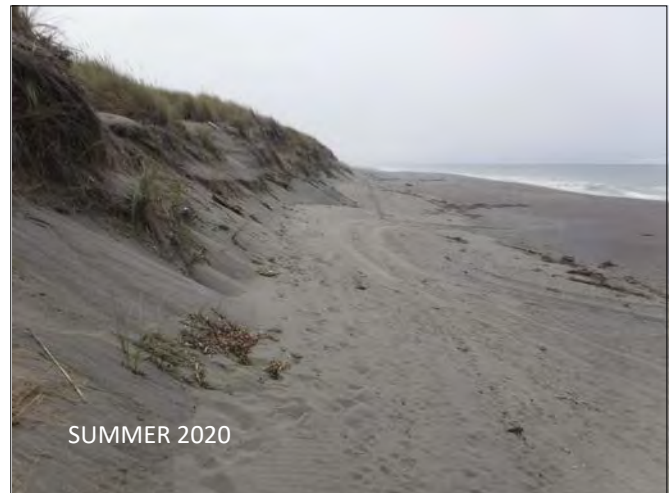
View south at 316 m (foredune base)

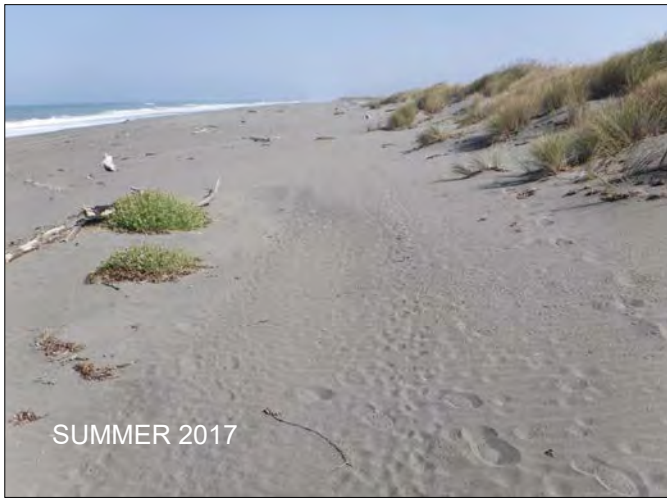
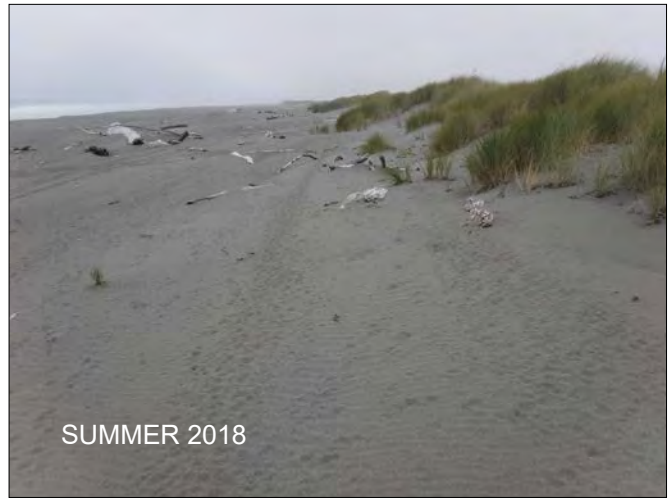
Eel River Estuary Preserve Transect 69

Notes: The profiles describe a peaked *Ammophila* foredune and foredune swale backed by a relict foredune, and a stable backdune area sloping down to the estuary. The foredune was scaped during winter 2016 prior to the survey. Between winter 2016 and summer 2016 significant deposition occurred in the mid to lower beach (up to 1+ m) while the beach at the base of the scarp changed little. By winter 2017 the beach had experienced deposition, which continued through summer 2017, resulting in a net gain of 1.0+ m. The resulting gently sloping backshore can be seen in the photograph taken from the transect and looking north (below). However, the beach was maintained at up to 2.4 m below summer 2016 levels. In summer 2018 the beach received up to 1.0 m of deposition. Between winter and summer 2019 the upper beach eroded, losing up to 2.5 m vertically, and an offshore bar formed. In winter 2020 the foredune eroded back up to 10.0 m and increased in steepness. Over the course of the study, the beach was lowered significantly and the foredune eroded and steepened, retreating 30.0 m at its base. These conditions suggest low resiliency, consistent with the historic designation of medium erosion for this stretch of shoreline.

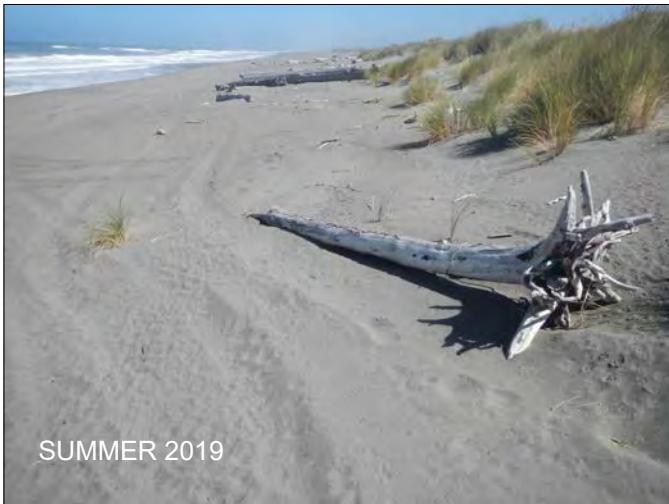
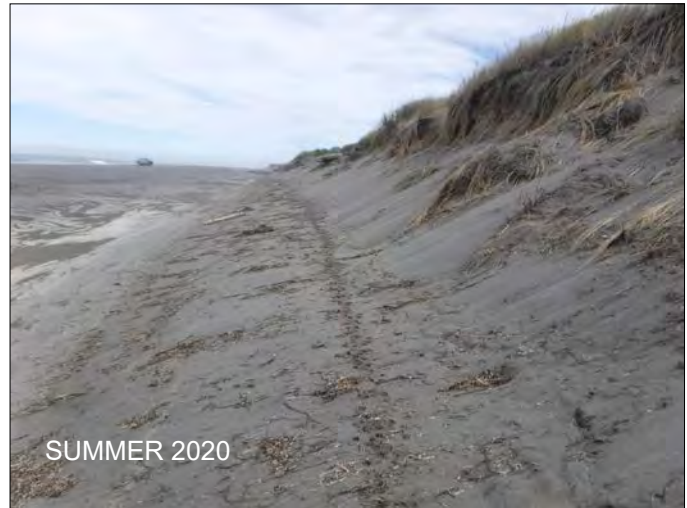
View north at 294 m (foredune base)

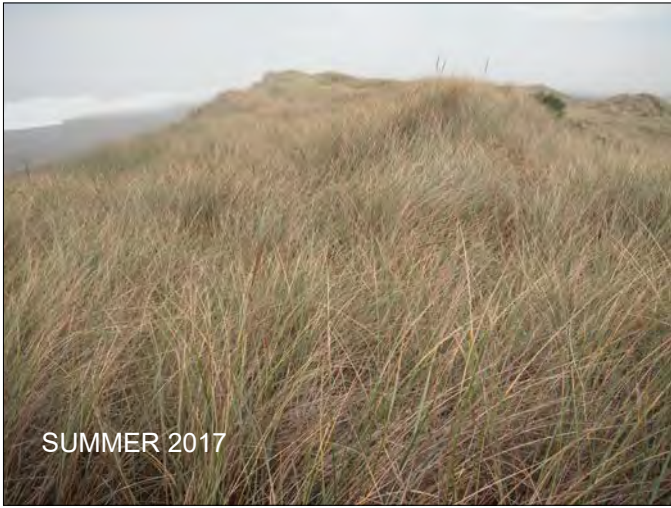
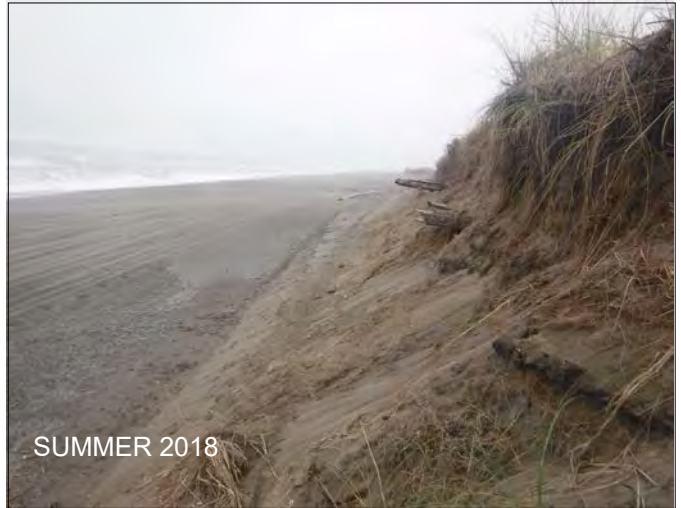
Eel River Estuary Preserve Transect 70

Notes: The transect is located near the south end of the barrier where the dune system narrows. At the start of the survey the transect was located just north of a foredune breach area. The *Ammophila* foredune was scarped during winter 2016 prior to the survey. By summer 2016 additional scarping had occurred and the beach lost 1.5 m of elevation. A scarp-fill ramp was created during winter and summer 2017. Between the summer 2017 and winter 2018 survey a major scarping event eroded the foredune 10.0m horizontally (see photos next page). By the summer 2018 survey the scarp had further eroded at the base but up to 1.0 m of sediment was deposited on the upper beach, forming a bench. Between winter and summer 2019 the foredune was breached and eroded entirely (see photo below). Over the course of the study the foredune was completely removed, retreating 70.0 m, and an overwash fan formed behind it. This transect exhibits an extreme lack of resiliency, and the stretch of shoreline is characterized as medium erosion.

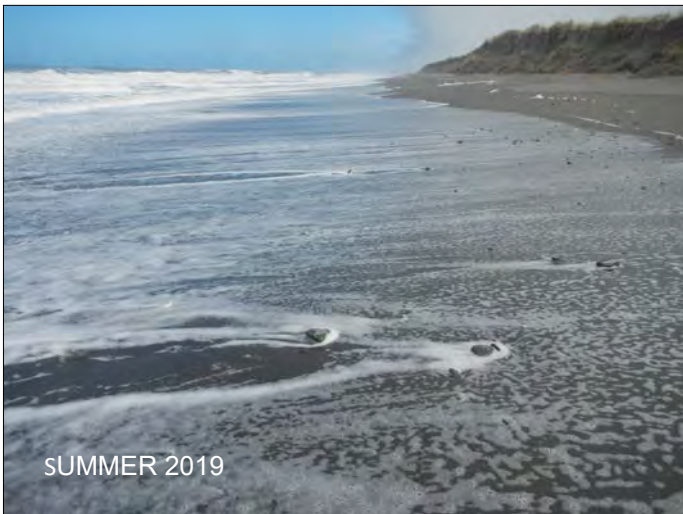
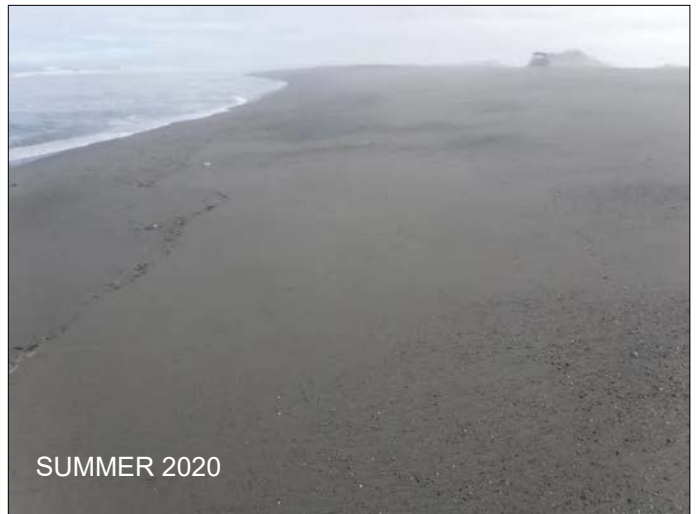
View north at 256 m (foredune crest, left and scarp, right) and below at 252 m
