HUMBOLDT COASTAL RESILIENCY PROJECT  
AND  
CLIMATE READY PROJECT

SUMMARY DATA FOR CROSS-SHORE TRANSECTS  
WINTER 2016-SUMMER 2020

Andrea Pickart and Candace Reynolds, U.S. Fish and Wildlife Service,  
and Ian Walker, U.C. Santa Barbara

July 2021

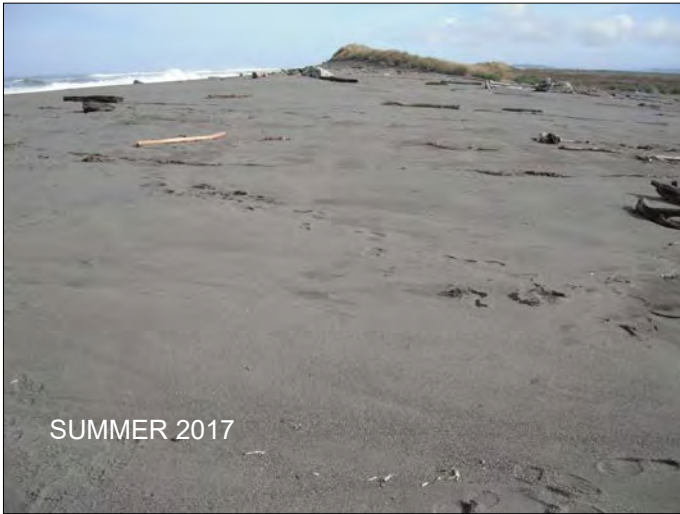
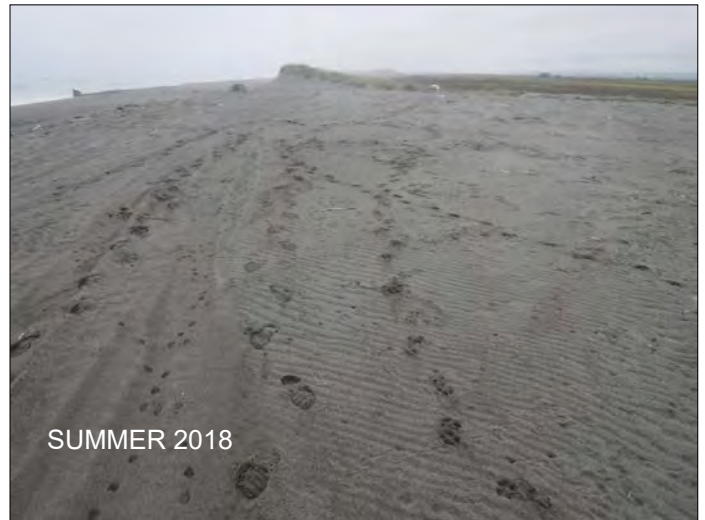
Eel River Estuary Preserve Transect 71

Notes: The transect passes through a large foredune breach area that is subject to washover during high water events. The profile describes a berm that is primarily influenced by waves in the winter months and modified by aeolian action in the summer, and is retreating inland. Extensive beach erosion occurred in winter 2016 after the survey, creating a steep berm in summer 2016. Additional erosion occurred on the seaward side of the berm in winter 2017, but deposition of 0.3 m occurred on the crest of the berm. Minor deposition by aeolian processes occurred in summer 2017 at the crest. The berm eroded back 30.0 m between summer 2017 and winter 2018, but deposition by summer 2018 replaced some of it, leaving a swale in the area of the former crest of the berm. Between winter and summer 2019 there was major erosion of the berm, which retreated horizontally. Over the course of the study the berm retreated 95 m, exhibiting extreme lack of resilience in keeping with the historic trend of medium erosion along this stretch of shoreline.

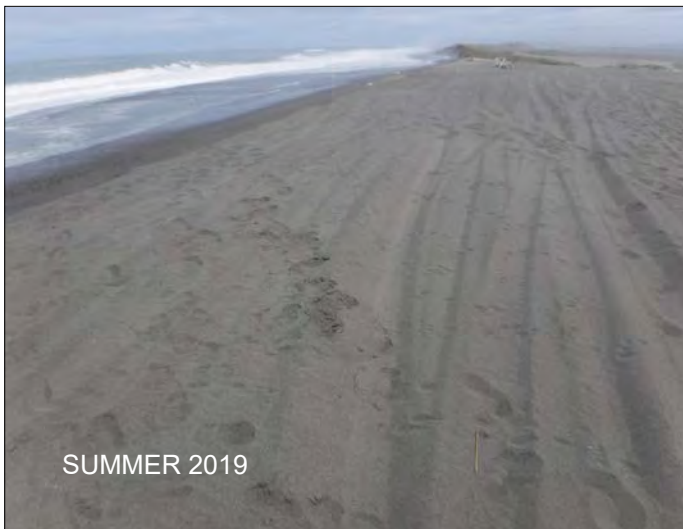
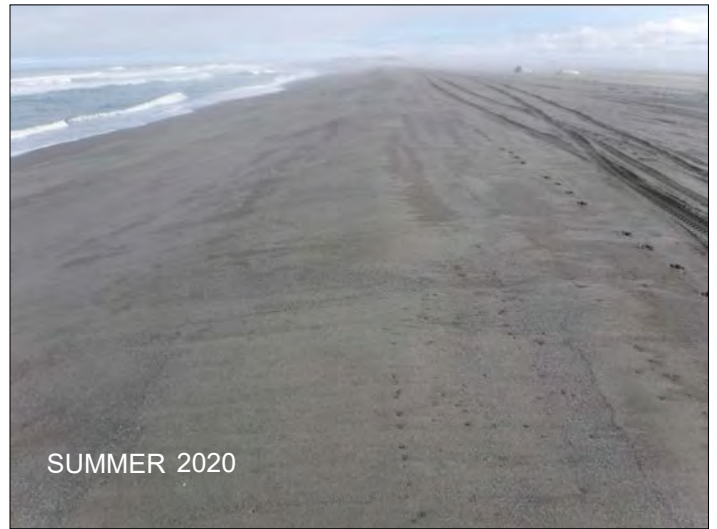
View north at 166 m (overwash area)

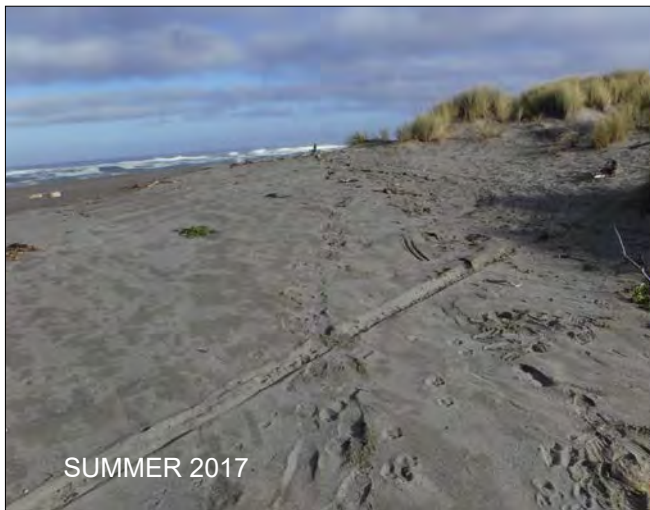
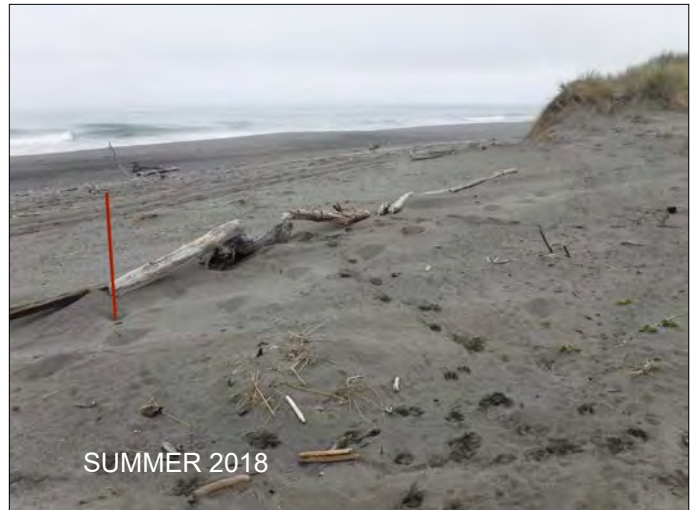
## Eel River Estuary Preserve Transect 72

Notes: The transect passed through remnant vegetated areas between narrow breach areas that are subject to washover during high water events. The former foredune area is within the washover and is now a berm that is primarily influenced by waves in the winter months and modified by aeolian action in the summer. The transect skirts the edge of the remnant foredune to the north as can be seen in the photograph below taken southeast along the transects from the upper beach. As in Transect 71 to the north, there was significant beach scarping between winter and summer 2016 forming a berm. The area was overwashed in winter 2017, and the berm was reshaped to a gradually sloping beach. Some aeolian deposition occurred during summer 2017, moving the crest of the berm landward. Between summer 2017 and winter 2018, the crest of the berm eroded 40.0 m horizontally and lost 1.0 m of elevation. Up to 0.5 m was deposited in the overwash lobe. Additional erosion of the berm occurred between winter and summer 2019. In winter 2020 the berm was eroded back significantly, but shifted west in summer 2020 with new deposition. Over the course of the study the berm retreated 50.0 m, exhibiting a lack of resiliency in keeping with the designation of this shoreline historically as medium erosion.

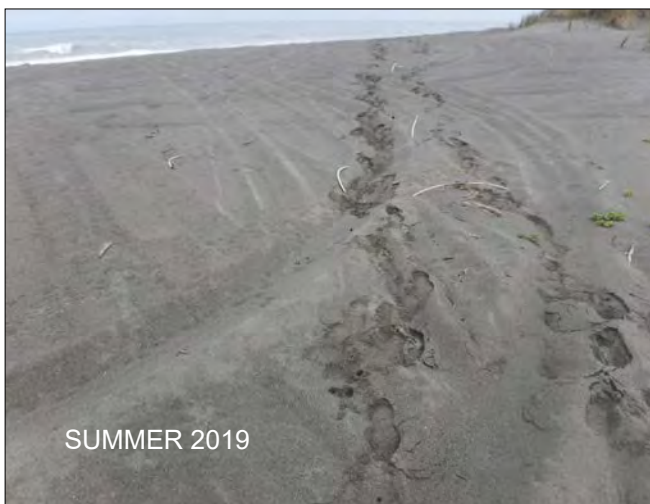
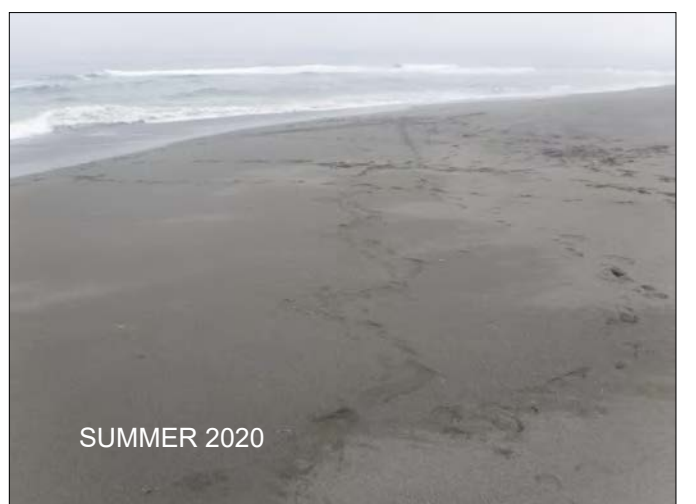
View southeast at 124 m (crest of berm) looking northwest along transect

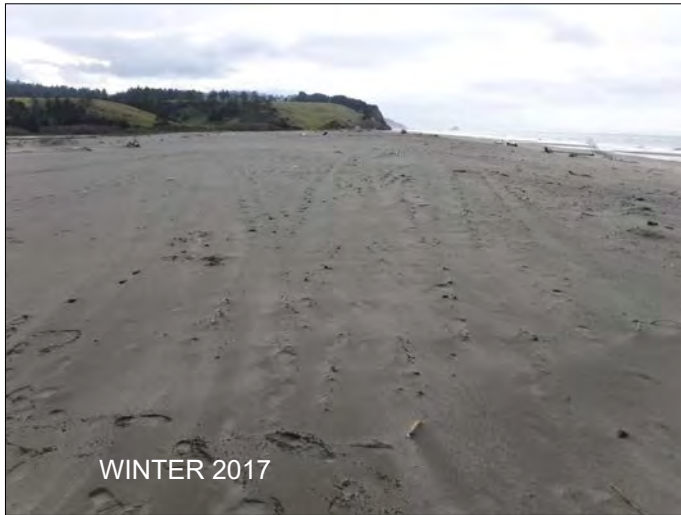
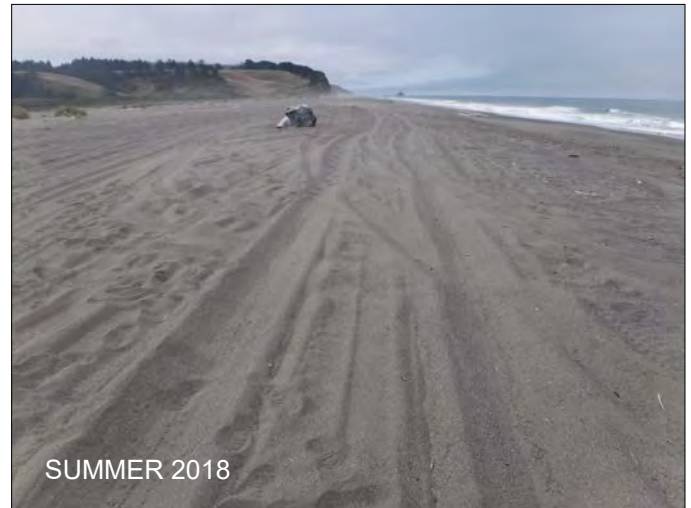
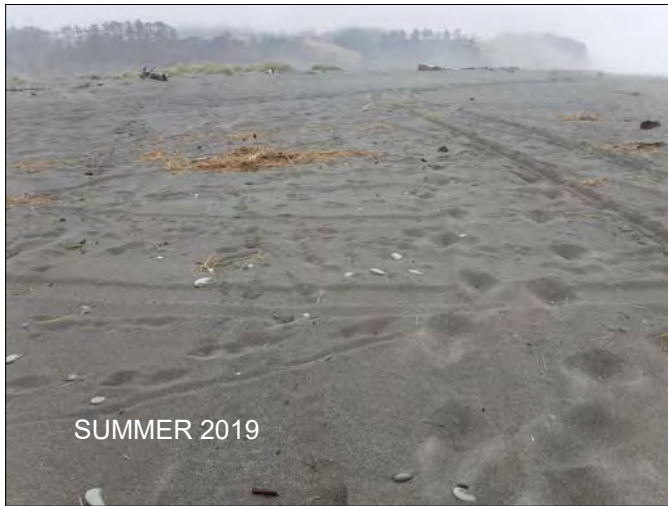
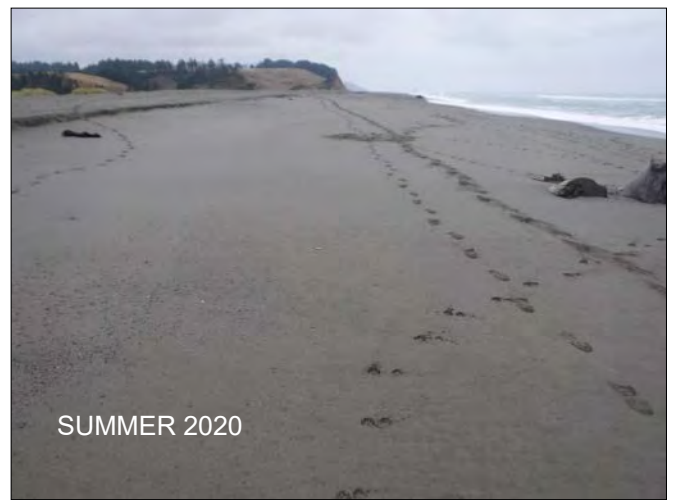
## Russ Property Transect 73

View south at 296 (upper beach)

**RUSS SUMMARY.** This single transect is located in a largely unvegetated area that previously underwent erosion and removal of vegetation. The shoreline continues to retreat and this site exhibits an extreme lack of resiliency.
