Humboldt Coastal Resilience Project

Phase 3 Beach-Dune Transect Profiles

November 2019

Submitted by: Andrea Pickart, Candace Reynolds, US Fish and Wildlife Service and Ian Walker
Arizona State University

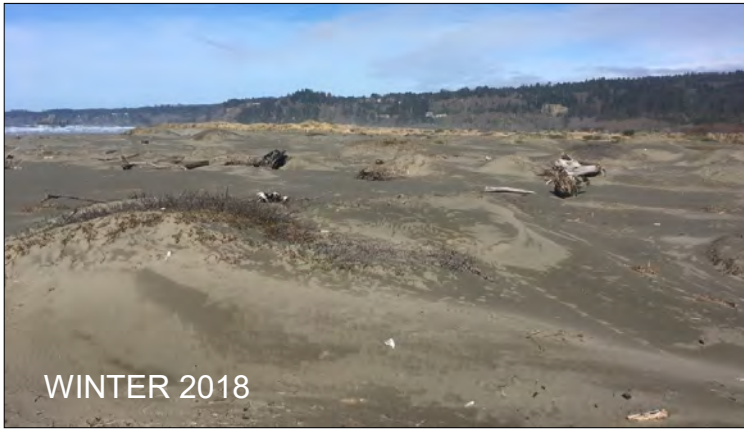
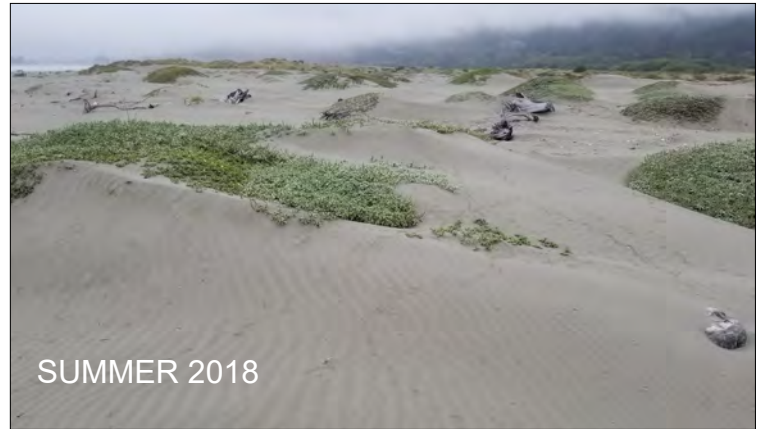
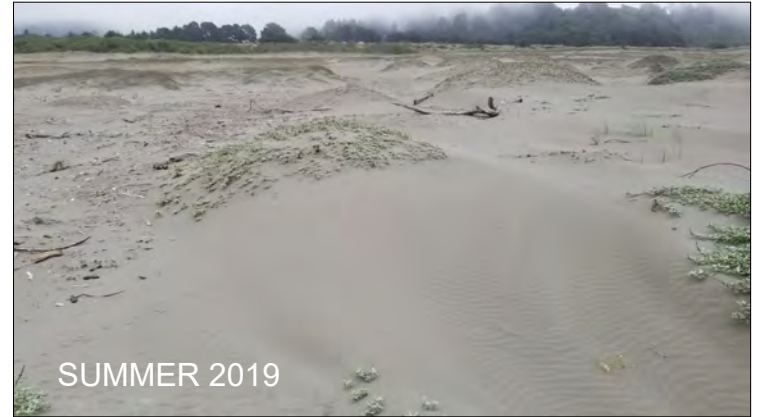
Little River Transect 1

View north at 242 m (foredune crest)

Notes: The transect is located in an area of Little River State Beach restored through the removal of European beachgrass (*Ammophila arenaria*) by heavy equipment beginning with a pilot project in 2004 and completed in 2008. Data are not available for winter 2016 but profiles otherwise show a winter storm flattening of the backshore by wave runup, erosion, and deposition, followed by development of transverse dunes in summer. The backshore gradually rises in elevation landward and transitions to a low foredune zone composed of a plateau-like nekha field, reaching a maximum elevation of 6.2 m NAVD 88. The transect bisects the concave portion of a beach cusp and the foredune zone is lower and narrower than in Transect 2 to the south, although in summer 2017 a transverse dune slipface at the boundary between the backshore and foredune zone reached elevation 6.2 NAVD 88 (240 m). In summer 2017 the westernmost vegetation occurred at 318 m. Between 90 m and 190 m upland areas in-

tersperse with deflation basins. Between winter 2018 and summer 2018 there was a loss of up to 0.4 m seaward as well as inland of the foredune, as well as a lowering of the foredune crest by 0.2 m. Between 2018 and 2019 the foreshore gained in elevation, and the transverse dunes in the backdune area migrated east.

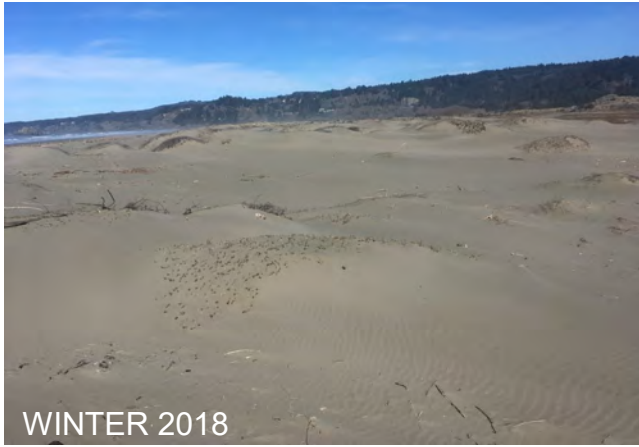
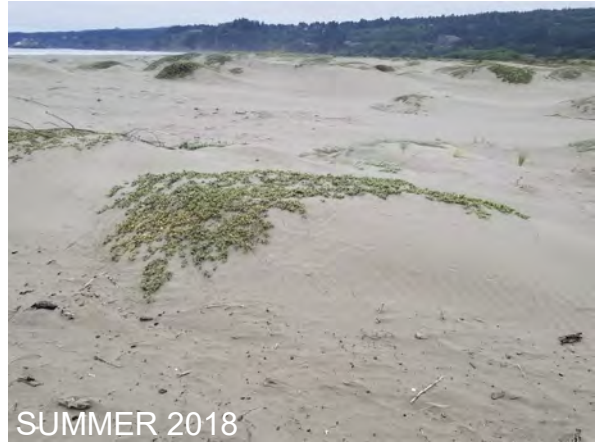
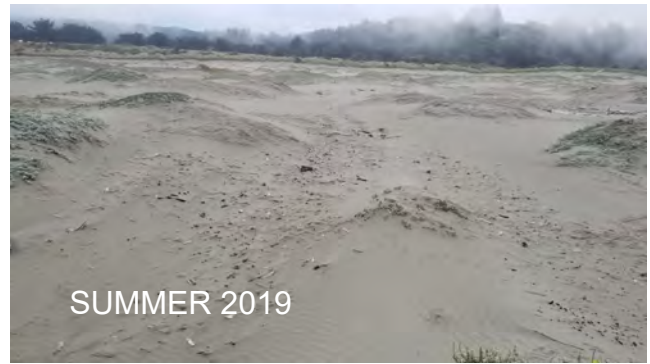
Little River Transect 2

View north at 208 m (foredune crest)

Notes: Similar to Transect 1, and located in an area of Little River State Beach restored through the removal of *Ammophila* by heavy equipment. Data are not available for winter 2016. Profiles show a winter flattening of the backshore by storm wave runup, erosion, and deposition, followed by development of transverse dunes in summer, with net accretion of up to 2 m on the lower beach between summer 2016 and summer 2019. The backshore gradually rises in elevation and transitions to a foredune zone consisting of a plateau-like nebkha field. The foredune zone is wider and higher than Transect 1, and is located at a convex portion of the beach cusp (as present in 2016). Nebkha show translation inland between summer 2017 and summer 2019. Maximum elevation of the foredune zone along the transect is 7.0 m NAVD 88 on the crest of the slipface just above and west of the deflation plain (160 m). The transect then extends through the deflation plain where there was both erosion and accretion in summer 2018. There is an abrupt peak at a relict,

unrestored foredune (16 m) where *Ammophila* is continuing to trap sediments from the deflation plain.

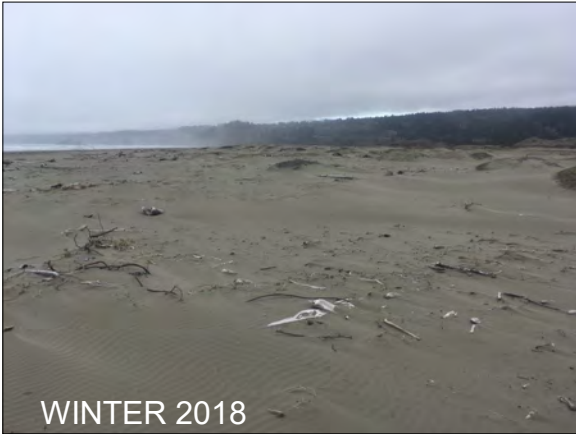
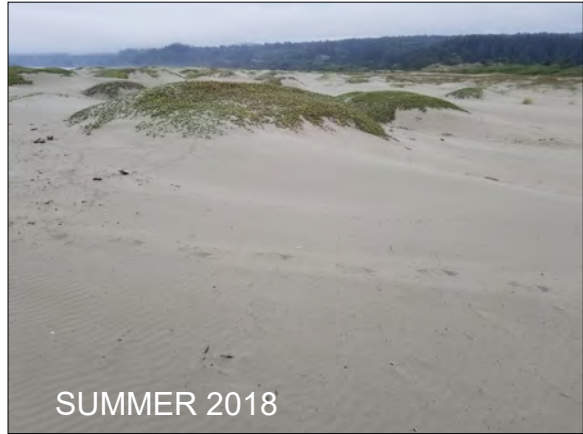
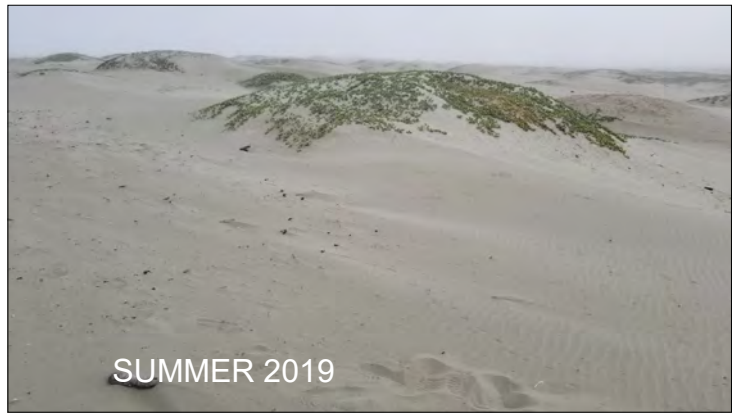
Little River Transect 3

View north at 284 m (foredune crest)

Notes: Similar to Transects 1-2, located in the southern portion of the restored area at Little River State Beach but extending into the unrestored backdune. Data are not available for winter 2016. Profiles show annual winter flattening of the backshore by storm wave runup, erosion and deposition, followed by summer formation of transverse dunes. The backshore gradually rises in elevation and transitions to a low rounded foredune zone. There is less vegetation and more even topography in the foredune zone of this transect compared with 1 and 2. Deposition at 284 m in summer 2018 raised the maximum elevation of the foredune zone by 0.4 m to 6.8 m. The eastern edge of the foredune zone steepened in 2018 indicating slipface development.

Beyond the foredune zone the transect passes through a deflation basin that underwent erosion in summer 2018, with resulting deposition downwind. The two relict *Ammophila* foredunes (132 m and 76 m) remained stable in 2018. East of these relict ridges is a second deflation plain in the more stable, backdune (unrestored) area

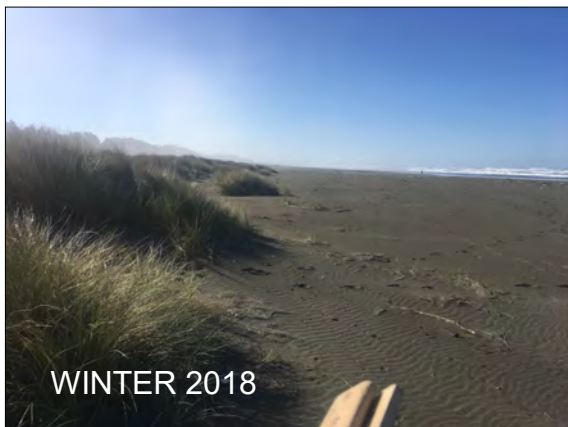
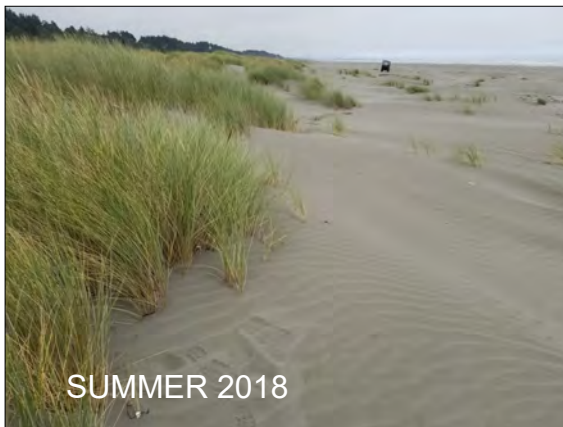
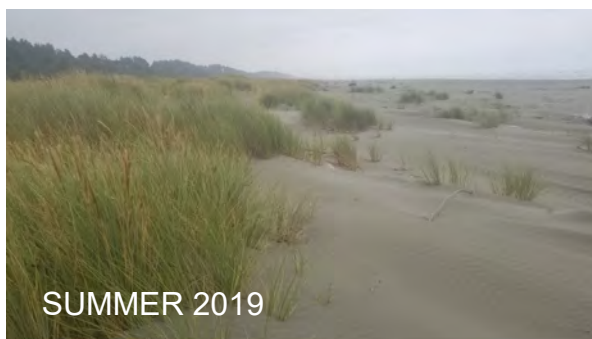
Little River Transect 4

View south at 230 m (foredune base)

Notes: The transect, located south of the restored area at Little River State Beach, is characterized by a broad, sparsely vegetated (*Ammophila*) backshore /incipient foredune that forms transverse dunes during summers and is flattened by wave runup in winters. From summer 2017 to summer 2019 the backshore/incipient foredune experienced net deposition. There is a stable established foredune separated from a relict foredune by a foredune swale. A backdune region has some deflation basins among *Ammophila* nebkha. The east end of the transect is an older, landward, relict foredune. The photographs above are taken looking south from the base of the foredune.

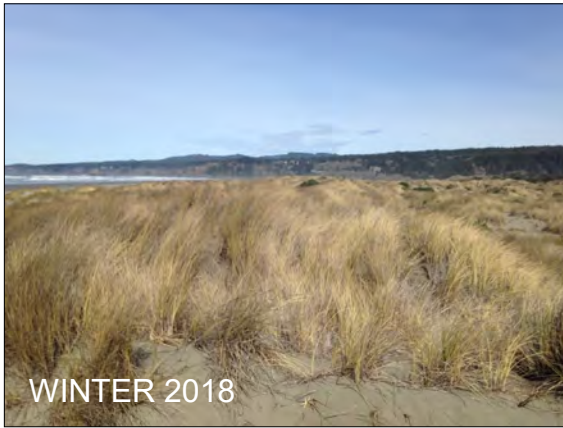
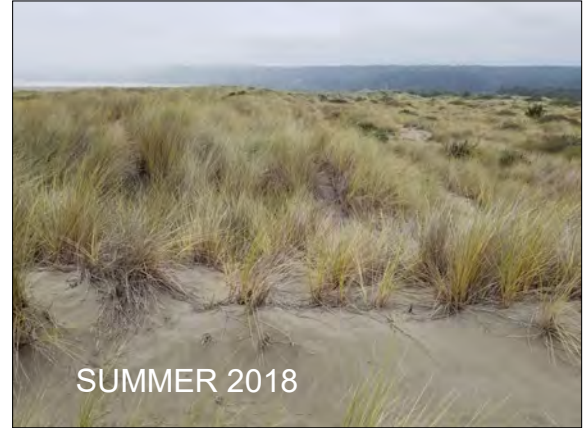
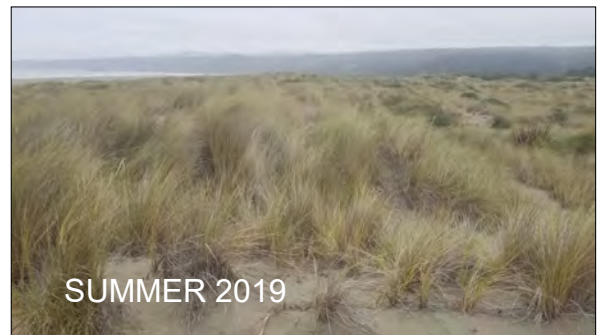
Little River Transect 5

View north at 160 m (foredune crest)

Notes: Similar to Transect 4, Transect 5 (located in the unrestored portion of Little River State Beach) is characterized by a broad *Ammophila* backshore/incipient foredune that forms transverse dunes during summers. The incipient foredune experienced up to 1 m of deposition between summer 2016 and summer 2019. There is an established, two-peaked *Ammophila* foredune separated from a landward relict foredune by a foredune swale, and a deflation plain separates these from an older, landward, relict foredune at approximately 60 m.

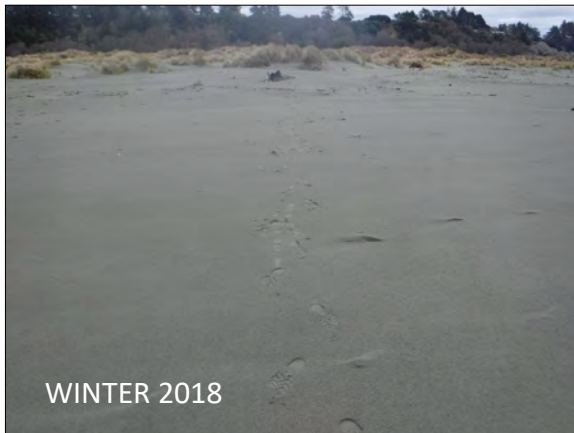
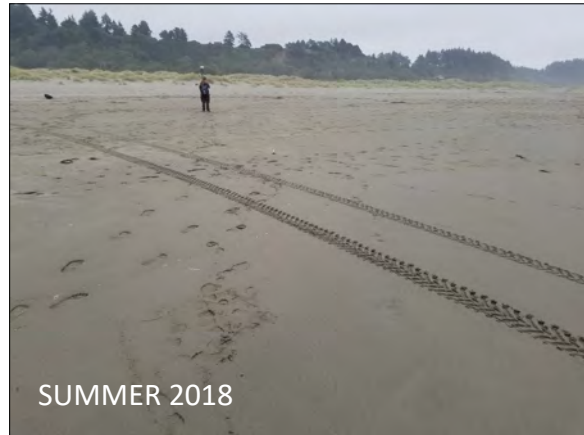
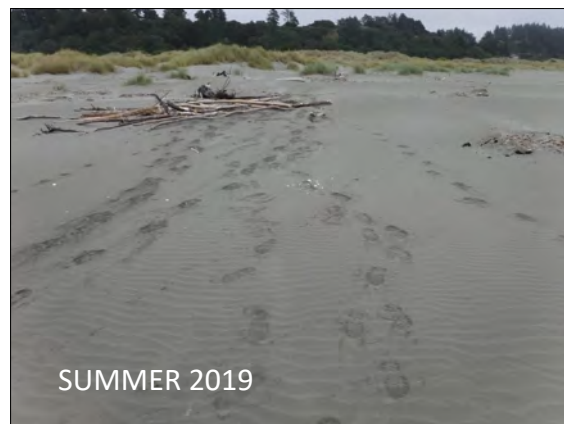
Clam Beach Transect 6

View southeast at 252 m (upper beach looking towards incipient foredune)

Notes: Data from winter 2016 are not available. The profile displays two relatively low and sparsely vegetated incipient foredune ridges. The outer incipient foredune was scarped in winter 2017, but ramping had smoothed the scarp by summer 2017. Deposition occurred on the backshore as well as the crest, lee and swale of the two incipient foredunes between summer 2016 and summer 2019. From summer 2017 to summer 2019 additional deposition occurred on the backshore and the stoss face of the inland incipient foredune. The higher, established foredune at 140 m remained stable, as did the backdune in general.

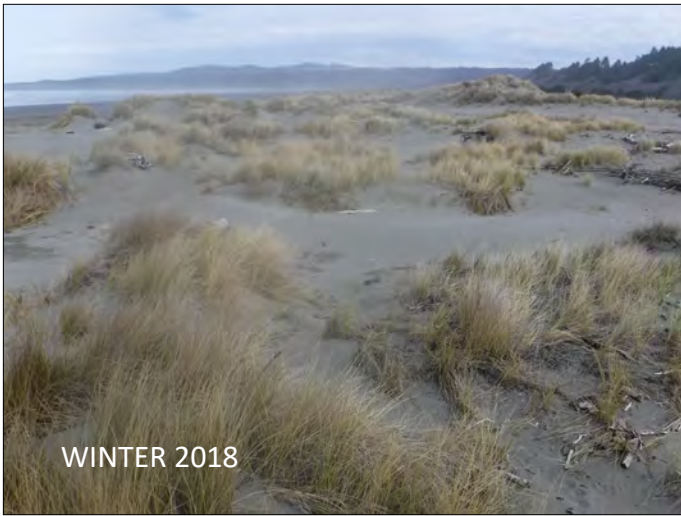
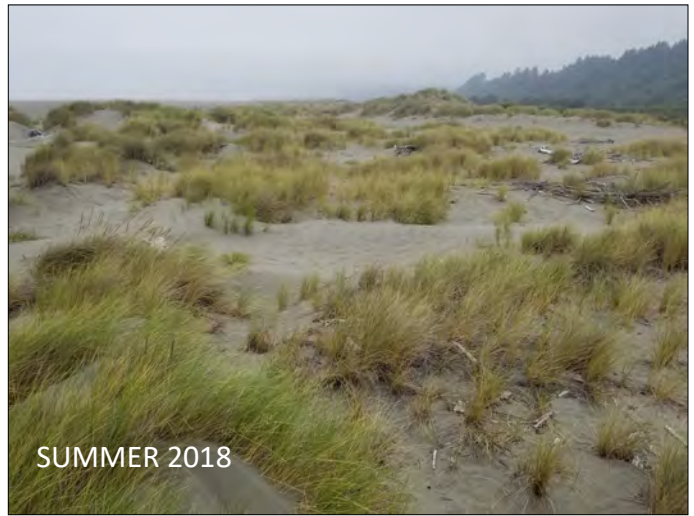
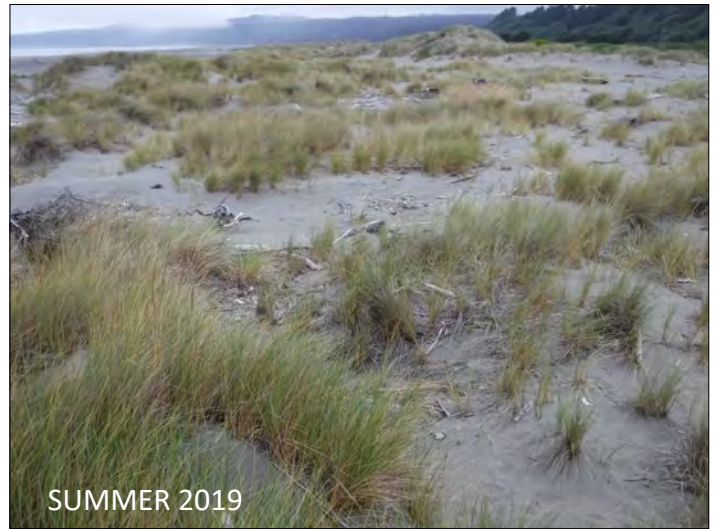
Clam Beach Transect 7

View north at 108 m (foredune crest)

Notes: Data for winter 2016 are not available. The base of the incipient foredune was scarped in winter 2017, with sediment deposited at the crest and in the swale between the incipient and established foredunes. Between winter 2018 and summer 2018 the incipient foredune translated inland. The backshore gained up to 1 m in elevation (240 m) between summer 2017 and summer 2018. Deposition on the backshore in summer 2019 brought it back to 2016 levels. The established foredune has been stable.

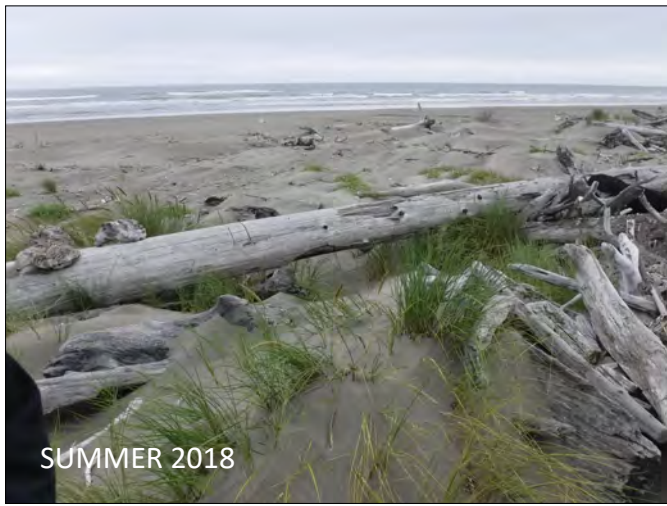
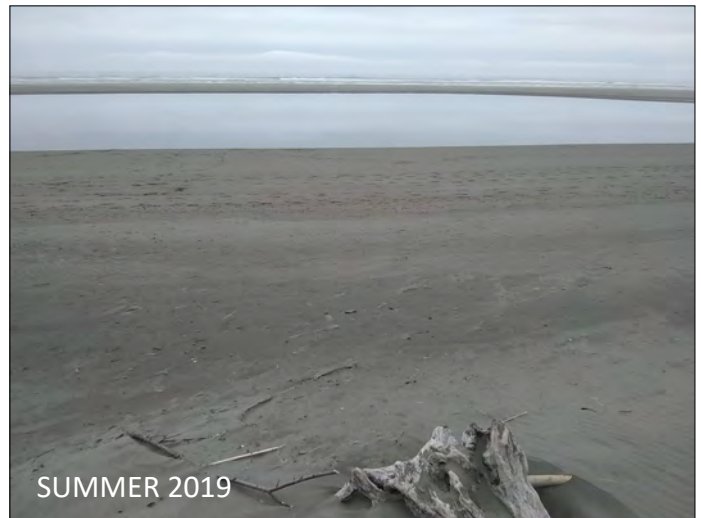
Clam Beach Transect 8

Clam Beach T8 View northwest at 58 m (Incipient Foredune)

Notes: Topographic data for winter 2016 are not available, but air photos show a large wood deposit on the upper beach following high water events. This transect is located north of the mouth of the Mad River and represents a dynamic area. The foreshore underwent seasonal deposition and erosion, with net deposition of up to 0.4 m between summer 2016 and summer 2017. The rounded topographic feature present between 88 m and 105 m in summer 2016 was unvegetated but may represent the initiation of an outer, seaward incipient foredune that was removed during high water events in winter 2017. Following the winter survey, wood was deposited on the more landward incipient foredune (causing the high peaks at 64 m and 56 m in the summer 2017 profile).

The established *Ammophila* foredune (2-30 m) had minor deposition on the crest and lee slopes of the two peaks in winter 2017, but lowered to 2016 levels in summer 2017. Between winter and summer 2019 surveys the entire seaward incipient foredune was removed when the river migrated northward.

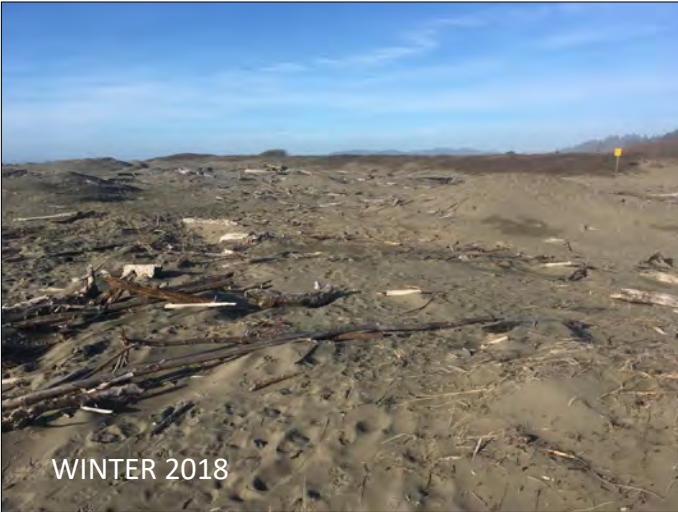
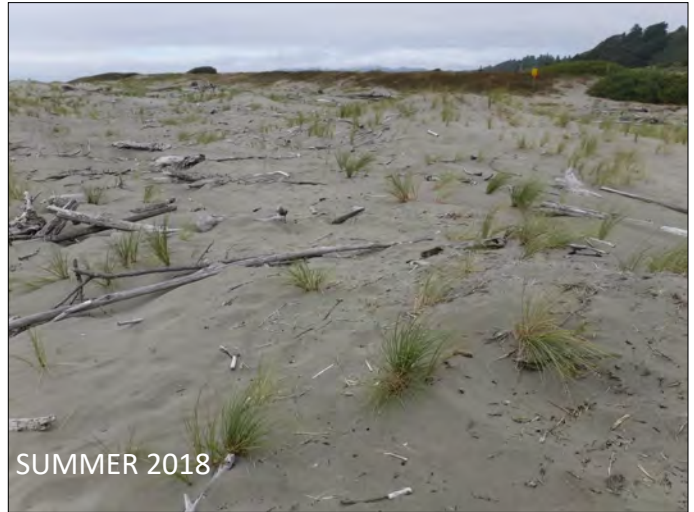
Clam Beach Transect 9

View north at 104 m (foredune crest)

Notes: The transect is located just north of the mouth of the Mad River in a dynamic area. Ongoing *Ammophila* removal occurred to the north. Winter 2016 data are not available, however a scarp line is visible on the winter 2016 air photo. The profiles show prevailing overwash influence with deposition of up to 1 m, from summer 2016 to summer 2018. The upper beach flattens in winter, followed by aeolian formation of transverse dunes in summer, with scattered *Elymus mollis* and *Cakile* spp. colonizing as far west as 274 m. In 2019 the mouth of the Mad River migrated north obliterating most of the transect and only a few points could be taken at the east end.

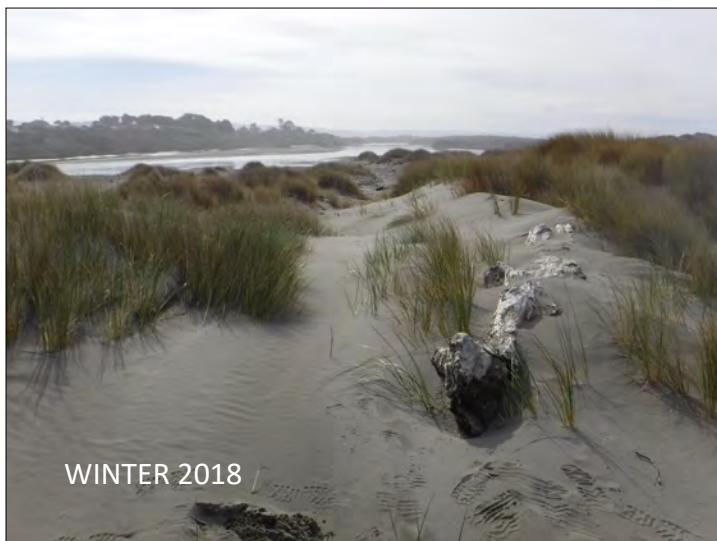
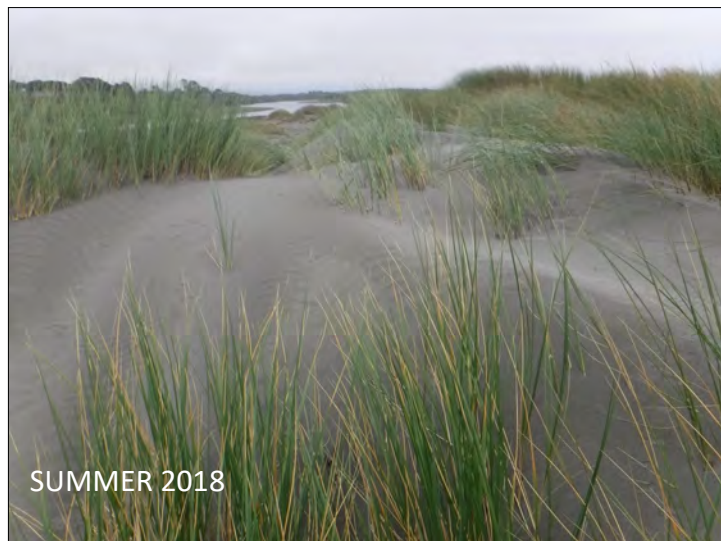
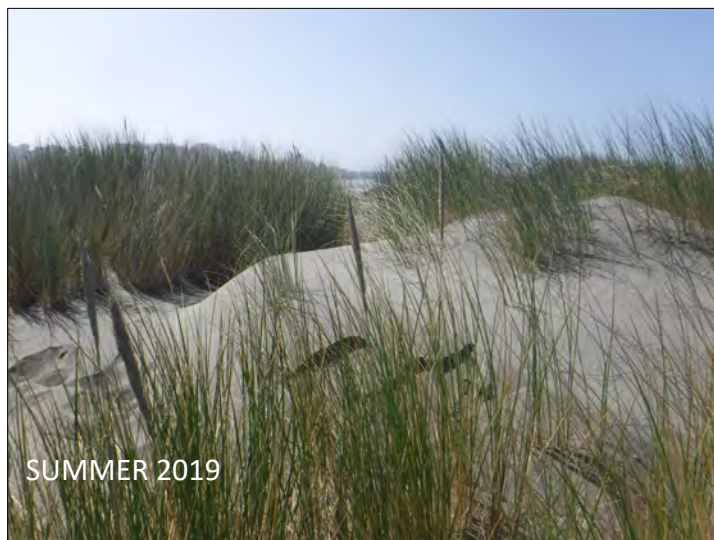
Mad River Transect 10

View southeast at 194 m (foredune crest)

Notes: This profile comprises a cross section of the Mad River Spit near its southern end. Data are not available for winter 2016. In summer 2017 the transect began farther to the east. Erosion along the east edge of the spit during the winter of 2017 resulted in adjustment of the east end of the transect further west. The spit is not well vegetated and the profile exhibits dynamic changes. The crest of the spit (characterized here as the foredune crest) has steadily gained in elevation. In summer 2018 over 1 m of deposition occurred in the region around 194 m. This can be seen in the photographs above in which the advancing lobe of sand has covered the wood visible the previous winter. The crest saw only minor deposition in summer 2019, however the upper beach was eroded, losing 1 m of elevation.

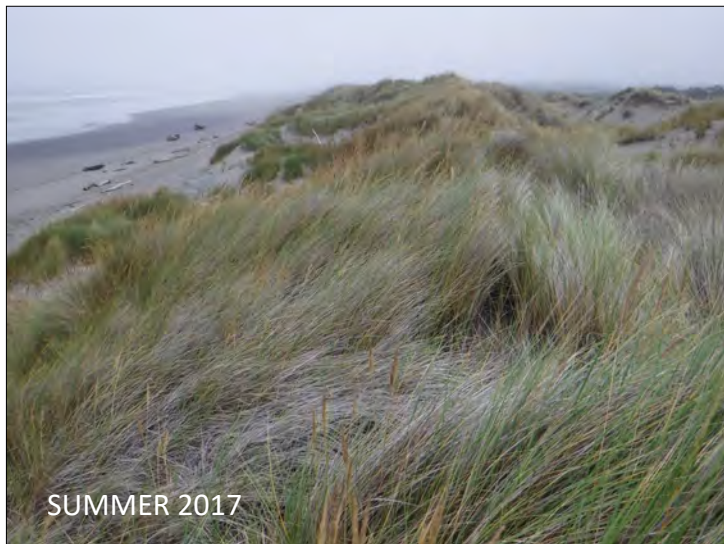
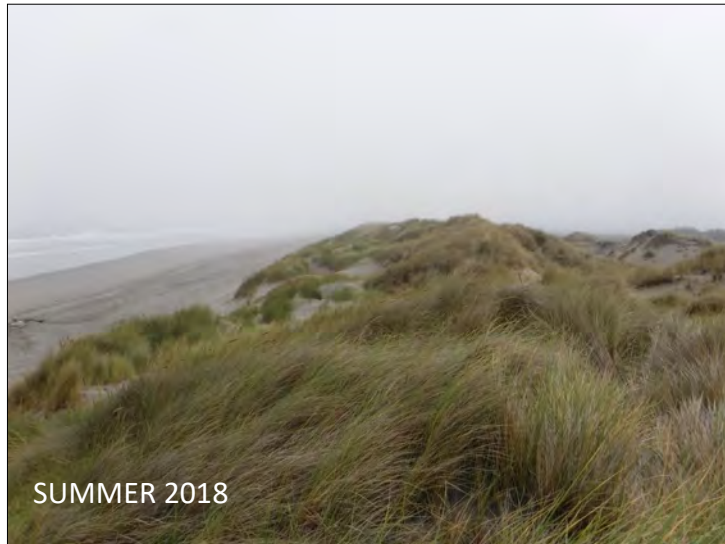
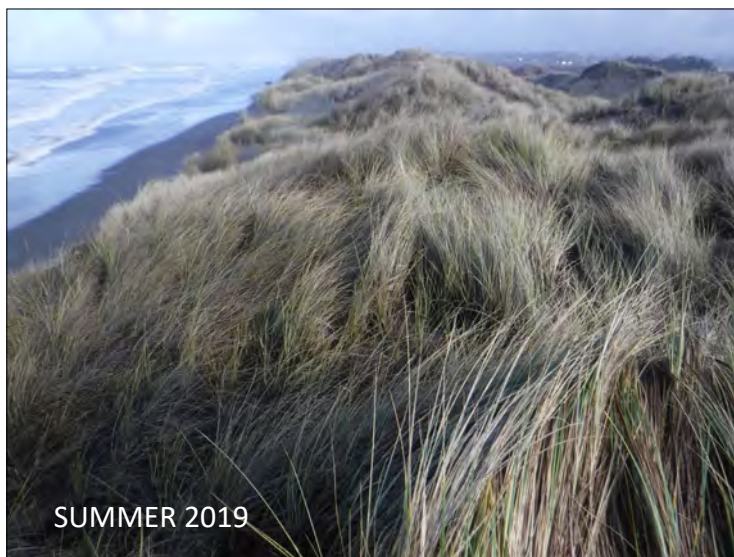
Mad River Transect 11

View north at 282 m (foredune crest)

Notes: This transect located in Mad River County Park is the first transect located south of the Mad River mouth, and the first going south along the littoral zone to exhibit a foredune over 10 m in elevation (10.7 m NAVD 88). In winter 2016 the upper beach was relatively steep, and by winter 2017 the beach had accreted almost a meter in elevation. However, a high water event and foredune scarping occurred soon after the survey was completed, and by summer 2017 the elevation was again lost, leaving a steep beach with some deposition at the toe of the foredune. The upper beach has shown mostly minor recovery in elevation since then. Between winter and summer 2019 the foredune rescarped, and additional elevation was lost from the beach. There are areas of open sand in the eastern portion of the transect, and the profile shows continued translation of one slipface to the east.

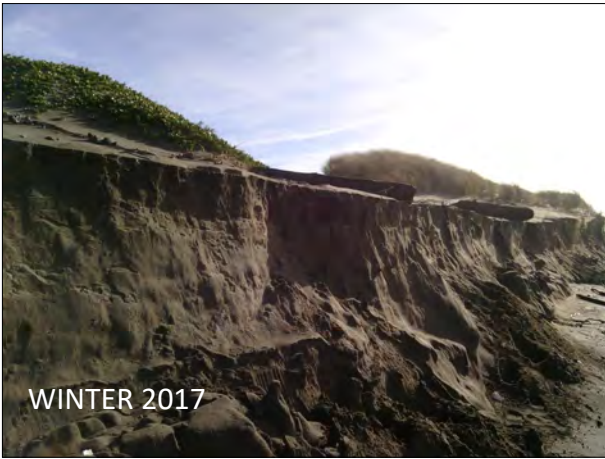
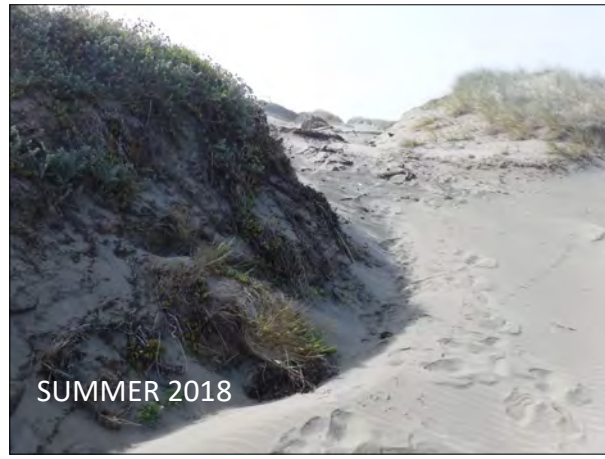
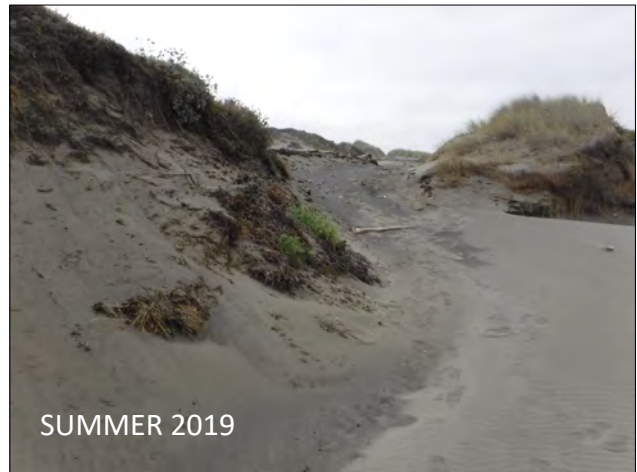
Mad River Transect 12

View southeast at 160 m winter 2017 and at 152 m on 7/20/2018 (incipient foredune/scarp)

Notes: The transect runs along the axis of the southern-most of a series of foredune blowouts, yielding a distinctive profile ending in the steep slipface of its depositional lobe. An incipient foredune seaward of the mouth of the blow-out was scarped after the survey in winter 2016. Erosion of the backshore persisted into summer 2016 although the incipient foredune had ramped and gained elevation. In winter 2017 high water events scarped the incipient foredune, removing 2.0 m vertically (see photo above left). Ramping and erosion of the scarp during summer 2017 reactivated the blowout, shifting the foredune crest west, and a new depositional lobe formed and has continued to migrate inland. In 2019 the incipient foredune lost elevation, but sand was deposited to the east. The eastern slipface of the larger depositional lobe has been stable over the three-year period.

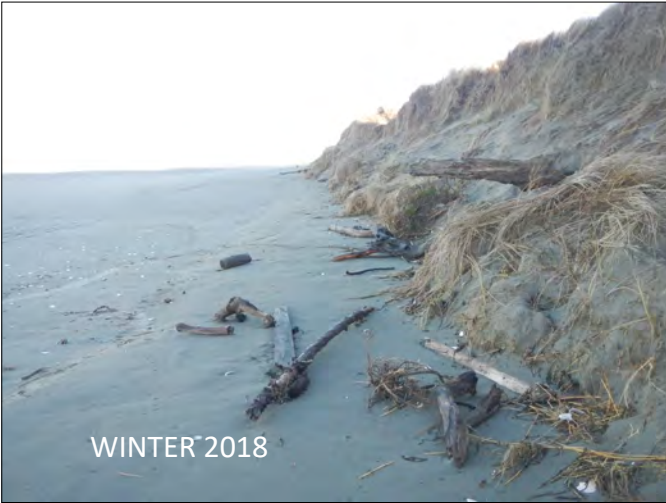
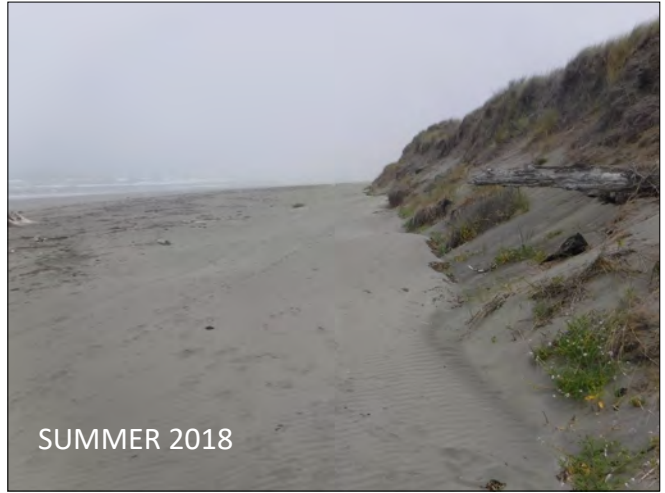
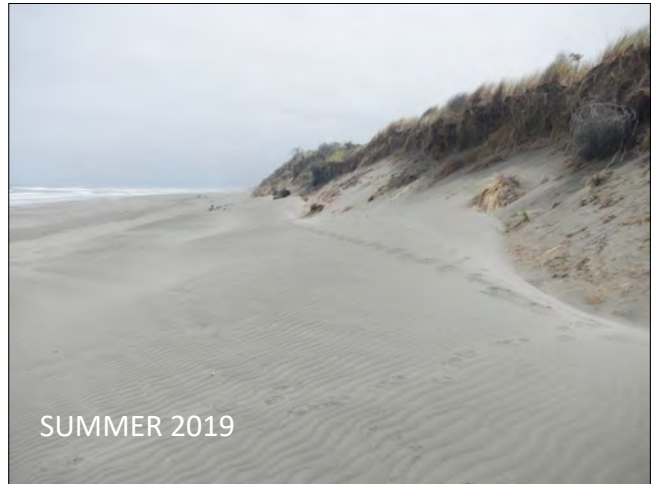
Mad River Transect 13

View north at 184 m (scarp)

Notes: The *Ammophila* foredune was significantly eroded during a high water event just before the winter 2016 survey, leaving a high, vertical scarp at the time of the survey. The scarp has since undergone slumping and additional scarping (following the winter 2017 survey). Since winter 2016 the upper beach has recovered approximately 0.8 m of elevation. Ramping had begun to occur in summer 2019.

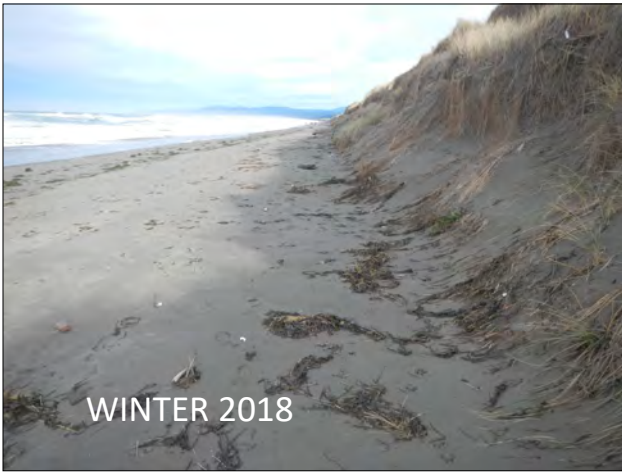
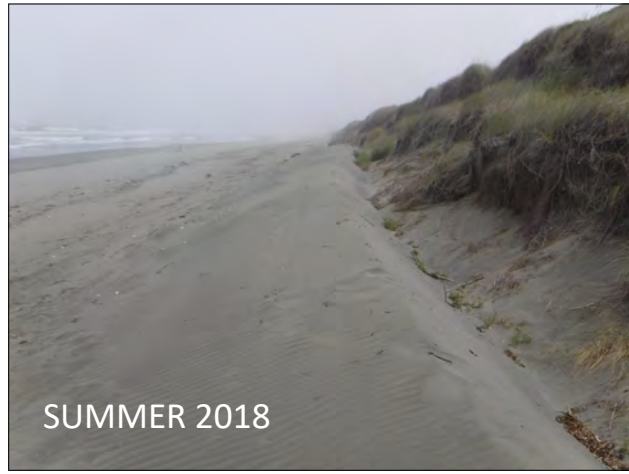
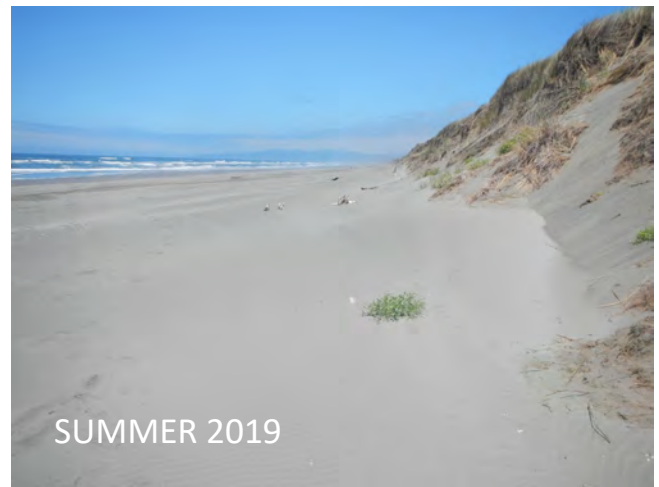
Long Transect 14

View north at 162m (scarp)

Notes: Moving from north to south, the elevation of the foredune crest has increased, reaching a maximum on this transect of 12.0 m NAVD 88. The *Ammophila* foredune was significantly eroded during a high water event just before the winter 2016 survey, leaving a high, vertical scarp at the time of the survey. The scarp remained virtually unchanged through summer 2016, while the foreshore steepened and there was minor deposition on the backshore at the base of the foredune. Prior to the winter 2017 survey the backshore eroded, losing up to 1 m elevation near the base of the foredune, and block slumping had occurred on the scarp. A high water event after the survey rescarped the entire foredune causing up to 8 m horizontal retreat, which shows up in the summer 2017 profile. By summer 2018 the profile was little changed except for the formation of a low scarp fill ramp, which reformed in summer 2019.

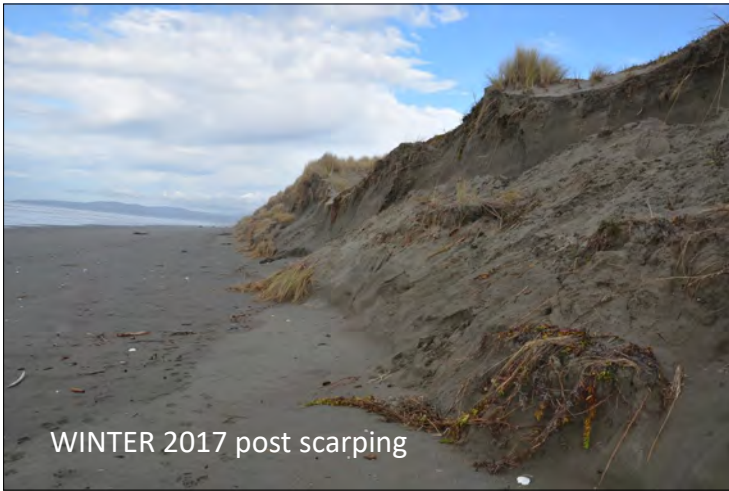
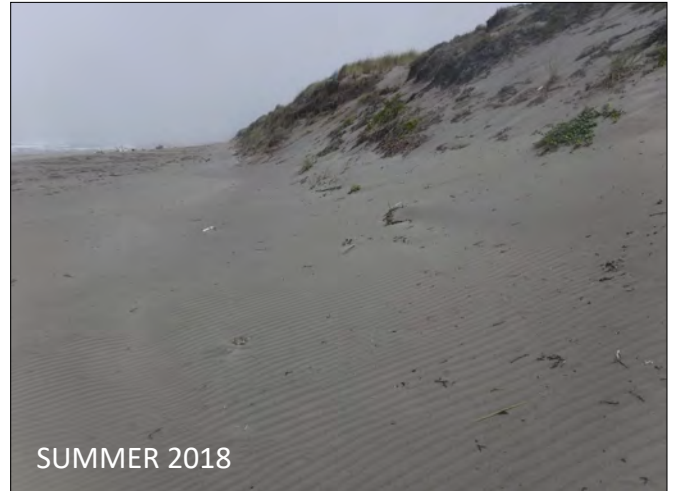
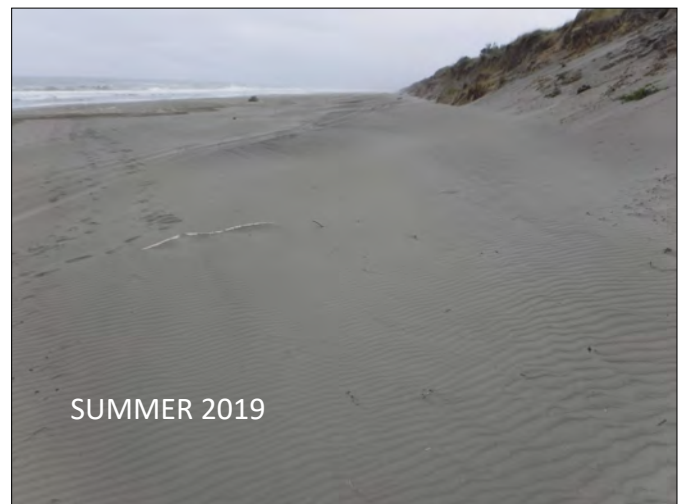
Woll Transect 15

View north at 166 m (scarp)

Notes: This high *Ammophila* foredune has a crest elevation of 12.6 m NAVD 88. The base of the incipient foredune had been scarped in winter 2016 prior to the survey, and between the winter and summer 2016 surveys it retreated an additional 5 m horizontally, although the beach gained in elevation by the summer survey. In winter 2017 the beach was lowered by 1.0 m vertically by the time of the winter survey. Soon after the survey a high water event removed the incipient foredune. By summer 2017 slumping had occurred, the backshore had received deposition of 0.5 m, and a ramp was forming. In 2018 the stoss face of the foredune changed little, but the upper beach elevation received deposition of 0.4-0.6 m. In 2019 the scarp receded further.

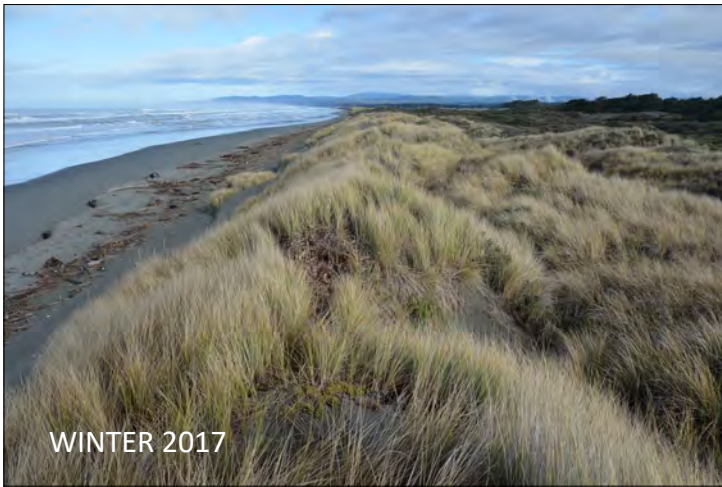
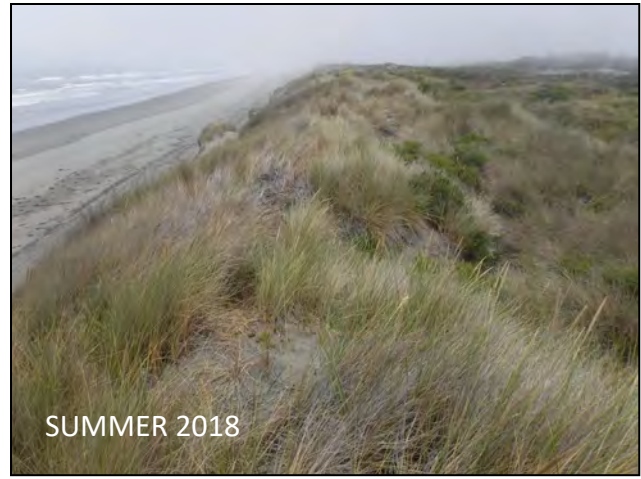
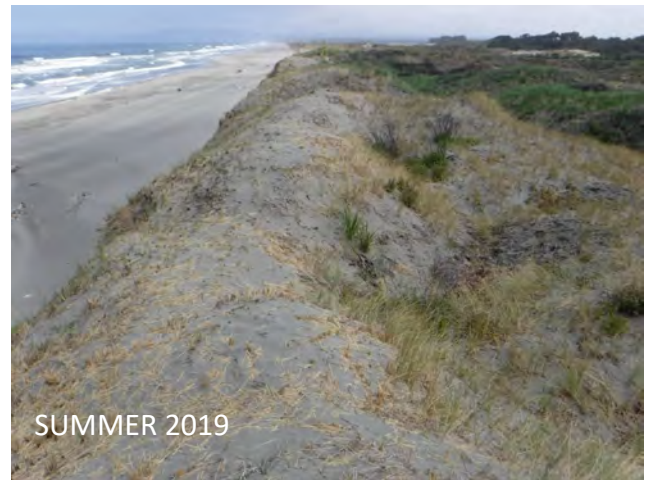
Bair Transect 16

View north at 154 m (foredune crest)

Notes: The foredune crest elevation of this steep, peaked *Amophila* foredune is 12.7 m NAVD 88. Low scarping occurred at the base of the foredune in winter 2016 prior to the survey, and from then until winter 2017 the backshore built up slightly and a scarp-fill ramp formed. Soon after the winter 2017 survey a high water event scarped the base of the foredune, causing retreat of up to 6 m horizontally and lowering the backshore 0.5 m vertically. By summer 2017 the base of the scarp had slumped and the backshore had increased in elevation, contributing to the formation of a scarp-fill ramp. By summer 2018 the ramp was still present but erosion had lowered the elevation of both the ramp and the upper beach, ending with an elevation similar to winter 2016. The foredune saw additional scarping in winter 2019. In summer 2019 a burn treatment occurred on the foredune, as is visible in the 2019 photograph.

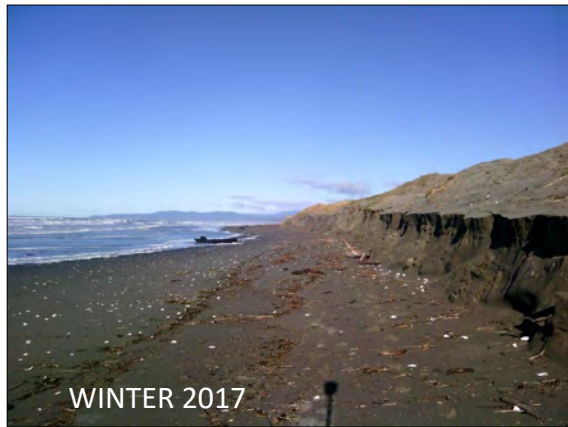
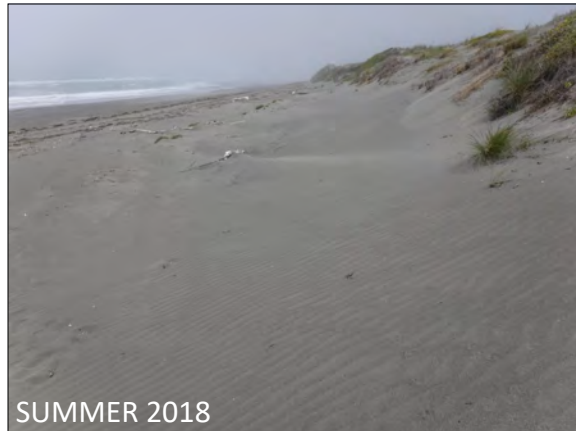
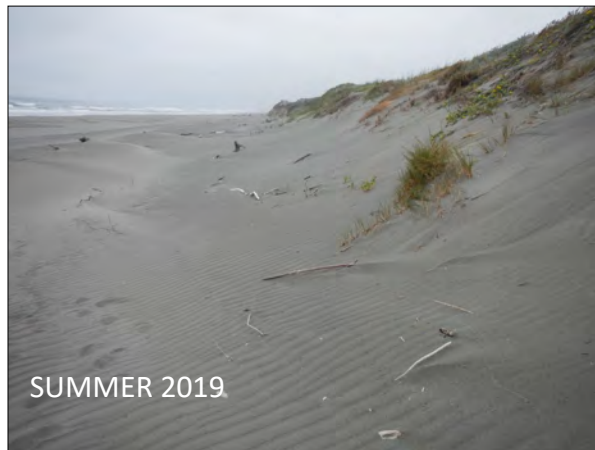
Bair Transect 17

View north at 119 m (left, showing scarp) and 105 m (right, and below showing ramp)

Notes: Significant scarping of the established foredune and lowering of the beach occurred prior to the winter 2016 survey (no incipient foredune was present). By summer 2016 a combination of slumping and ramping had smoothed the foredune slope. By the time of the winter 2017 survey the upper beach had scarped and lowered 1.0 m, and shortly after a large highwater event scarped the foredune back 10 m horizontally. By summer 2017 the beach had accreted 0.5 m vertically, but the ramp was only just reaching the base of the scarp. Therefore, sand transport from the beach to the foredune was limited during this season. Between summer 2017 and summer 2018 the foredune toe had regained elevation and the ramp was fully formed, allowing sand transport from the beach to the foredune. This transect is located in the Lanphere Adaptation Site, where *Ammophila* was removed from the foredune in winter 2016, and native species planted in winter 2017. Post vegetation removal, the first foredune crest deflated approximately .2 m, with sand deposited in the swale between the two foredune crests. As vegetation became

established there was little change in this area from summer 2017 to summer 2018. The foredune base and ramp changed little between 2018 and 2019.

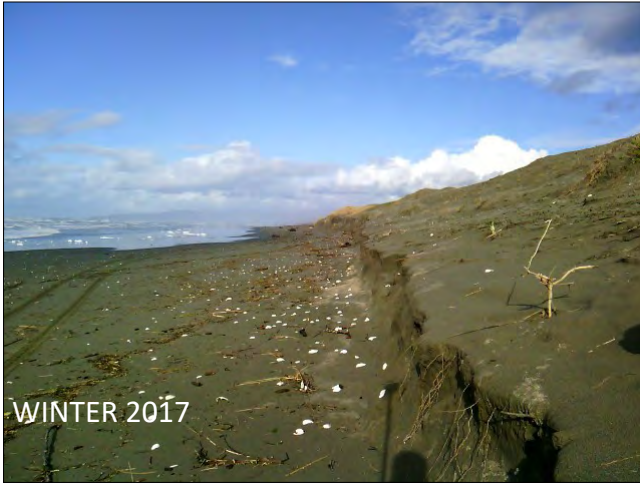
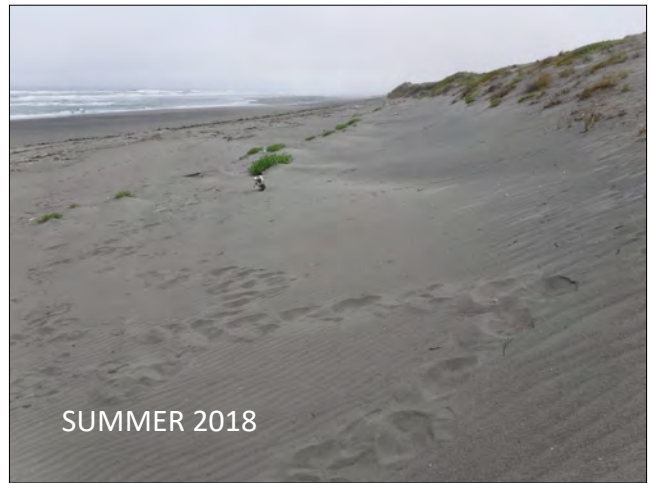
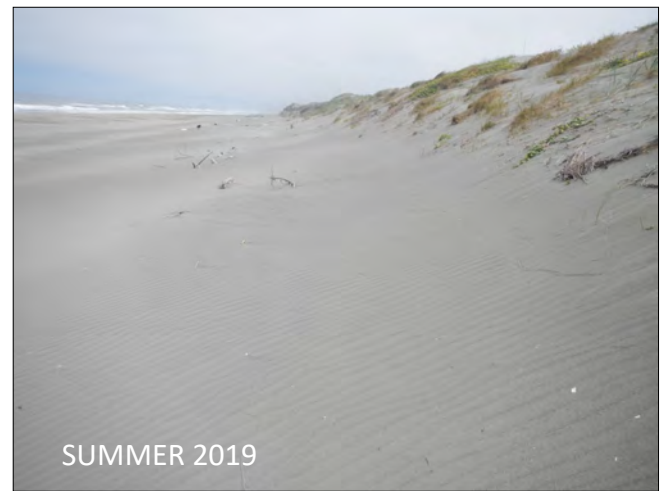
Bair Transect 18

View north at 120 m (left, showing scarp) and 110 m (right, showing ramp)

Notes: Scarping of the established foredune occurred prior to the winter 2016 survey resulting in 1.0 m loss of beach elevation and 10 m horizontal erosion of the lower stoss face of the foredune. By summer 2016 a combination of slumping and ramping had filled the scarp but only slightly raised the upper beach. Prior to the winter 2017 survey the upper beach scarped, losing 1.0 m of elevation. Soon after the winter survey a highwater event caused further erosion, with horizontal loss of 10.0 m and vertical loss of 1.4 m at the base of the foredune. By summer 2017 the beach had accreted 0.6 m vertically, but the ramp was only just reaching the base of the slumping scarp. Therefore, sand transport from the beach to the foredune was limited during this season. Between summer 2017 and summer 2018 the foredune toe had regained elevation and the ramp was fully formed, allowing sand transport from the beach to the foredune. This transect is located in the Lanphere Adaptation Site, where *Ammophila* was removed from the foredune in win-

ter 2016. In summer 2019 the lower stoss face steepened, eroding approximately 1 m in width.

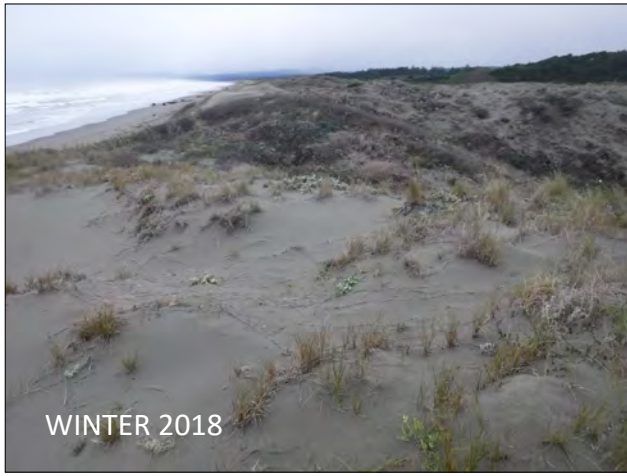
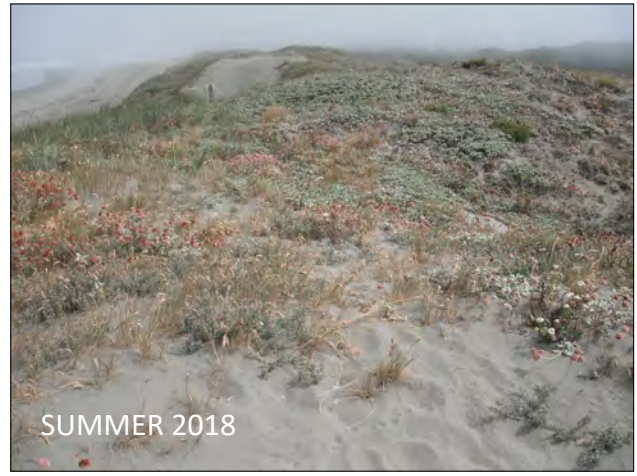
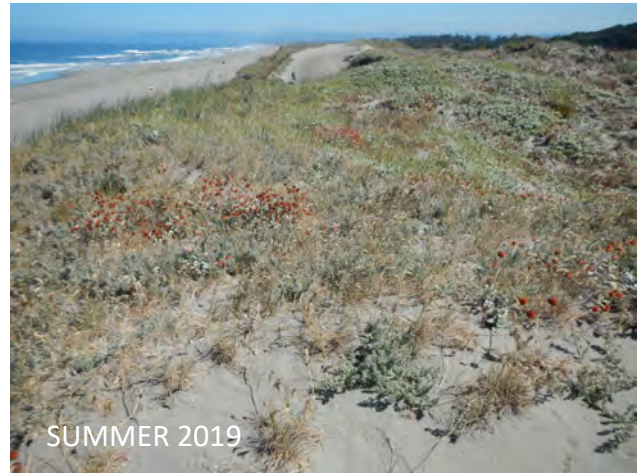
Lanphere Dunes Transect 19

View north at 147 m (foredune crest)

Notes: The profile describes a high, broad foredune vegetated by native species. Significant scarping after the winter 2016 survey shows up in the summer 2016 profile, having removed 2.6 m vertically including the small incipient foredune. By winter 2017 a scarp-fill ramp was forming and the backshore had regained 2.0 m of elevation, although the foreshore had not recovered. However by summer 2017 the ramp was continuous and becoming vegetated and the beach has recovered to winter 2016 elevations. From 2017 to 2018 erosion of the backshore and foredune toe returned this portion of the profile to conditions similar to summer 2016. The crest of the foredune has undergone 0.2 m of deposition during the two year period, visible in the photographs above. However, there was little change to the profile between 2018 and 2019, with its relatively mild winter, although the position of the offshore bar shifted.
