Humboldt Coastal Resilience Project

Phase 3 Beach-Dune Transect Profiles

November 2019

Submitted by: Andrea Pickart, Candace Reynolds, US Fish and Wildlife Service and Ian Walker
Arizona State University

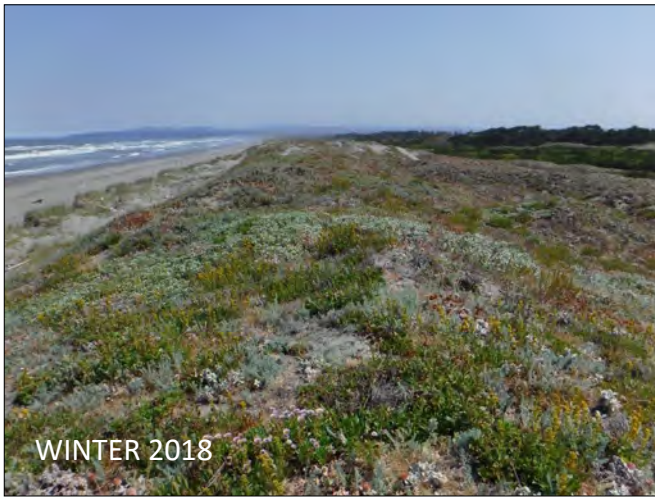
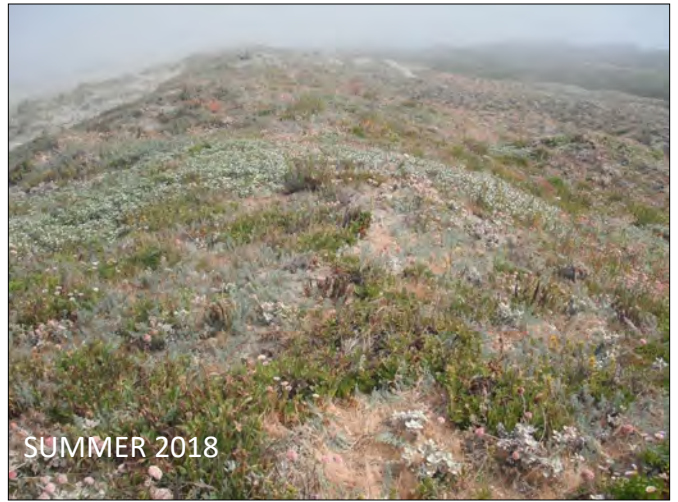
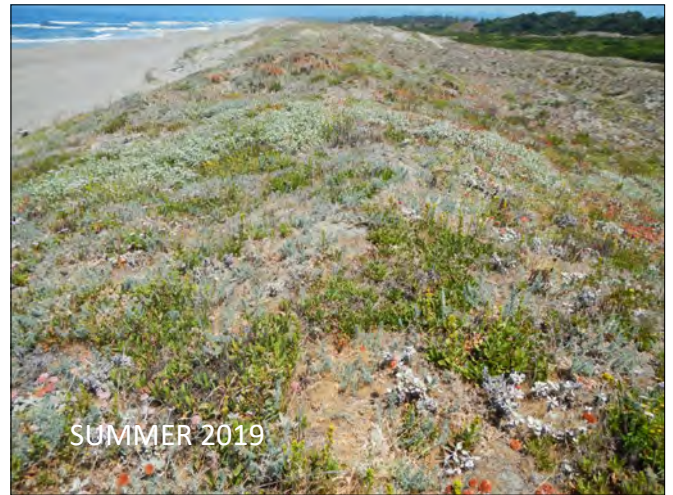
Lanphere Dunes Transect 20

View North at 197 m (foredune crest)

Notes: The established, native, two-peaked foredune was relatively stable over much of the two year period, with minor deposition on the landward peak where the transect crosses the depositional lobe of an old stabilizing blowout. The incipient foredune was scarpd between the winter 2017 and summer 2017 surveys, and continued eroding, with upper beach lowering, through summer 2018. Between winter 2019 and summer 2019 the incipient foredune eroded away completely. At elevation 13.1 NAVD 88, this transect represented one of the highest foredune crests surveyed in the study area.

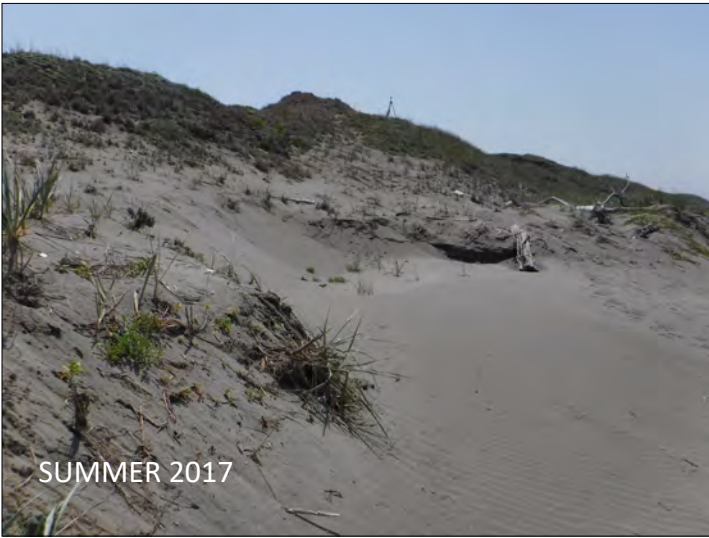
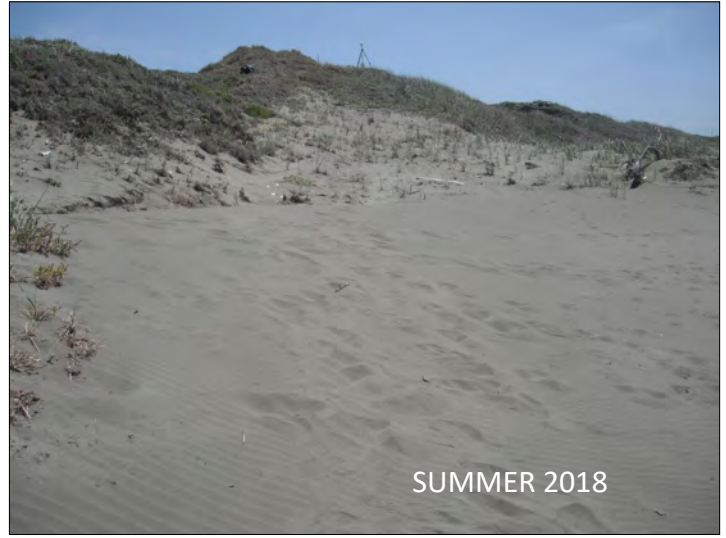
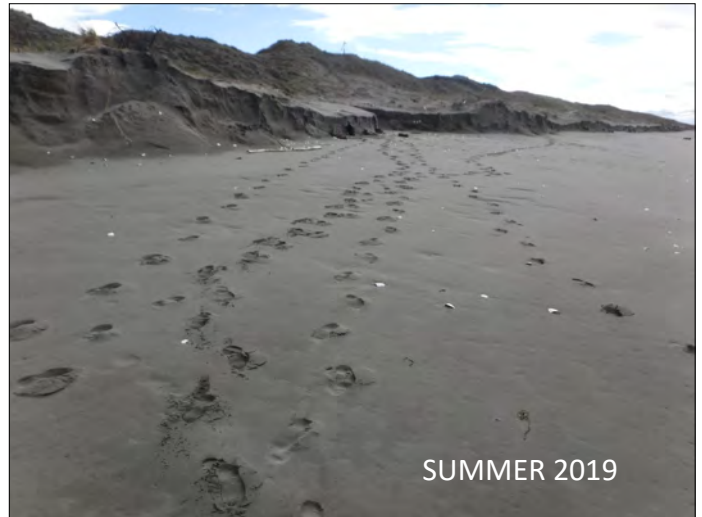
Lanphere Dunes Transect 21

View southeast at 199 m (incipient foredune)

Notes: The transect extends up an old, now-stabilized blowout, causing a peaked foredune topography vegetated with native species. The incipient foredune increased in elevation up to 1.0 m from winter 2016 to summer 2016. Following the winter 2017 survey it was severely scarping, losing up to 2.0 m vertically and 20 m horizontally, as seen in the summer 2017 profile. Post-scarping, by the summer 2017 survey a scarp-fill ramp had formed and by summer 2018 the incipient foredune increased in elevation by 0.8 m (see photos above taken SE along the transect). In winter 2019 the incipient foredune scarping, and between winter and summer 2019 further scarping occurred, removing the incipient foredune completely. The crest of the foredune, at 13.2 m NAVD 88, was the highest crest elevation measured along any of the transects in the study area.

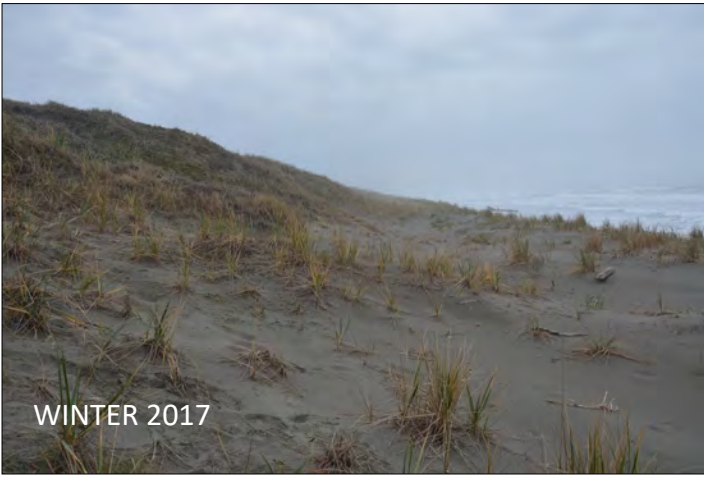
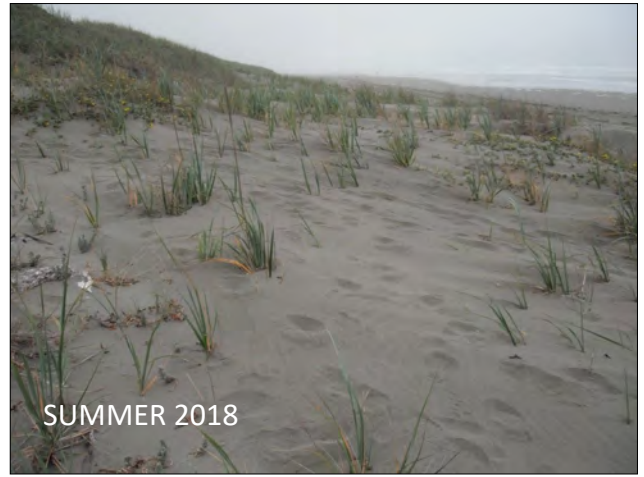
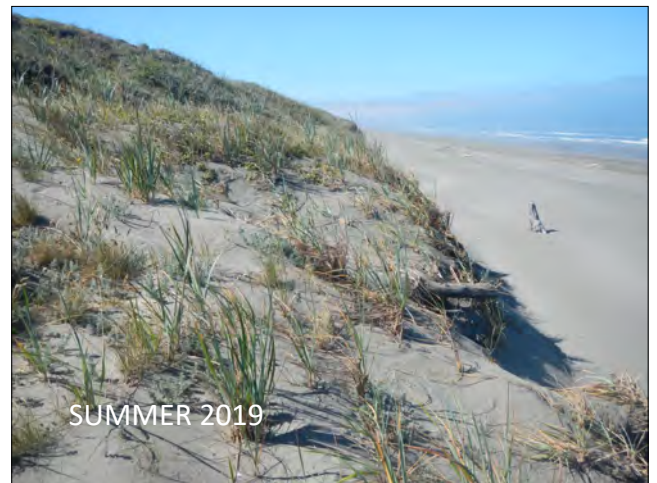
Lanphere Dunes Transect 22

View south at 187 m (incipient foredune)

Notes: The profiles show a high, stable, established foredune with a more dynamic incipient foredune. Vegetation is native. The incipient foredune increased in elevation 0.5 m between winter 2016 and summer 2017, remaining stable until the winter 2017 survey. However, scarping in winter 2017 (after the survey) resulted in narrowing and translation of the incipient foredune inland by summer 2017. By summer 2018 the incipient foredune has begun to weld onto the established foredune (see above photograph taken at base of established foredune). The foredune crest elevation is high, at 13.0 NAVD 88. Between winter 2018 and summer 2019 the incipient foredune scarped and was completely removed.

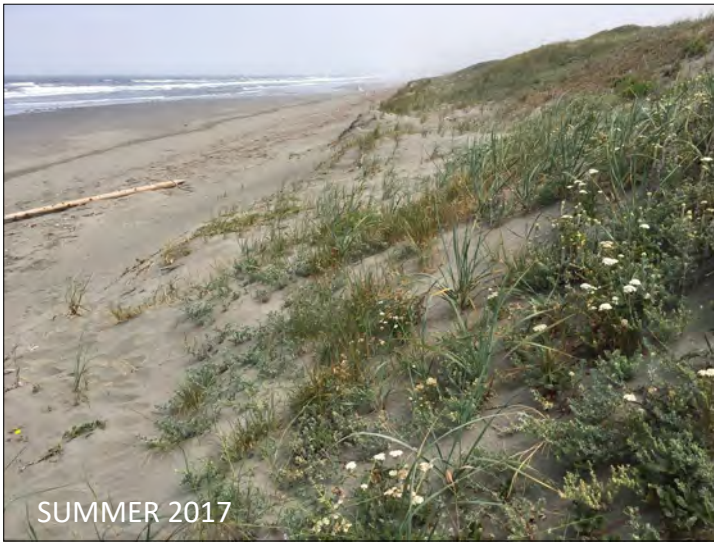
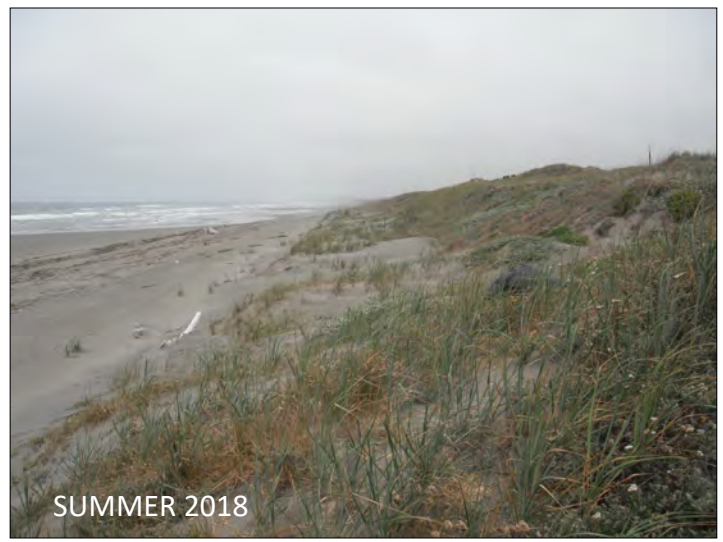
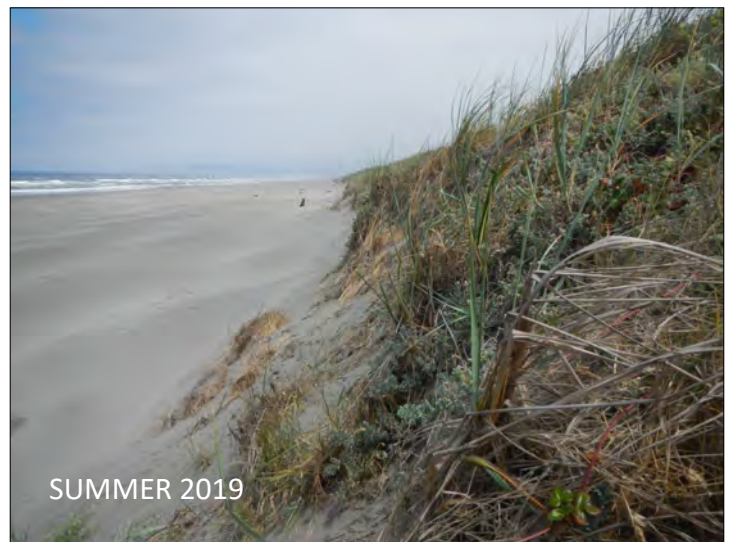
Lanphere Dunes Transect 23

View north at 165 m (foredune base)

Notes: This high (12.0 m NAVD 88), native, established foredune has been stable over the three year monitoring period, with a more dynamic incipient foredune. The incipient foredune was stable for the first year while the beach underwent seasonal changes. In winter 2017, prior to the survey, the incipient foredune was entirely removed through a dramatic 2.0 m vertical scarping event resulted in 20 m of retreat. By summer 2018, the beach had recovered some of its elevation especially on the backshore. Between winter and summer 2019 the established foredune scarped, retreating 8 m at its base.

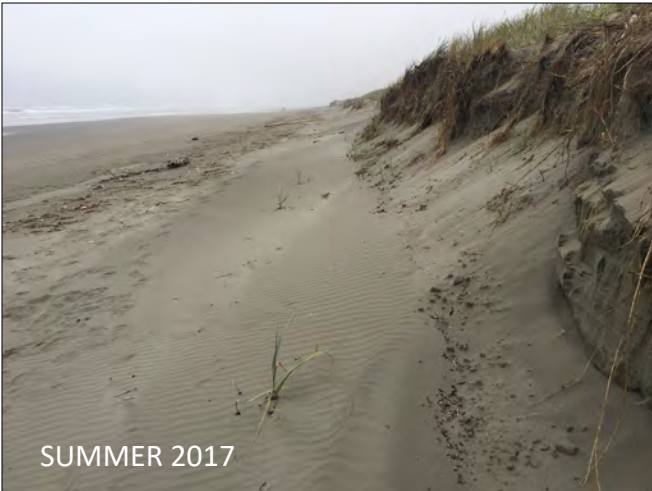
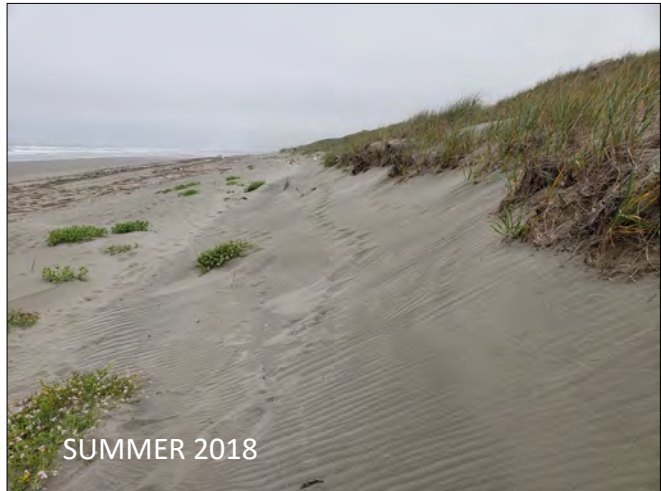
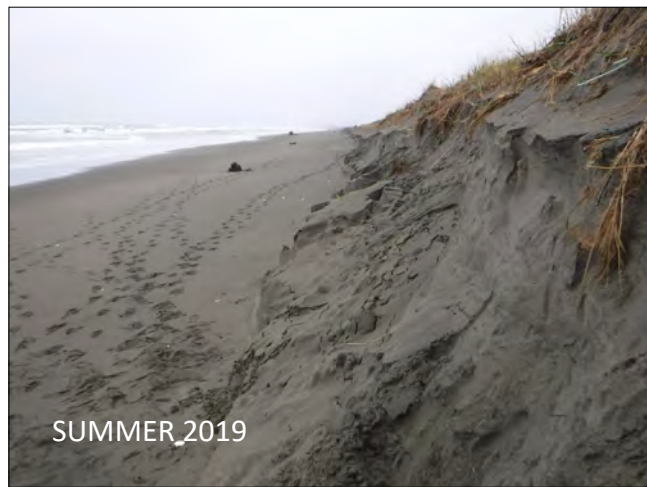
Lanphere Dunes Transect 24

View north at 181 m (foredune base)

Notes: Similar to T23, the broad, native, established foredune has been stable, while the incipient foredune was entirely removed in winter 2017 prior to the survey. High water events led to a 2.0 m vertical elevation loss, and 17 m of retreat. By 2018 ramping had occurred at the base of the foredune (see photo above). In winter 2019 the established foredune scarped back 10 m, although by summer 2019 deposition of +1 m had occurred on the upper beach.

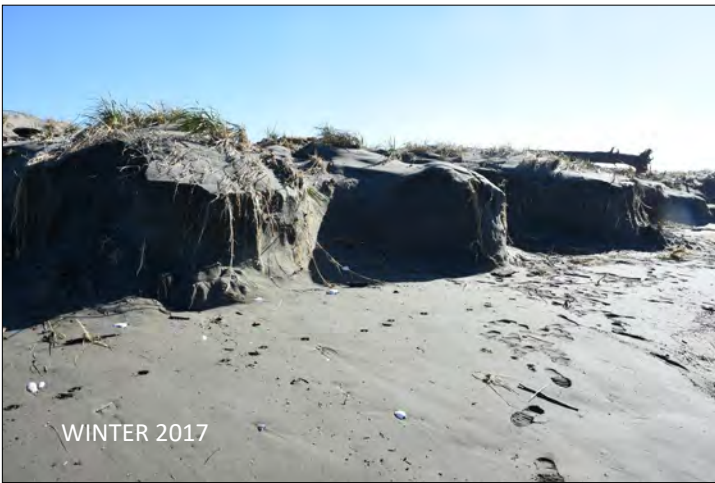
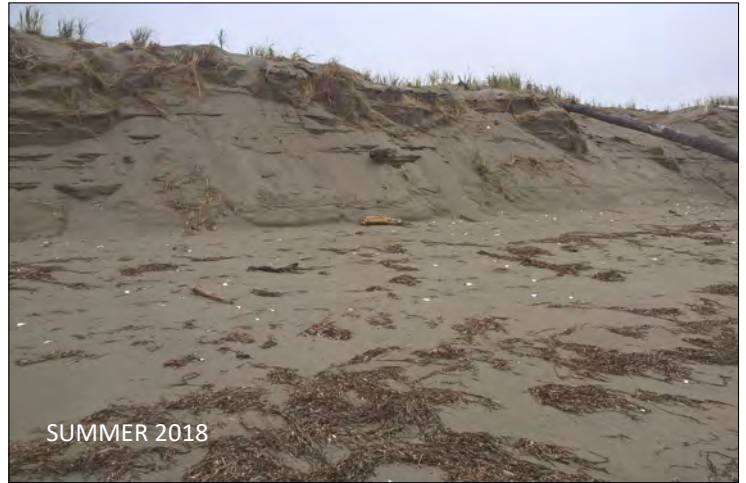
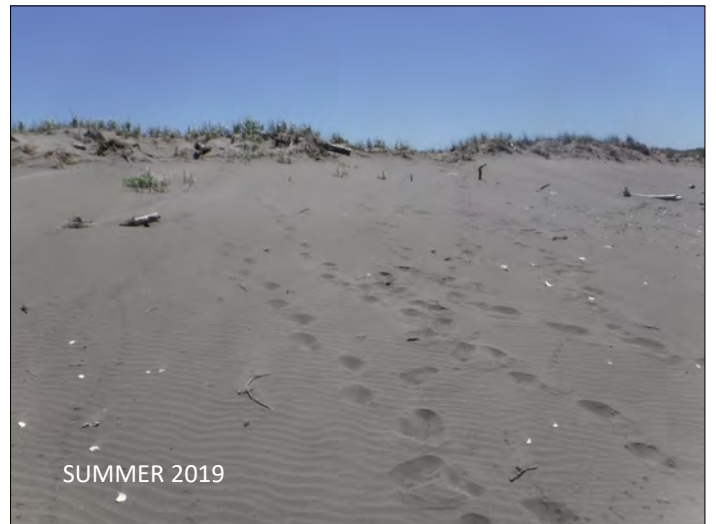
Ma-le'ī North Transect 25

View southeast at 207 m (upper beach)

Notes: The profile describes a sparsely vegetated parabolic dune that recently differentiated from a transgressive dunefield. It is fronted by a developing, native foredune. In winter 2017 the foredune was severely scarp'd with a loss of 1.6 m vertically. Additional scarping and beach lowering occurred by summer 2017 due to the narrow width of beach resulting from a persistent rip current. Some slumping but no ramping of the scarp had occurred by summer. Between the winter 2018 and summer 2018 surveys a high water event eroded the incipient foredune back another 12 m horizontally, removing the cusped edge. The beach was lowered by 0.5 m. Note the low beach and unusually high water line in the summer photo. By summer 2019 deposition on the upper beach and formation of a ramp allowed for some recovery of the developing foredune.

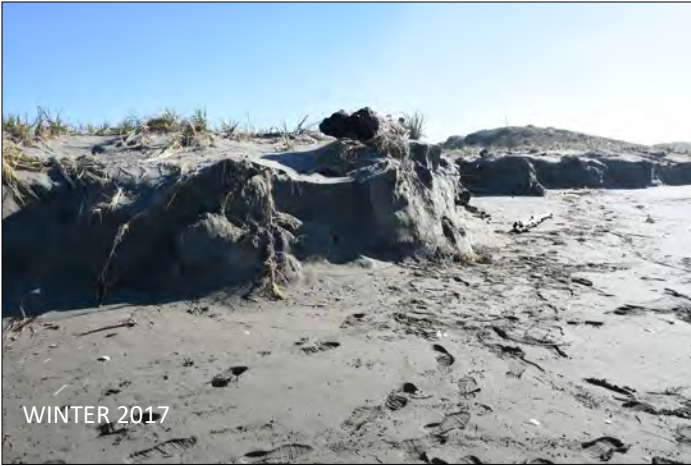
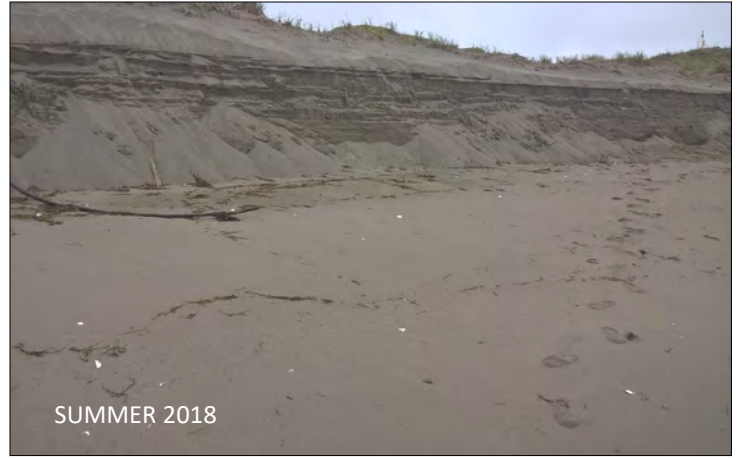
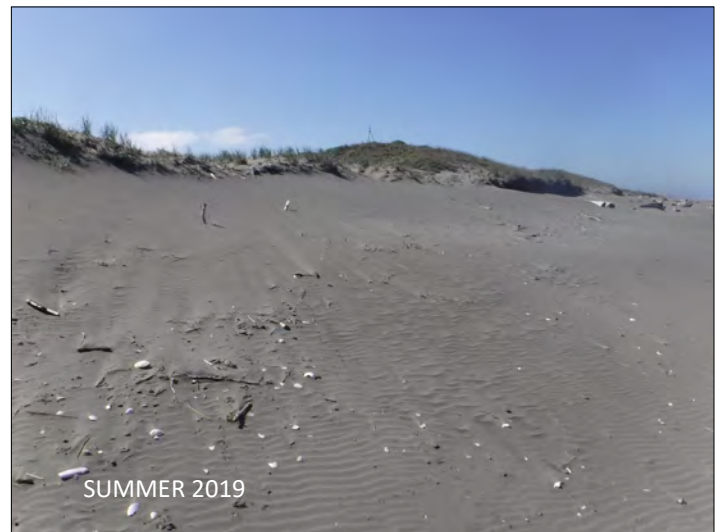
Ma-le'i North Transect 26

View southeast at 191 m (upper beach)

Notes: Adjacent to and similar to Transect 25 although this parabolic dune is shorter and its terminal slipface higher and steeper. In winter 2017 the developing fore-dune was scarped, losing 1.5 m of elevation, and the back-shore was lowered by 0.8 m. By summer 2017 an additional 20 m of retreat had occurred from renewed scarping due to the narrow width of beach resulting from a persistent rip current. Slumping had occurred along with some ramping. Between the winter and summer 2018 surveys the upper beach eroded up to 1.4 m, removing the ramp. In 2019 deposition on the upper beach rebuilt the ramp. At its eastern edge the parabolic dune has translated, with the slipface steepening through winter 2018 as a result of the relatively static position of its base, which was anchored by *Salix* growing in a deflation basin. Between winter 2018 and summer 2019 the base migrated inland 10 m horizontally.

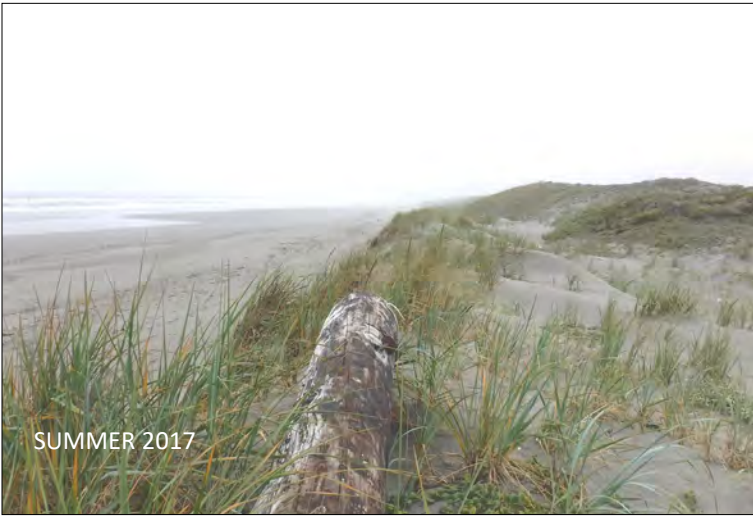
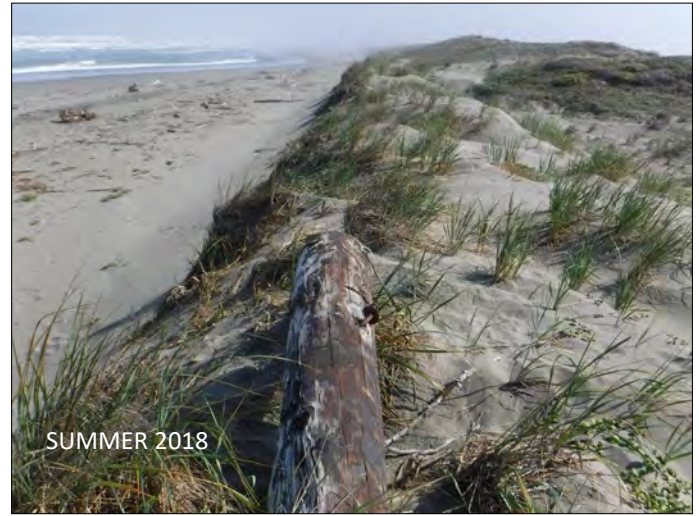
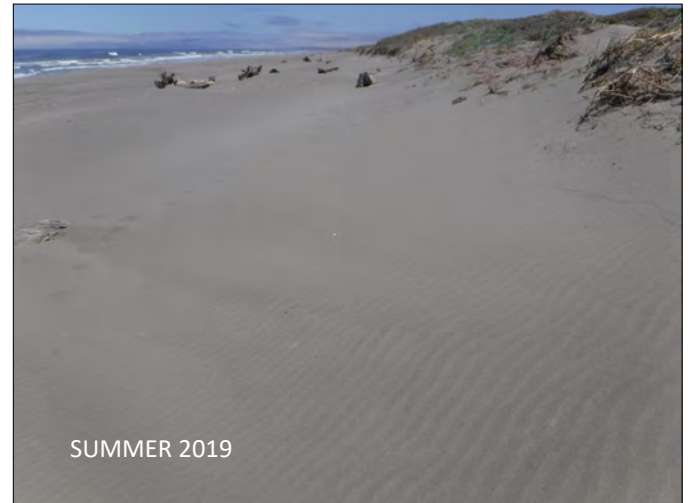
Ma-le'I North Transect 27

View north at 171 m (incipient foredune)

Notes: Scarping of the incipient *Elymus* foredune occurred in winter 2016, followed by scarp-fill ramping in summer 2016. The incipient foredune was then rescarped in winter 2017 during the high water event that emplaced the wood pictured in the photo above. Although little ramping occurred in summer 2017, the upper beach gained in elevation. Scarping resulted in mobilization of sand on the crest of the incipient foredune, similar to the slipfaces that can be seen to the north in the photograph. In 2019 additional scarping of the IFD occurred, leaving only a small IFD.

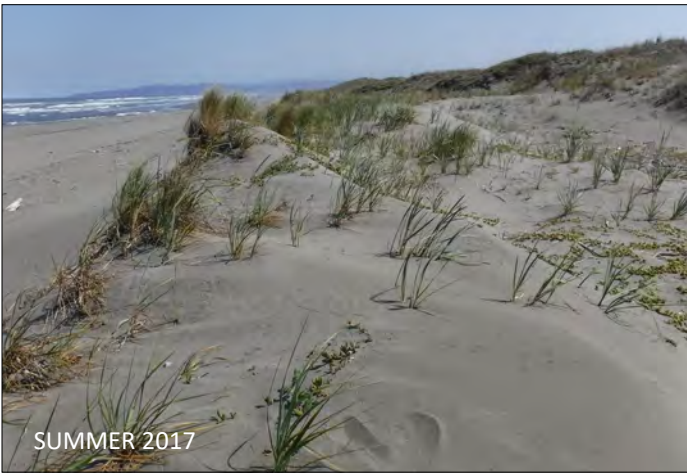
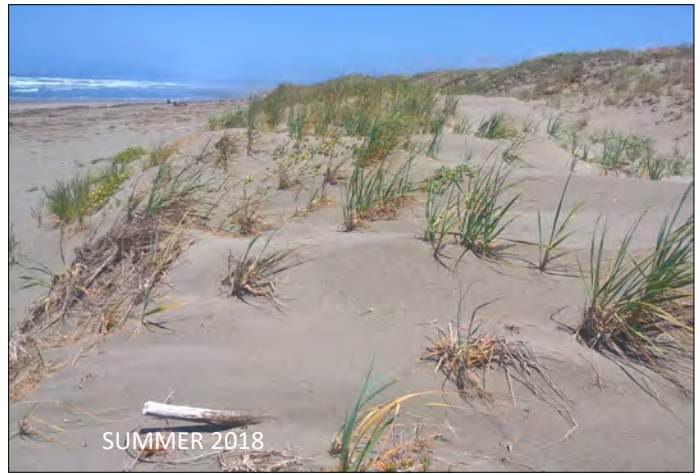
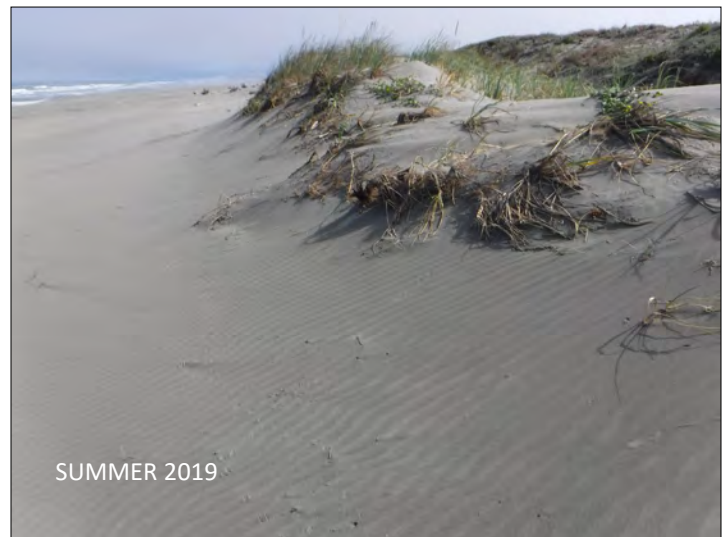
Ma-le'i North Transect 28

View north at 177 m (incipient foredune)

Notes: A 2.0 m vertical scarp occurred in the incipient *Elymus* foredune in winter 2016. By summer 2016 the scarp had increased in height from further erosion and sand at the top of the scarp mobilized, forming a slipface. In winter 2017 the incipient foredune re-scarped, retreating an additional 10 m, and up to 10 m of sediment eroded from the backshore. By summer 2017 the crest of the incipient foredune had migrated inland, de-emphasizing the incipient foredune swale. The beach regained elevation to near the level of summer 2016. Between summer 2017 and summer 2018 the incipient foredune remained relatively unchanged (see photos above). However, in 2019 the incipient foredune was entirely removed.

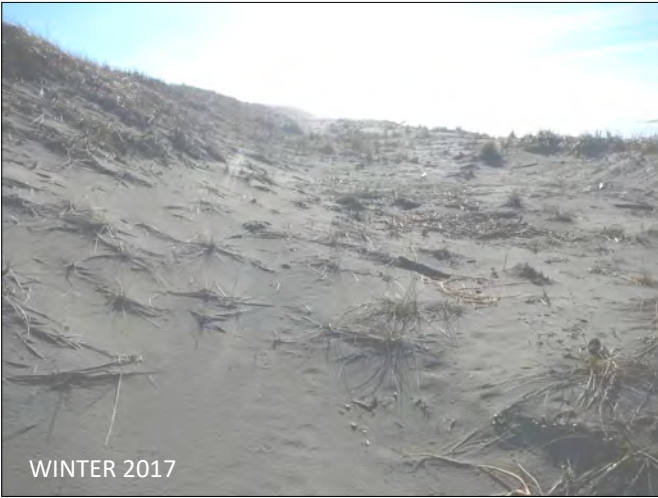
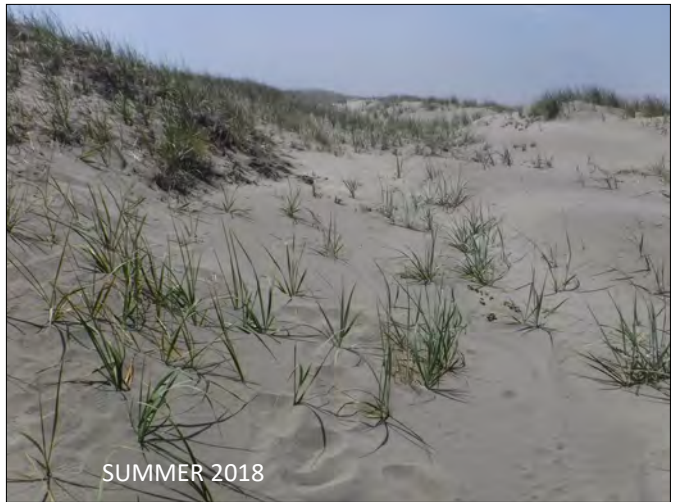
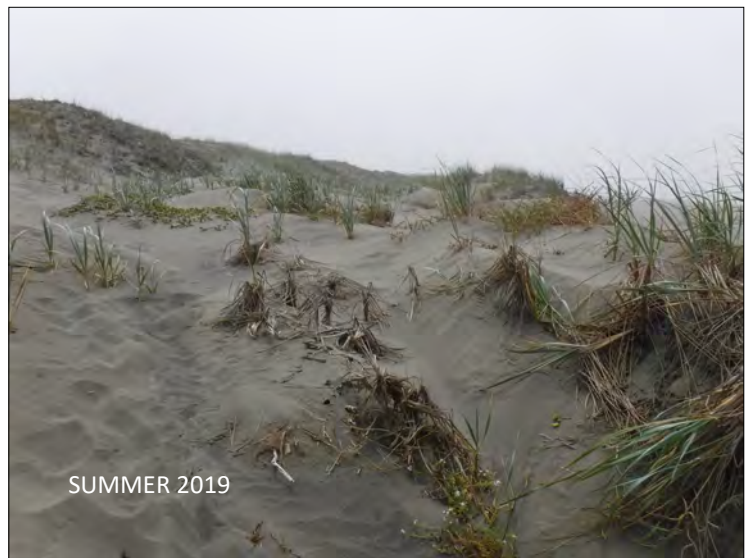
Ma-le'I North Transect 29

View south at 175 m (incipient foredune swale)

Notes: Similar to the previous transect, this profile depicts a stable, native, established foredune and a dynamic incipient foredune. Scarping of the incipient *Elymus* foredune occurred in winter 2016 with additional erosion of the upper beach occurring before the summer 2016 survey, which shows scarp-fill ramp formation. In high water events of winter 2017 the incipient foredune retreated an additional 10 m, leaving a 2.5 m scarp. In summer 2017 the mobilized sand on the incipient foredune crest formed a slipface, and by summer 2018 additional deposition had filled the swale (see photos above). In 2019 the incipient foredune had translated and become incorporated in the established foredune.

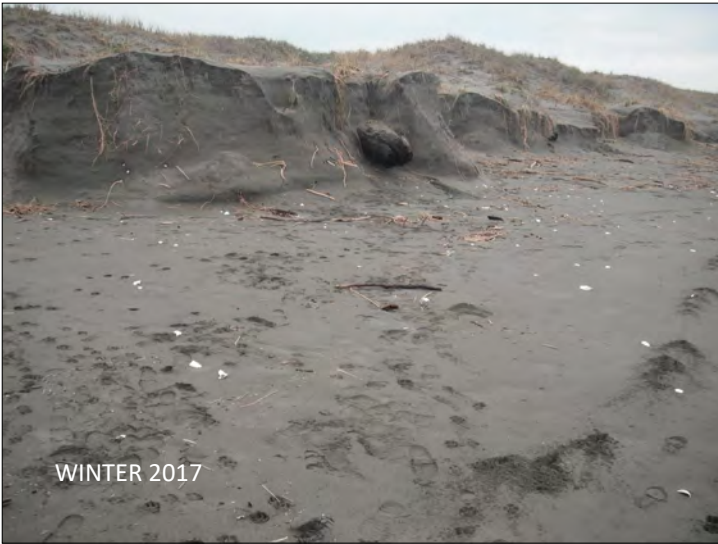
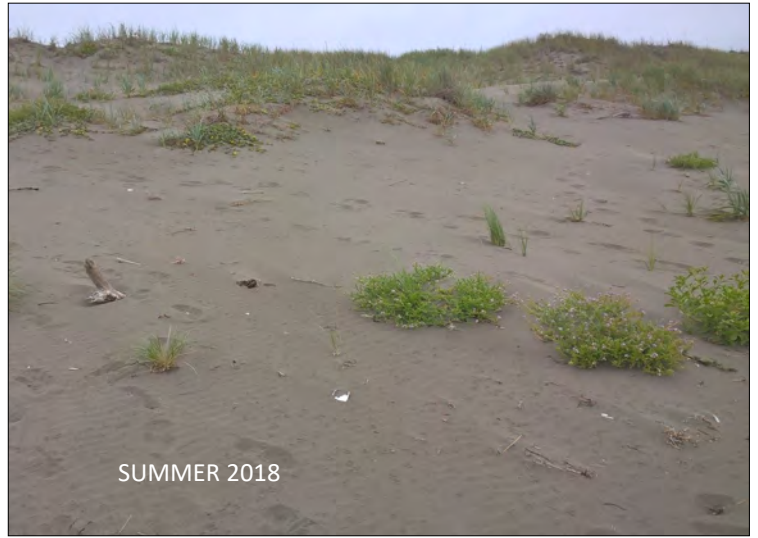
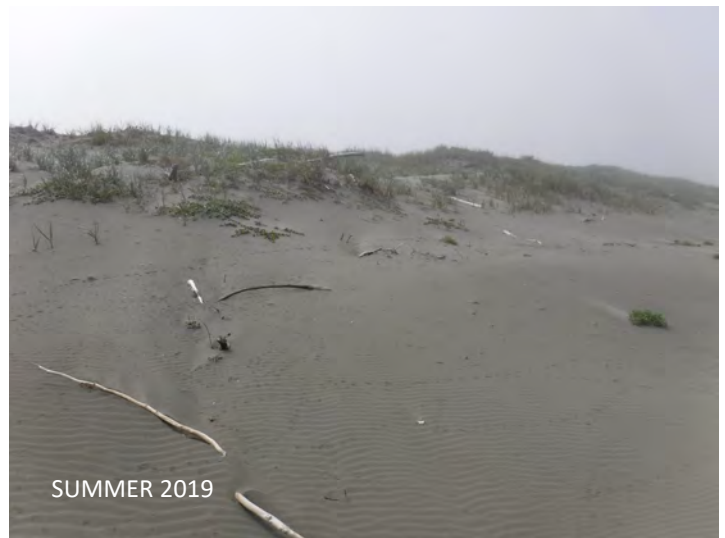
Ma-le'i North Transect 30

View southeast along transect at 147 m showing scarp (left) and ramped foredune (right)

Notes: The incipient *Elymus* foredune scarped dramatically in winter 2017, losing 2.0 m vertically and lowering the fore-shore and backshore. By summer 2017 the beach had regained the lost elevation and the incipient foredune slope was smoothed by erosion and ramping. The small peak at 109 m midway up the stoss face of the established foredune in winter 2016 is the relict of a knoll that eroded during the previous 3 years. The sand from the knoll moved up the face of the established foredune. By summer 2018 the incipient foredune was no longer a distinct feature, having welded on to the stoss face of the established foredune.. By 2019 this feature had migrated up the foredune.

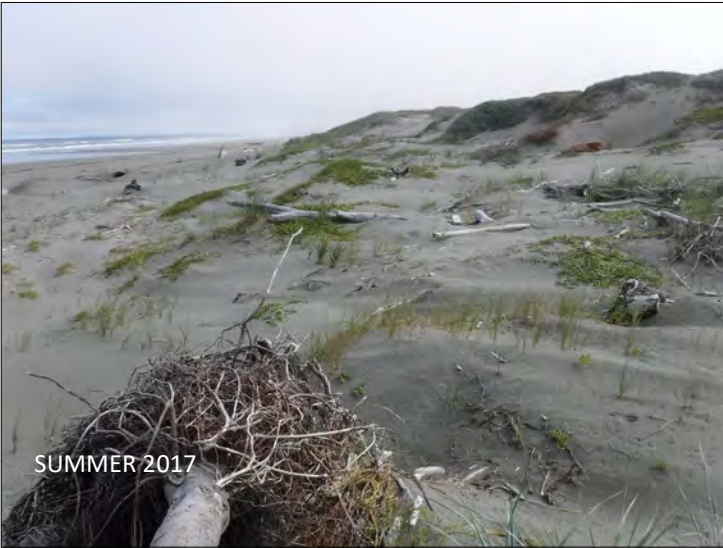
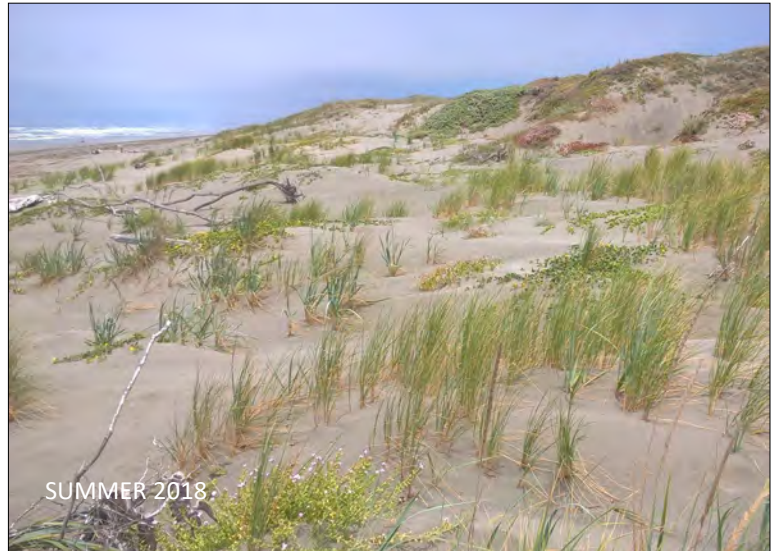
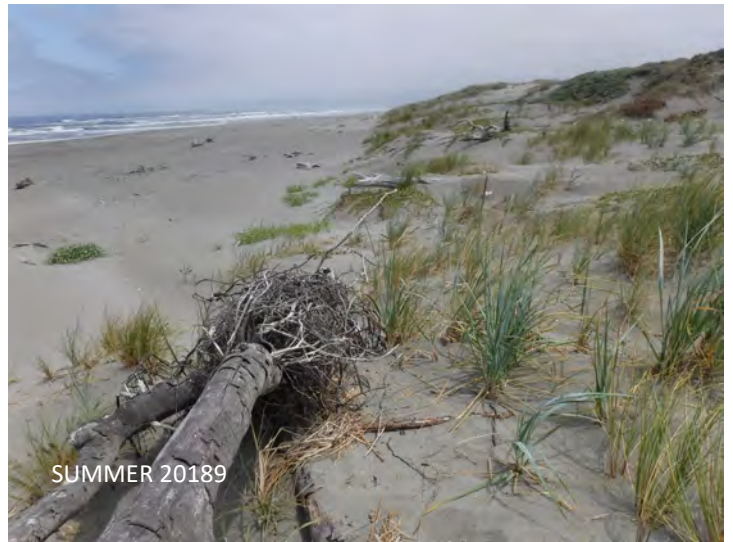
Ma-le'I South Transect 31

View north at 156 m (incipient foredune)

Notes: This stretch of restored shoreline at Ma-le'I South is described by a bench-like incipient *Elymus* foredune below a broad, native established foredune. Between winter 2016 and summer 2016 there was seasonal deposition on the upper beach and incipient foredune and minor erosion at the established foredune crest. In winter 2017 the incipient foredune was slightly scarped, leading to deposition and slipface formation on the crest. The profile changed little by the following summer other than 0.2 m deposition on the beach. By summer 2018 deposition had raised the incipient foredune crest, forming more of a swale between the incipient foredune and established foredune. In summer 2019 the incipient foredune continued to build. Relative to transects to the north, the beach and incipient foredune volumes have not varied widely over the three years of surveys.

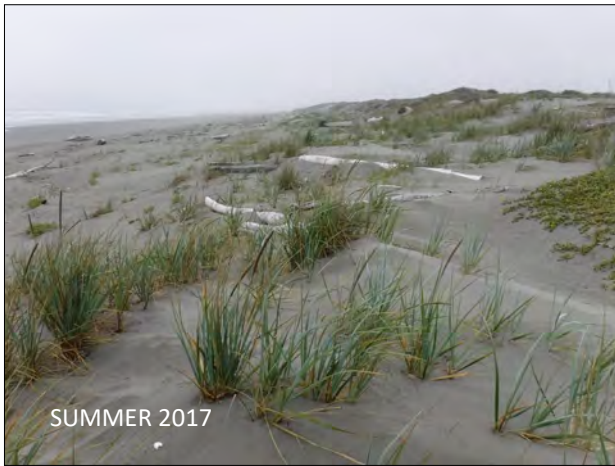
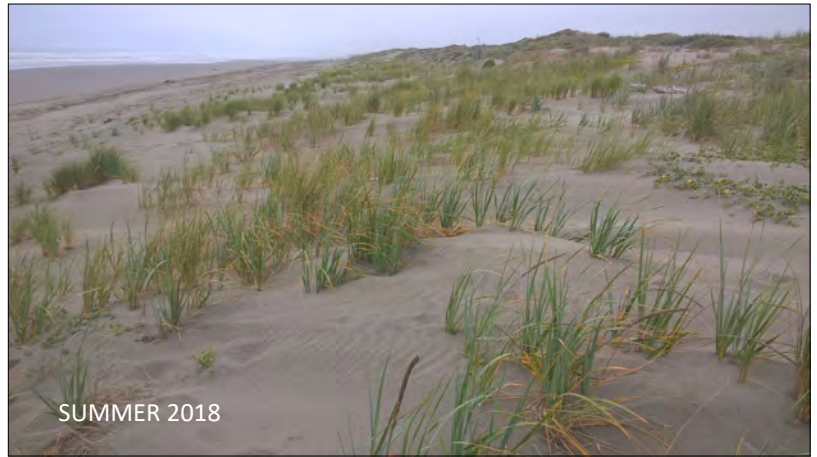
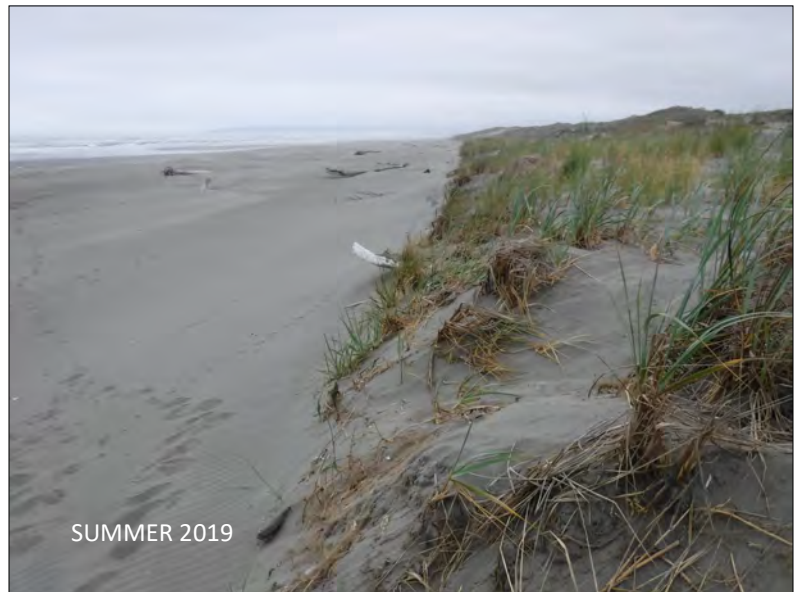
Ma-le'i South Transect 32

View north at 144 m (incipient foredune)

Notes: The broad, bench-like incipient foredune (similar to the previous transect) was scarped in winter 2016 and a steep beach slope resulted. In summer 2016 mobilized sand at the crest of the incipient foredune migrated into the incipient foredune swale and there was 0.5 m of deposition as the result of scarp-fill ramping. In winter 2017 the upper beach scarped and eroded. By summer 2017 sand had filled the scarp and deposition occurred on the incipient foredune. Additional deposition on the incipient foredune occurred by summer 2018, although erosion occurred on the upper beach. In 2019 the incipient foredune and upper beach were substantially scarped, as is visible in the photo at right

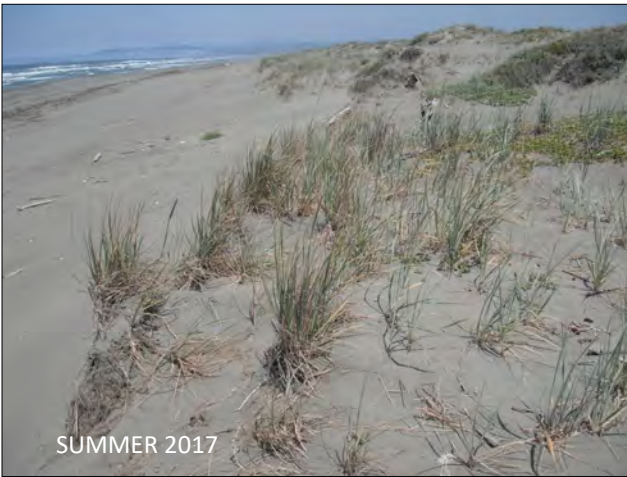
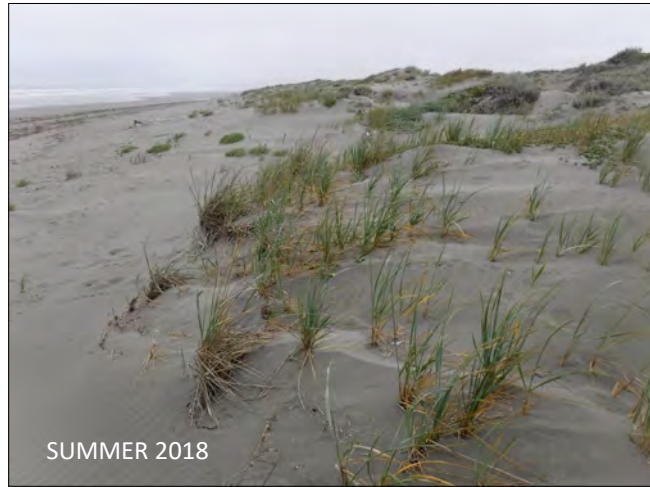
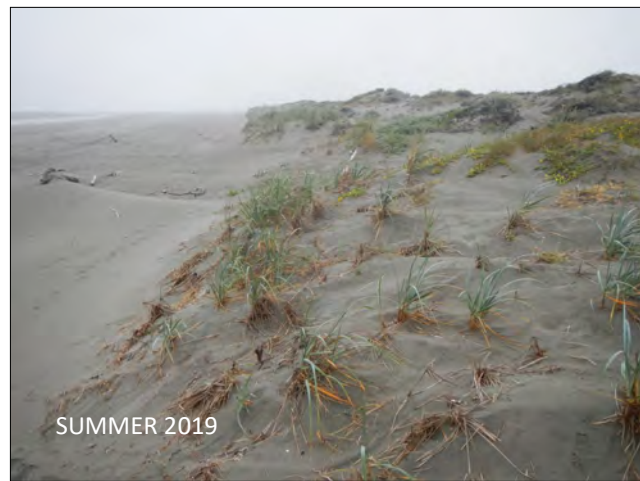
Ma-le'i South Transect 33

View north at 306 m (incipient foredune)

Notes: A 2.0 m vertical scarp formed in the incipient *Elymus* foredune during high water events in winter 2017. By summer 2017 0.4 m deposition occurred on the upper beach, but the vertical scarp remained, although sediment was mobilized on its crest. By summer 2018 a scarp-fill ramp had formed and sediment had translated inland and filled the incipient foredune swale (see photos above). The established native foredune is eroded into hummocks and erosion occurred in the blowout between the peaks at 230 and 270 m. In 2019 the upperbeach was eroded and the troughs were filled. This profile extends further inland than most in order to capture the Humboldt Bay Municipal Water District pipelines in an area that has been vulnerable to erosion and exposure in the past. This area is actively managed, with sand deposited over an exposed portion of the pipeline in 2015. Eastward translation of the sand

placed over the pipeline suggests future vulnerability. Note that the profile to the immediate west of the pipeline is stable, and the migration of the dunes at and east of the pipeline is unconnected to processes at the beach and foredune.

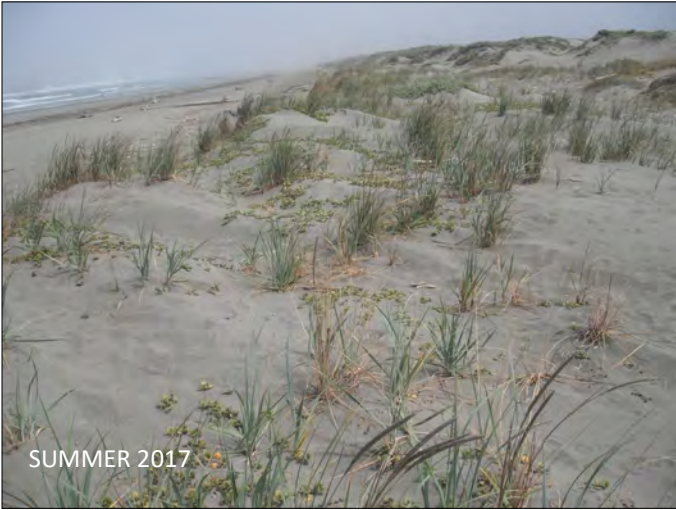
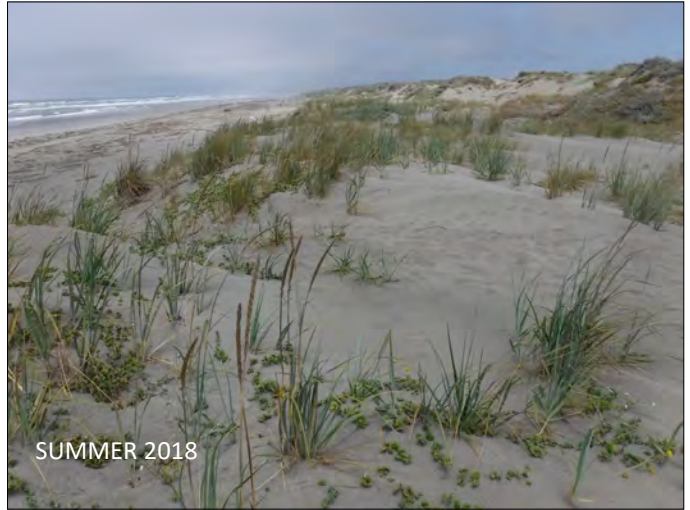
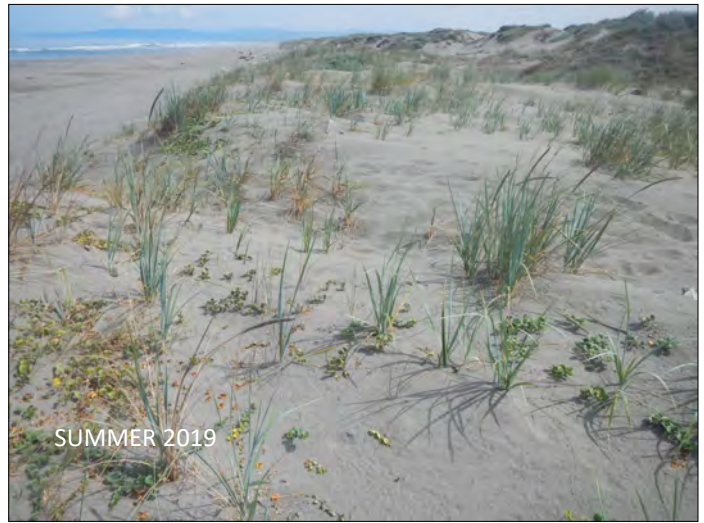
Ma-le'i South Transect 34

View north at 184 m (incipient foredune)

Notes: The original profile describes a broad, flat incipient foredune fronting a two-peaked established foredune. The incipient foredune was scarped prior to the winter 2017 survey and by summer deposition had occurred on the backshore, a scarp-fill ramp had formed, and the crest of the incipient foredune had eroded, creating a gradual slope from the upper beach. High water events in winter 2017 created a 1.8 m scarp in the incipient foredune, which retreated horizontally 12.0 m. The beach was lowered from 1.0-1.5 m. By summer 2018 a scarp-fill ramp had formed and the incipient foredune crest had increased in elevation. There was very little change in 2019.

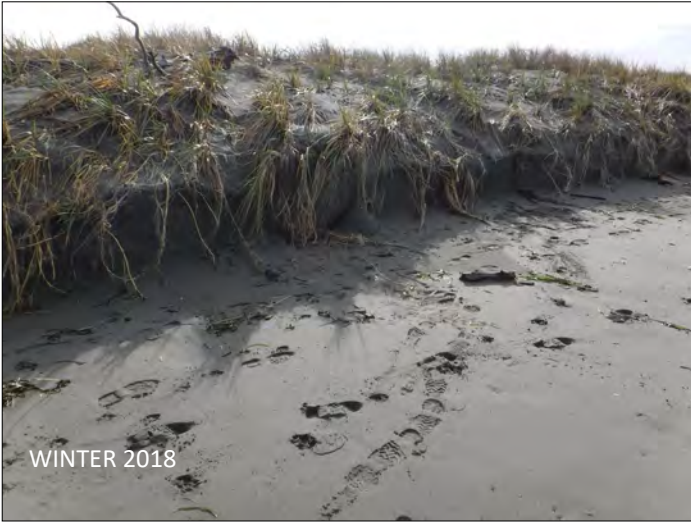
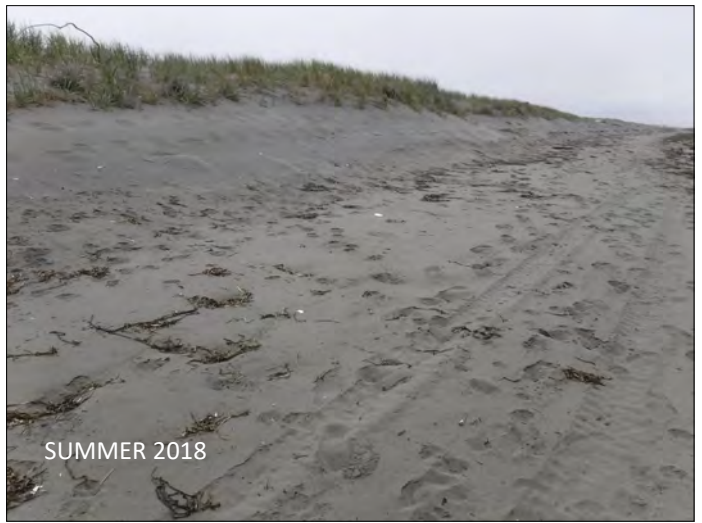
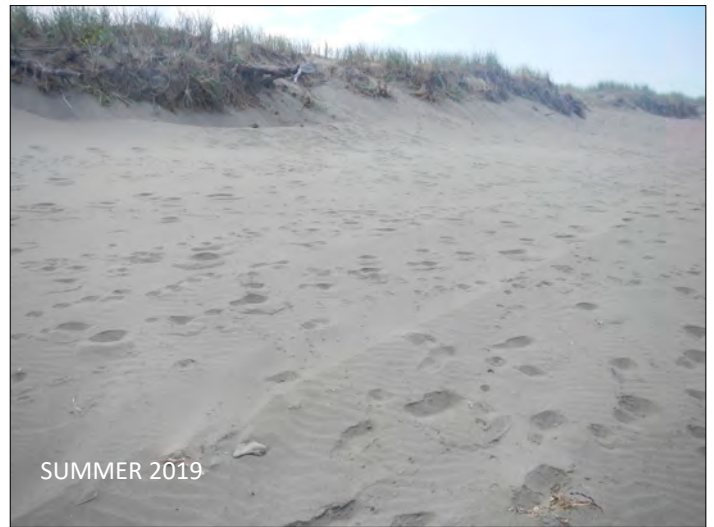
Ma-le'i South Transect 35

View southeast along transect from upper beach at 196 m

Notes: Through summer 2016 a wide, hummocky incipient foredune sloped gradually from the upper beach to the established foredune. In winter 2017 high water events carved a 1.2 m scarp, creating a more defined incipient foredune. The beach was lowered by 1.0 m and the incipient foredune retreated 15 m. Sand was mobilized on the crest of the incipient foredune, forming a slipface that partially buried *Elymus*. During winter 2018 the incipient foredune rescarped, and between the winter and summer 2018 surveys, additional beach erosion lowered the upper beach by 1.0 m, however a scarp fill ramp had formed (see photos above) and 0.5 m deposition occurred on the crest of the incipient foredune by summer 2018. By summer 2019 the incipient foredune had translated inland and increased in elevation.

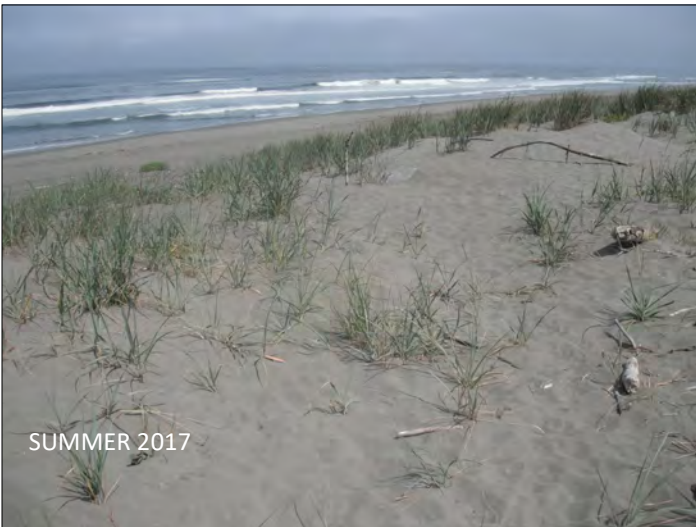
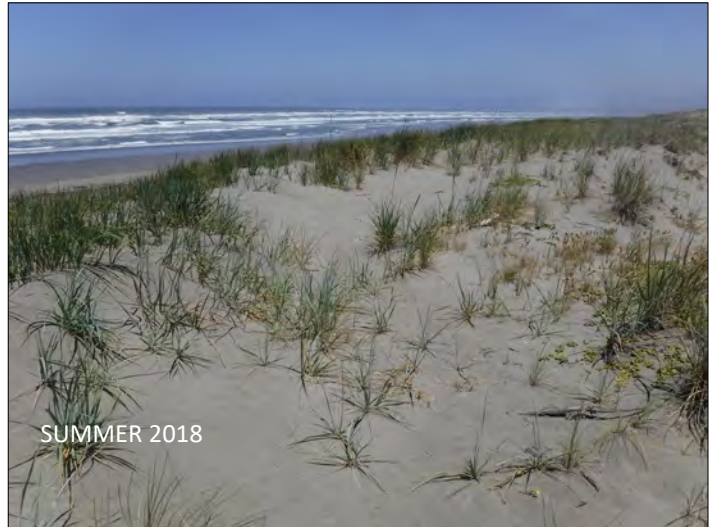
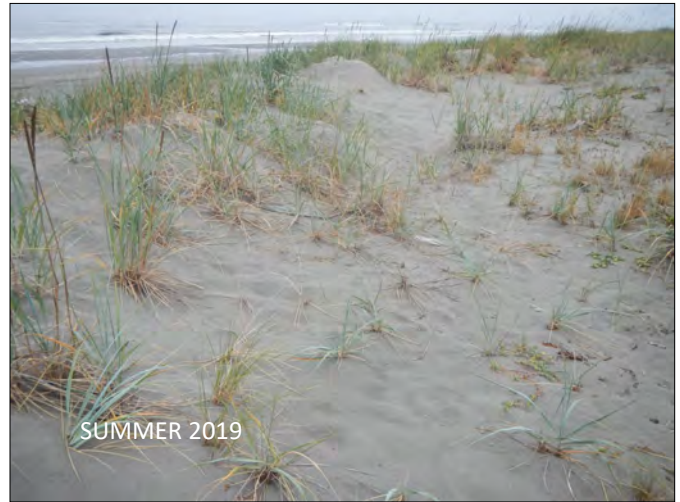
Ma-le'i South Transect 36

View northwest at 104 m (incipient foredune)

Notes: A wide, hummocky incipient foredune sloped gradually from the upper beach to the established foredune from winter 2016 through summer 2016. The beach remained relatively stable. In summer 2017 the incipient foredune built seaward, with 0.2 m of deposition at its western edge, which is visible in the rear of the left photograph taken from the crest of the incipient foredune looking northwest along the transect. There was little change during winter 2018, and in summer 2018 the incipient foredune had an additional .5 m of deposition (see photo on right), while the upper beach was eroded an equivalent amount. There was little change in 2019.
