Humboldt Coastal Resilience Project

Phase 3 Beach-Dune Transect Profiles

November 2019

Submitted by: Andrea Pickart, Candace Reynolds, US Fish and Wildlife Service and Ian Walker
Arizona State University

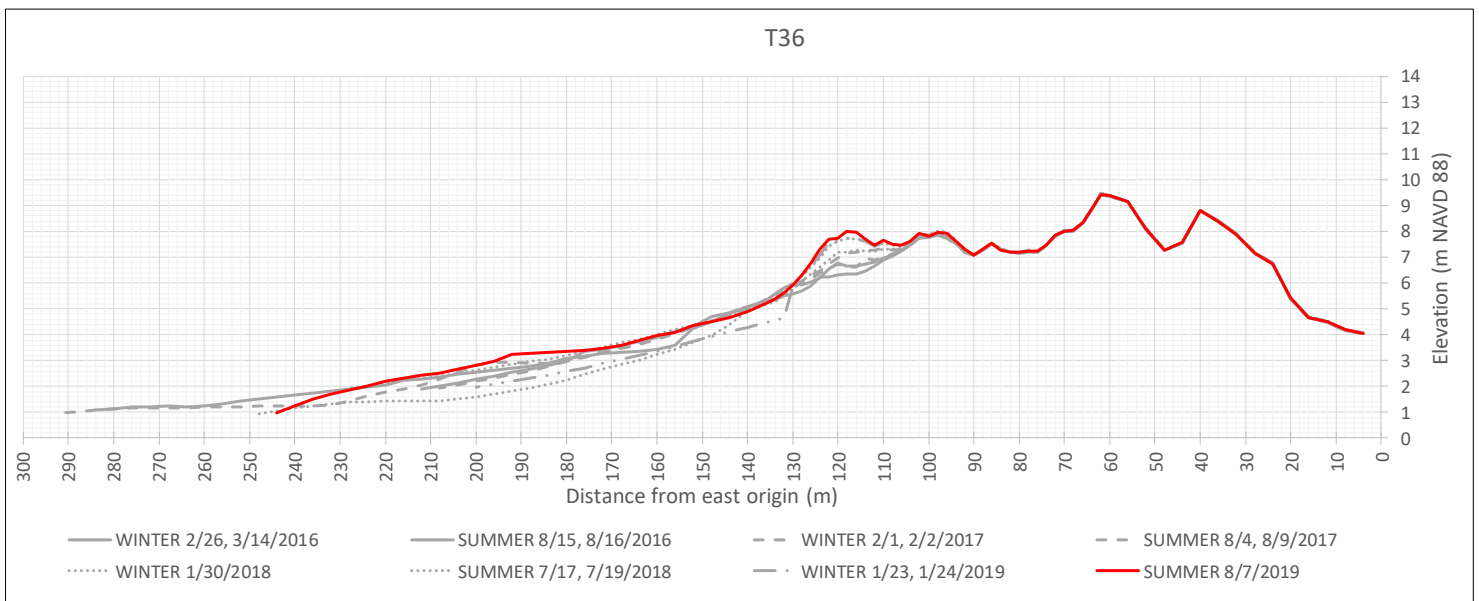
Ma-le'i South Transect 36

Notes: A wide, hummocky incipient foredune sloped gradually from the upper beach to the established foredune from winter 2016 through summer 2016. The beach remained relatively stable. In summer 2017 the incipient foredune built seaward, with 0.2 m of deposition at its western edge, which is visible in the rear of the left photograph taken from the crest of the incipient foredune looking northwest along the transect. There was little change during winter 2018, and in summer 2018 the incipient foredune had an additional .5 m of deposition (see photo on right), while the upper beach was eroded an equivalent amount. There was little change in 2019.

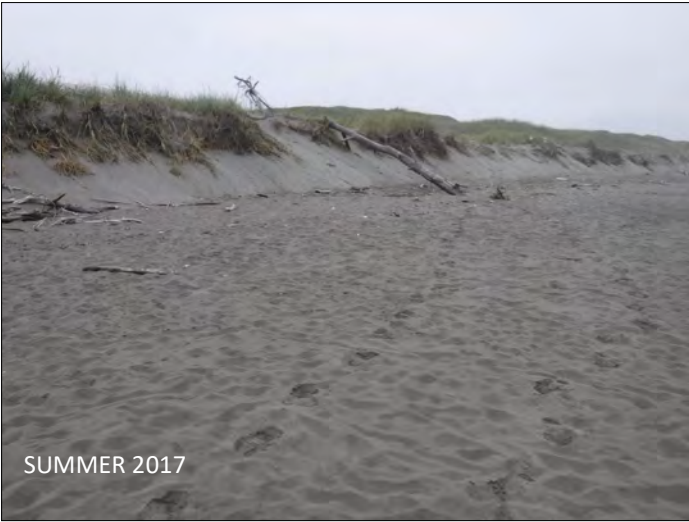
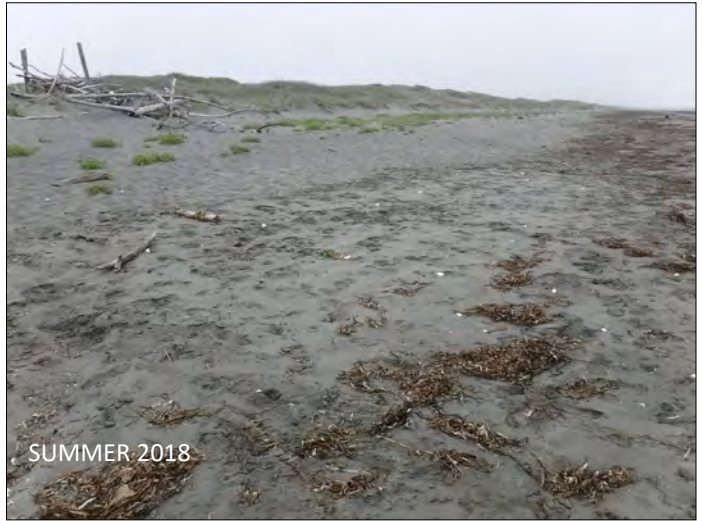
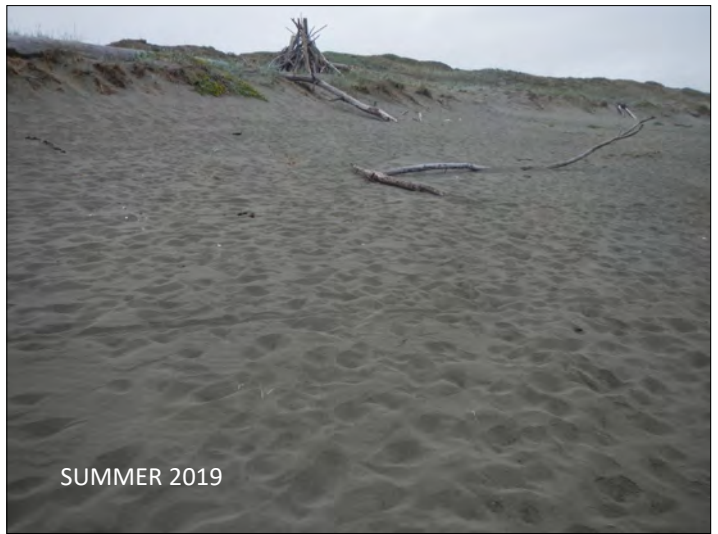
Ma-le'i South Transect 37

View southeast along transect from upper beach at 208 m

Notes: The broad, native established foredune at this site sloped gradually to the backshore in winter 2016, and in summer 2016 an incipient foredune formed with the deposition of 0.5 m on the backshore. The incipient foredune was then eroded during winter 2017 leaving a 1.0 m scarp and the loss of 0.5 m of upper beach. The deep incision in the profile is caused by the oblique transect crossing two sides of an eroded cusp in the incipient foredune. Additional scarping and beach lowering occurred after the survey during winter 2017. This shows up in the summer 2017 profile as a 3.0 m scarp and 12.0 m of horizontal retreat. The beach remained low during the summer, with high tides in August reaching the bottom of the scarp. However, by summer 2018 a scarp fill ramp had formed and over 1 m of deposition occurred on the upper beach, returning the profile to a condition similar to 2016. In 2019 the incipient foredune increased 0.3 m in elevation, translating inland.

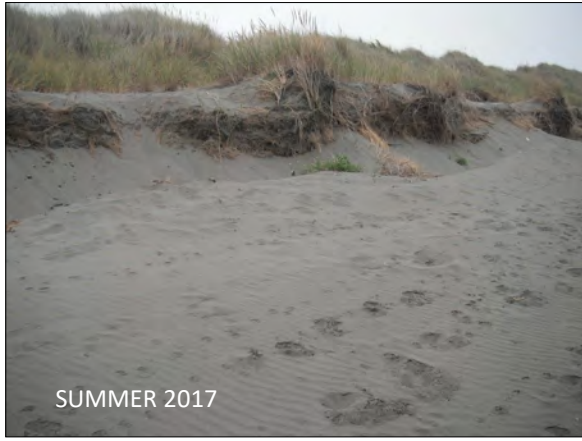
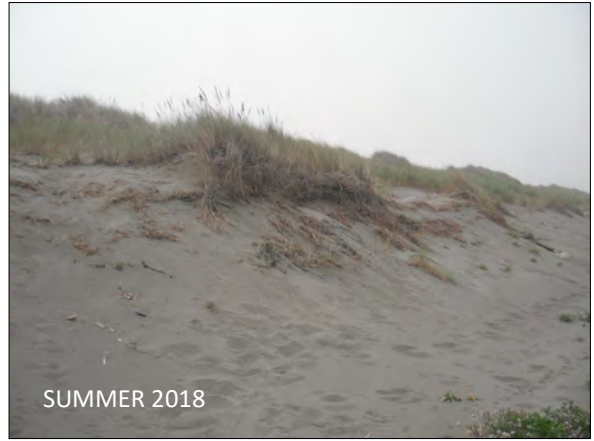
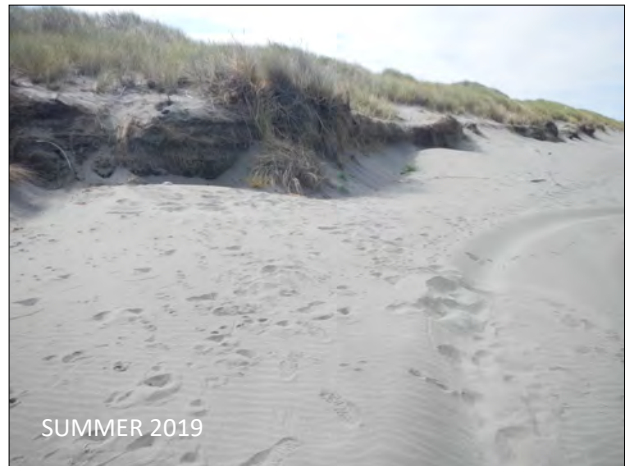
Friends of the Dunes Transect 38

View southeast along transect at 180 m from upper beach showing incipient foredune

Notes: The profile describes a stable, peaked *Ammophila* foredune seaward of an older, formerly native foredune, with a dynamic incipient foredune. Data are not available for winter 2016 but summer 2016 shows a well developed incipient *Ammophila* foredune that was significantly scarped (2.0 m elevation loss and 20 m horizontal retreat) in winter 2017, effectively removing the incipient foredune. Beach deposition occurred in summer 2017 but no scarp-fill ramping occurred, just minor slumping. By summer 2018 a loss of 0.5 m vertically had occurred on the upper beach at the toe of the incipient foredune (see photos above). Additional erosion of the upper beach occurred in 2019.

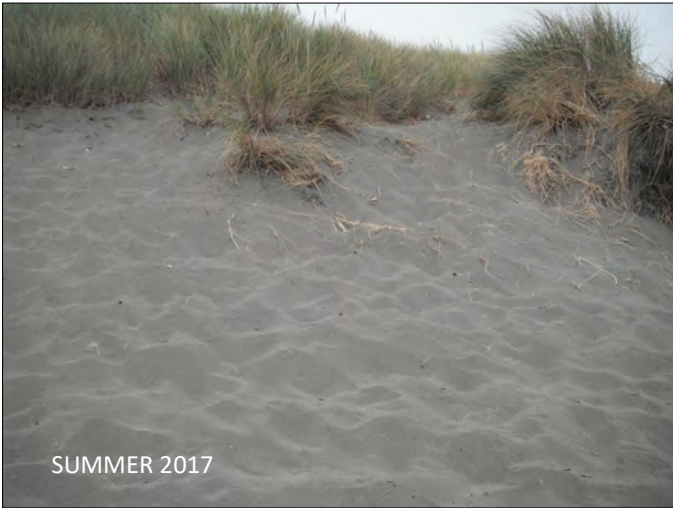
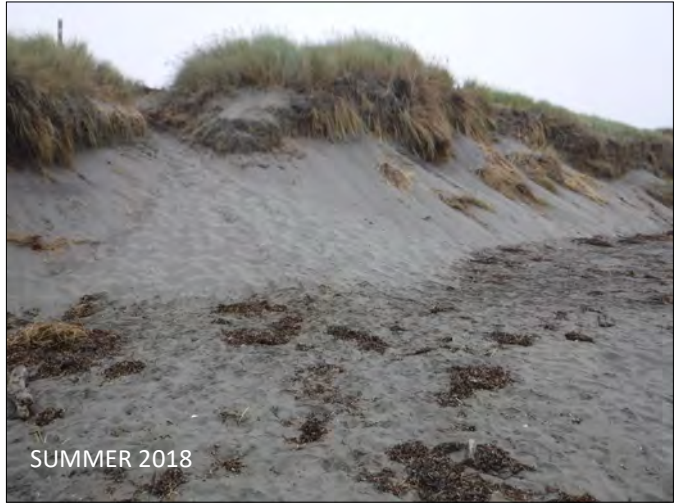
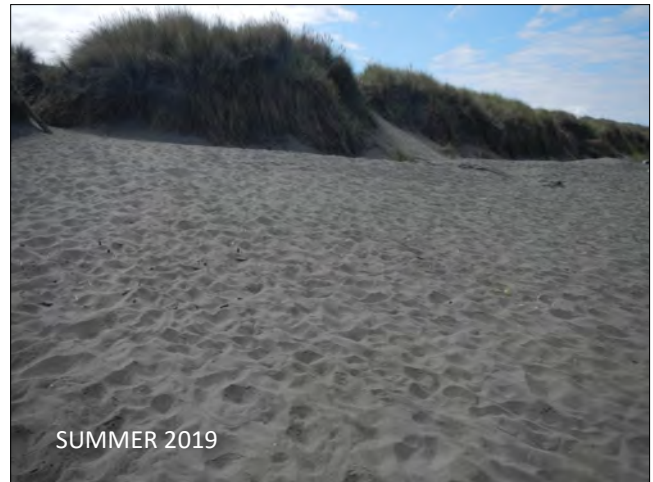
Friends of the Dunes Transect 39

View southeast along transect at 114 m (upper beach) with view of scarped established foredune

Notes: The profile extends through a manual restoration area, although *Ammophila* was not removed on the outer incipient foredune until October 2017. Scarping of the upper beach occurred at some point between the winter 2016 and summer 2016 surveys, allowing the mobilization of sand in the summer such that deposition of 0.1-0.3 m occurred on the incipient foredune stoss, crest and lee faces. In winter 2017 the upper beach again underwent significant lowering and scarping (1.6 m elevation loss, 30 m horizontal retreat along the transect). Deposition on the beach, slumping of the scarp, and scarp-fill ramping occurred in summer 2017, creating a smoothly sloping upper beach (see photograph for view looking inland along transect from upper beach). Between the winter and summer 2018 surveys, the established foredune was scarped, with the stoss face retreating up to 10 m midway up the stoss face (see photos above). A scarp fill ramp was partially built during winter and summer 2019.

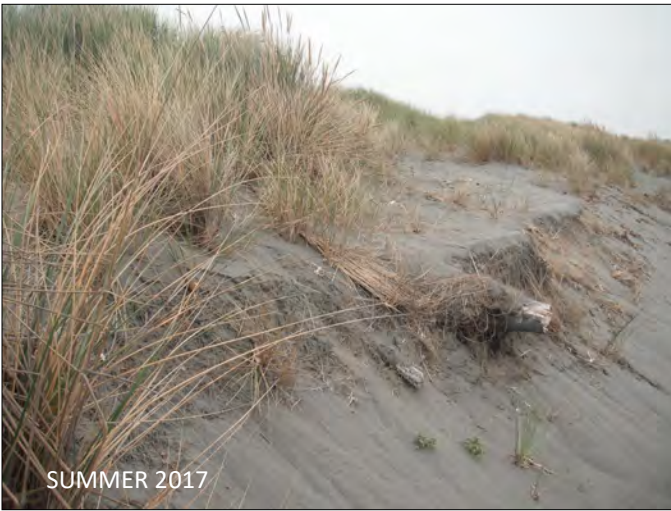
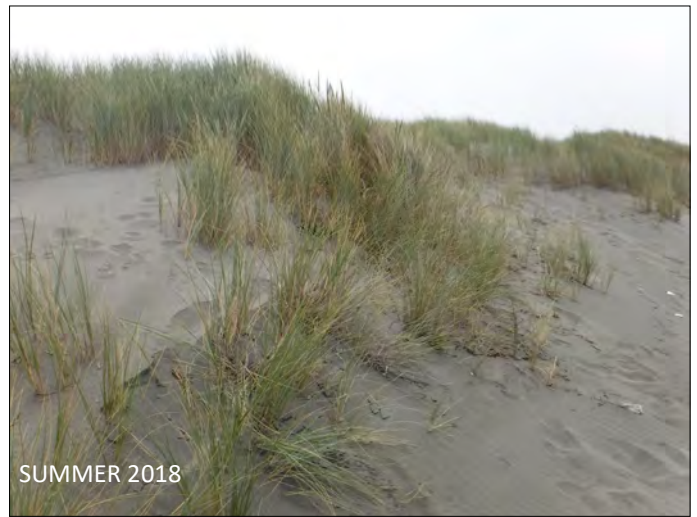
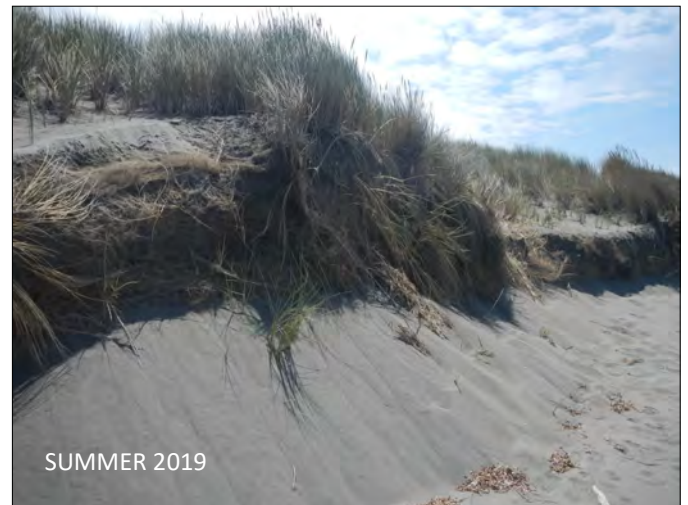
Friends of the Dunes Transect 40

View southeast at 134 m showing incipient foredune

Notes: The profile depicts multiple incipient and established foredunes built by *Ammophila*, although the area behind the first persistent incipient foredune (crest at 115 m) has undergone *Ammophila* removal. Between winter 2016 and summer 2016 deposition of 0.5 m occurred on the upper beach, creating a new sparsely vegetated *Ammophila* incipient foredune (crest at 125 m). This incipient foredune was then scarp-ed in winter 2017 and the beach eroded, emphasizing the incipient foredune topography although its crest elevation was unchanged. Some slumping had occurred by summer 2017 (see left photograph above looking inland along transect from base of scarp) but the incipient foredune profile did not change. By summer 2018 a scarp-fill ramp had formed (right photo above). The feature was again scarp-ed in winter 2019, with some recovery in summer 2019.

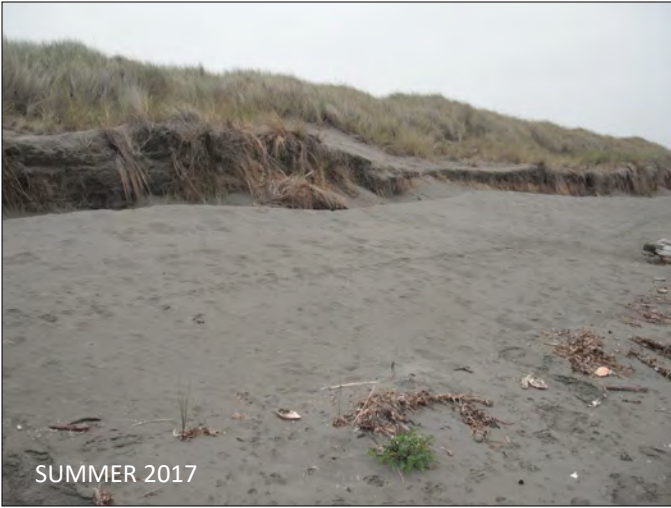
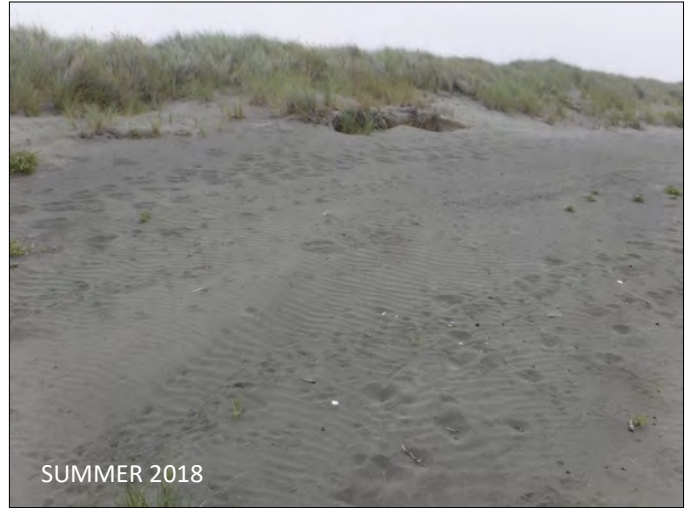
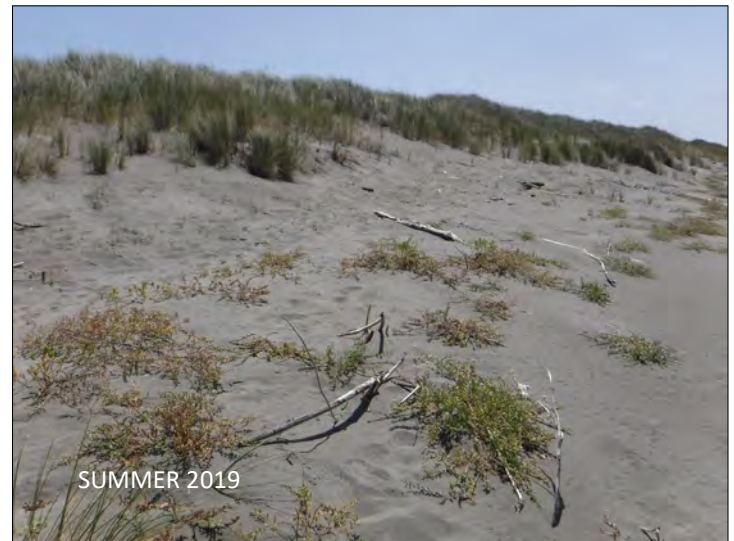
MCSD Transect 41

View southeast along transect at 152 m, showing incipient foredune from upper beach.

Notes: The transect is located in an unrestored portion of property owned by the Manila Community Services District. The profile depicts a dynamic incipient foredune and a stable peaked *Ammophila* foredune fronting a backdune area stabilized by *Ammophila* and *Carpobrotus*. The incipient *Ammophila* foredune saw deposition of up to 0.6 m between winter and summer 2016. It was then almost entirely scarped in winter 2017 (loss of 2.4 m vertically and 24 m horizontally). By summer 2017 there was minimal recovery, although some upper beach deposition occurred, as can be seen in the photograph at left above, taken at the upper-beach looking southeast. Between winter 2018 and summer 2018 a scarp fill ramp formed, with deposition of up to 0.7 m on the upper beach. By summer 2019 vegetation was colonizing the upper beach (photo right).

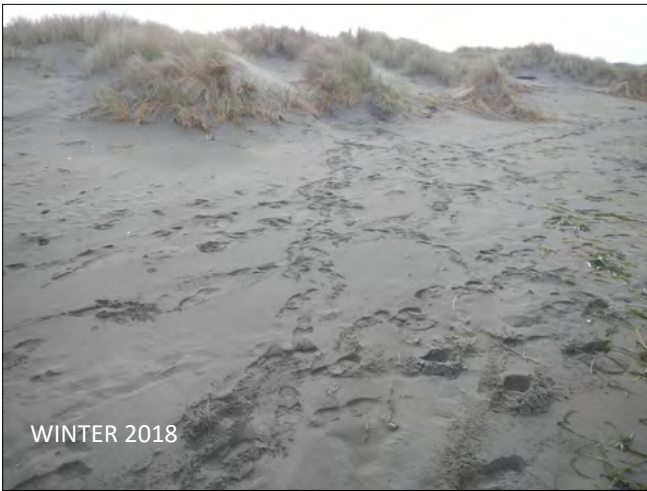
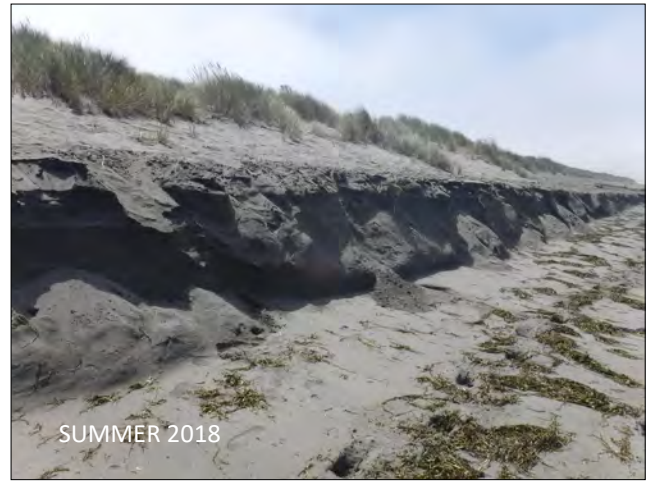
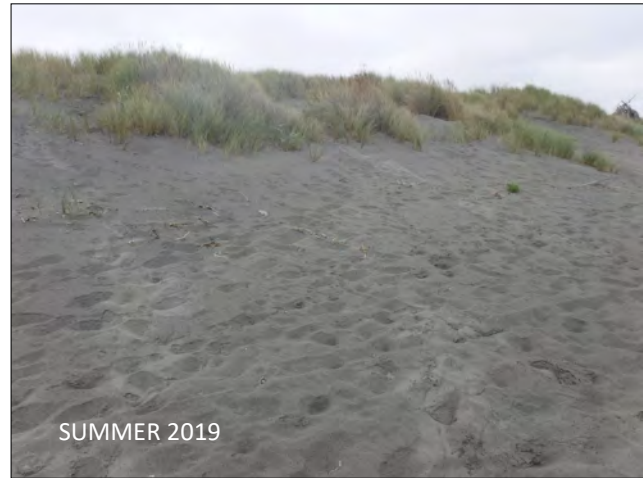
MCS D Transect 42

View southeast along transect at 156 m (upper beach) showing beach

Notes: The transect is located in the Manila Dunes Recreation Area. The area was restored in the 1990s-2000s, but was not maintained, and *Ammophila* has reinvaded the foredune zone. An incipient foredune was forming in summer 2016, but was scarped in the high water events of winter 2017, losing 1 m vertically and retreating 10 m horizontally along the oblique transect. While scarp-fill ramping smoothed the upper beach profile by summer 2017, elevation of the upper beach was still 0.8 m below the previous year's elevation and the incipient foredune had not rebuilt. Between winter and summer 2018 surveys the lower beach scarped dramatically, resulting in the loss of up to 1.0 m elevation (see photos above). By summer 2019 a new scarp fill ramp had established (see photo at right).

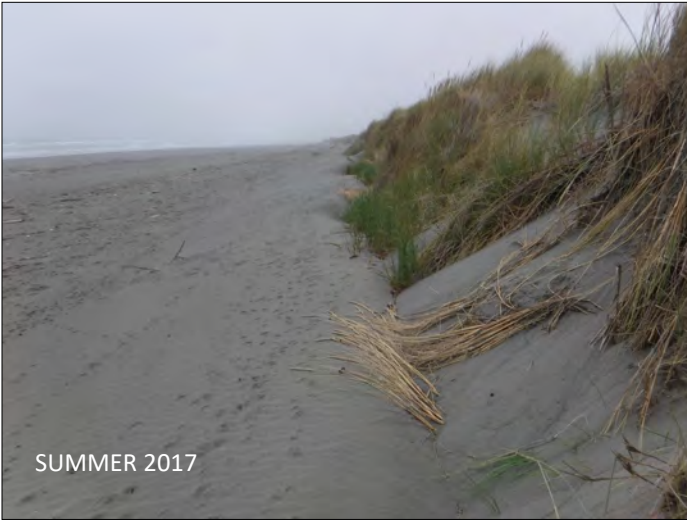
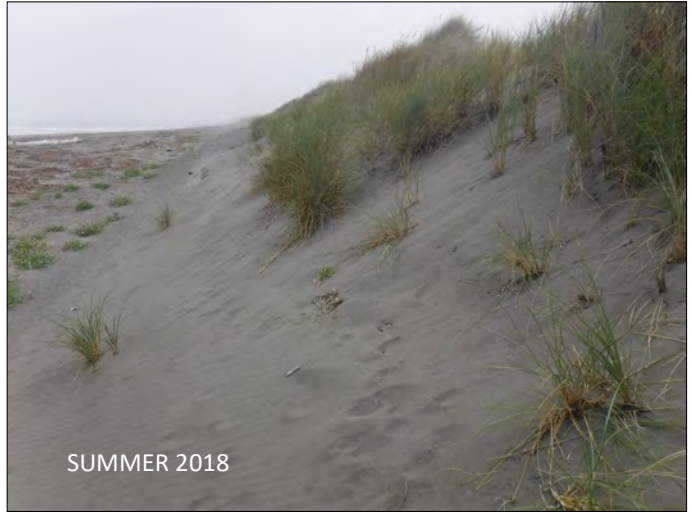
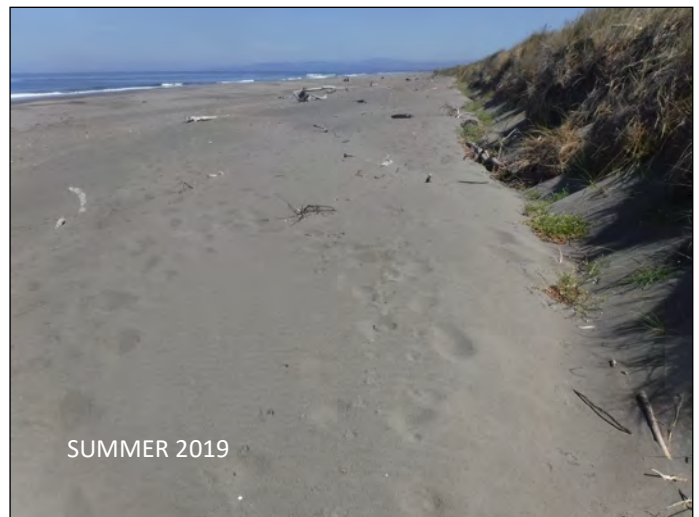
MCS D Transect 43

View north at 172m of foredune base

Notes: The transect is located in the Manila Dunes Recreation Area. The area was restored in the 1990s-2000s, but was not maintained, and *Ammophila* has reinvaded the foredune zone. The profile describes a dynamic incipient *Ammophila* foredune, behind which a formerly erosional area slopes up to a now stable (per the three year monitoring period), native, established foredune. The incipient *Ammophila* foredune was scarped 1.4 m vertically in winter 2017, retreating 16 m along the transect. By the summer 2017 survey, a scarp-fill ramp had formed and partially filled the scarp (photo upper left). Between the winter 2018 and summer 2018 surveys the ramp was eroded and the beach lowered, By summer 2019 a scarp fill ramp had reformed (photo right).

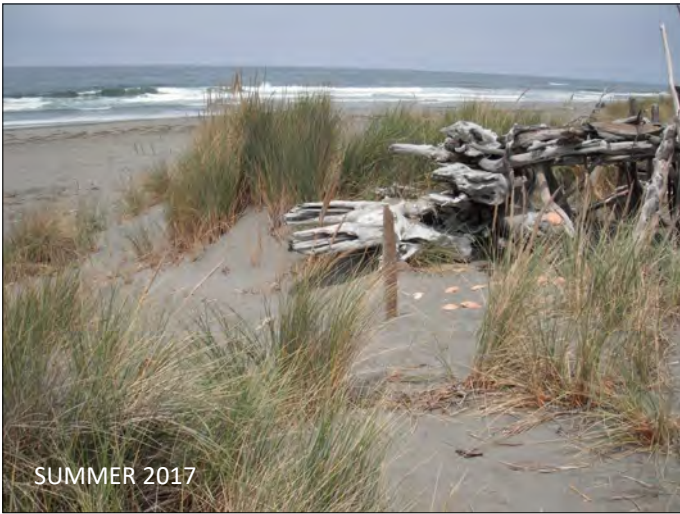
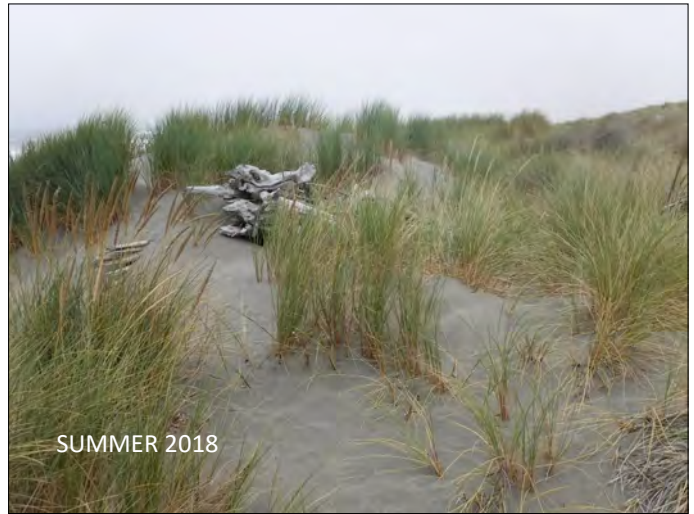
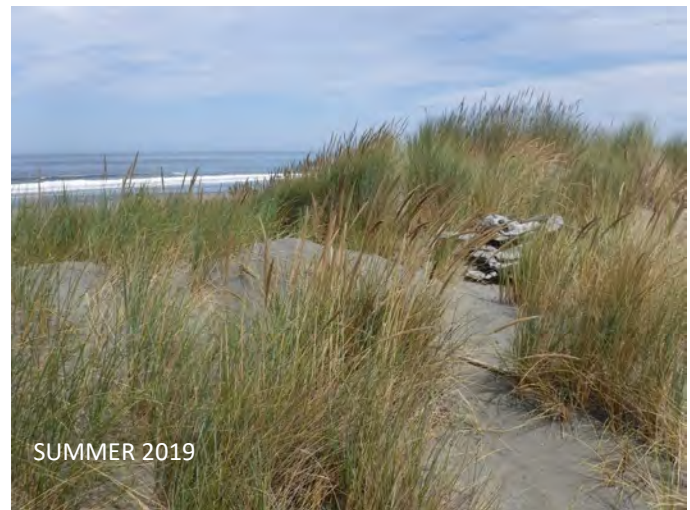
MCS D Transect 44

View northwest along transect taken at foredune base (140 m) showing incipient foredune

Notes: The transect is located in the Manila Dunes Recreation Area. The area was restored in the 1990s-2000s, but was not maintained, and *Ammophila* has reinvaded the foredune zone. The profile describes a dynamic incipient *Ammophila* foredune in front of a broad, restored (but reinvading) stable, established foredune that slopes down to the deflation plain. The back-shore and incipient *Ammophila* foredune was scarped (approximately 0.8 m vertical loss and 15 m horizontal loss along the transect) during high water events in winter 2017. By the summer 2017 survey, a scarp-fill ramp had formed, raising the backshore elevation and partially filling the scarp. In addition, new deposition (0.5 m) occurred at the crest of the incipient foredune following scarping. Between summer 2017 and summer 2018 the incipient foredune grew in elevation by an additional 0.5 m (see photos above, note burial of wood by sand deposition on left photo). In summer 2019 the incipient foredune increased in height by 0.5 m.

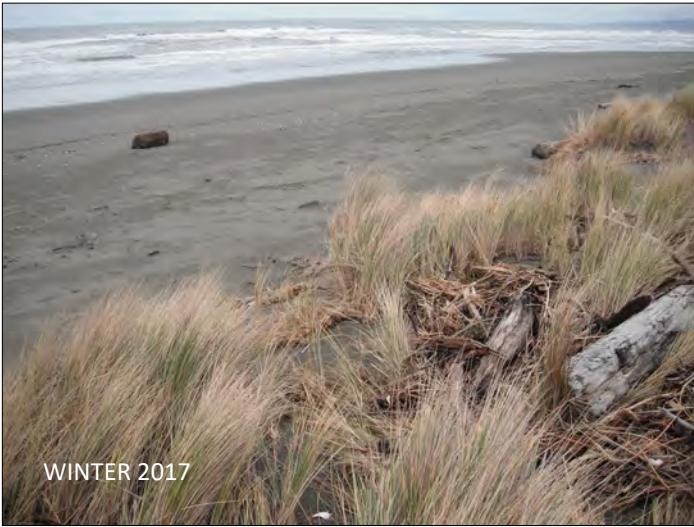
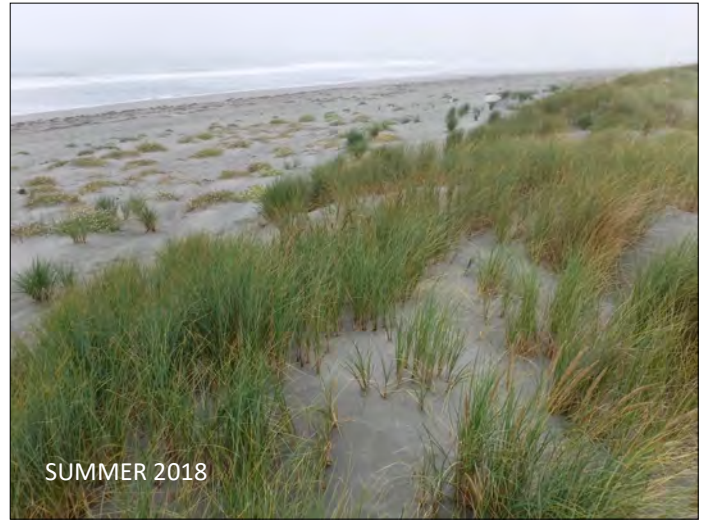
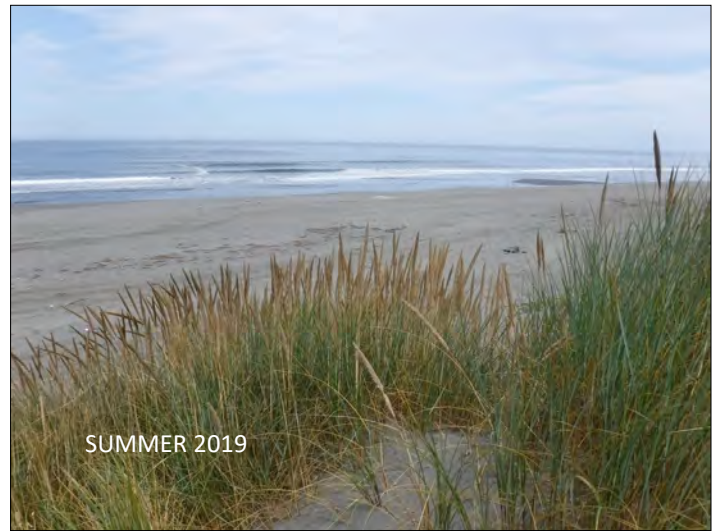
MCS D Transect 45

View north west at 144 m (incipient foredune)

Notes: The transect is located in the Manila Dunes Recreation Area. The area was restored in the 1990s-2000s, but was not maintained, and *Ammophila* has reinvaded the foredune zone. The profile describes a dynamic incipient *Ammophila* foredune (crest 130 m) in front of an older, now established *Ammophila* foredune (crest 110m). Behind that are relict native foredune peaks at 94 and 60 m. The incipient foredune scarped in winter 2016 prior to the survey, creating a more defined incipient foredune topography in summer 2016. By the following winter a scarp-fill ramp had filled the scarp, creating a gently sloping backshore. From winter 2017 to summer 2017, sand mobilized by the scarp deposited 0.5 m on the incipient foredune crest. Between summer 2017 and summer 2018 the incipient foredune increased in elevation by an additional 0.5 m. Deposition occurred on the upper beach in winter 2019, This profile began with scarping followed by steadily increasing volumes in the backshore and incipient foredune over the three year monitoring period.

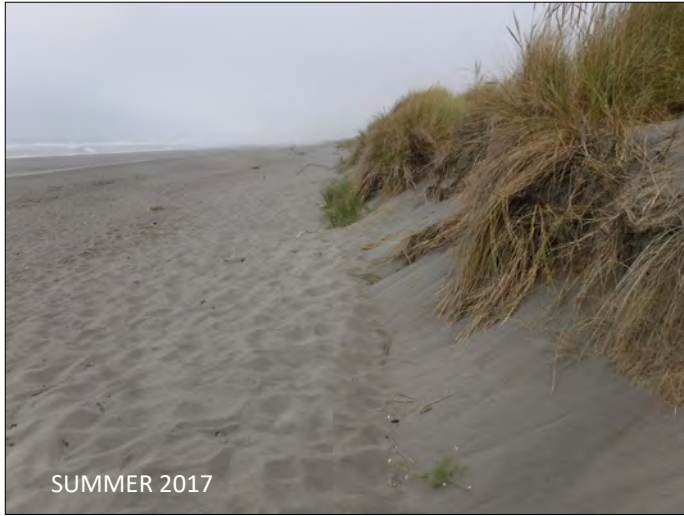
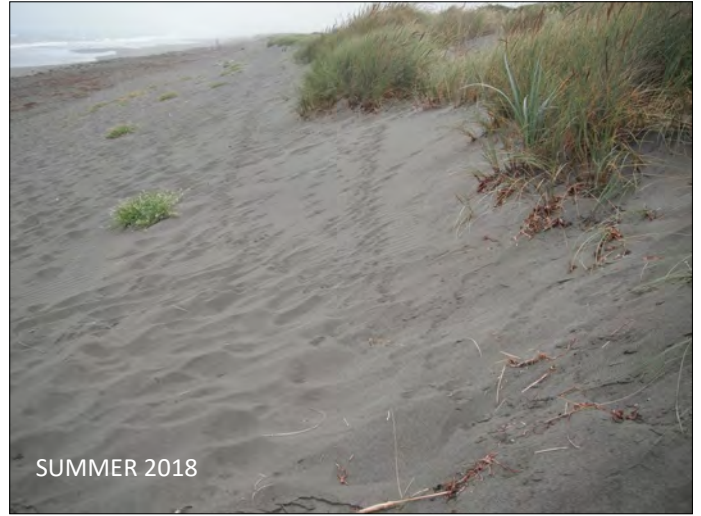
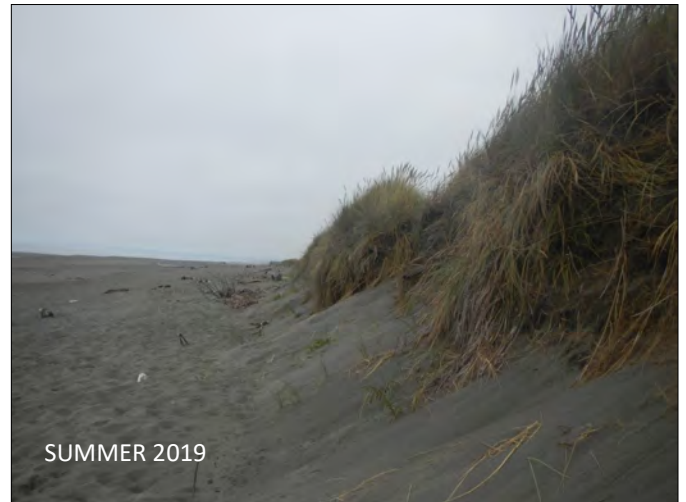
Samoa Pacific Transect 46

View north at 126 m (foredune base)

Notes: The transect describes a steep *Ammophila* foredune (crest 106 m) with a relict native (now invaded) foredune at 76 m. The base of the foredune was scarped between the winter and summer 2016 surveys, resulting in beach lowering of 1.5 - 2.0 m. In winter 2017 the foredune was further scarped, re-treating 10 m horizontally and removing 2.2 m vertically. From winter to summer 2017 there was upper beach deposition, with a scarp-fill ramp beginning to form, and minor deposition at the crest of the scarp. By summer 2018 the stoss face was completely ramped and had recovered the foredune morphology present in 2016. In 2019 additional scarping occurred, resulting in a steep foredune stoss face.

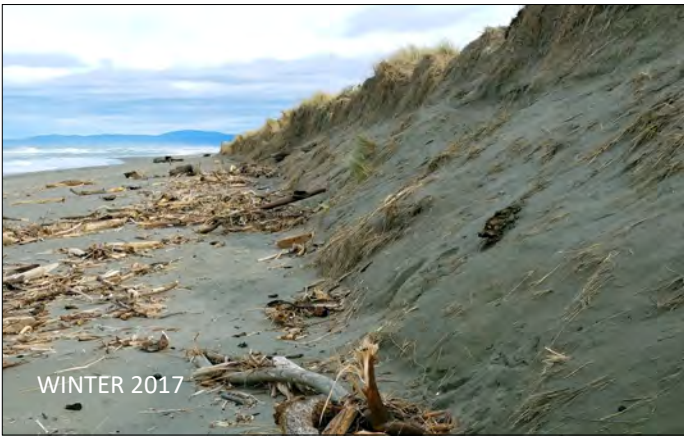
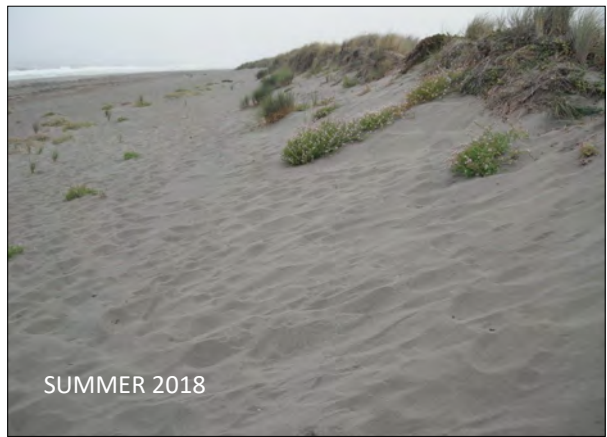
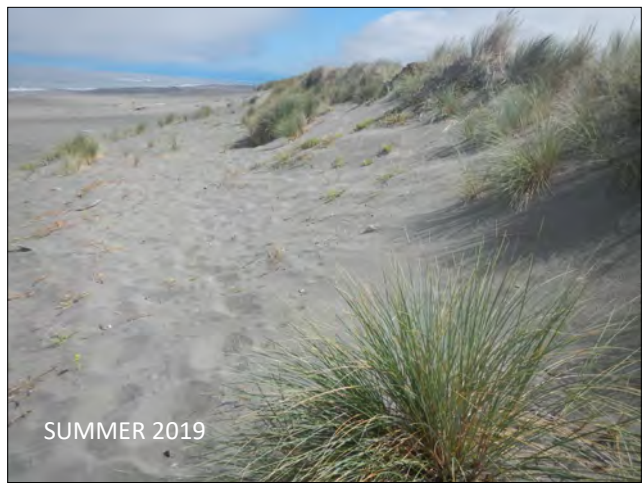
Samoa-Pacific Transect 47

View north showing scarp at 78 m (left) and scarp-fill ramp at 72 m (right and below)

Notes: The transect is composed entirely of dunes that formed since 1939 and under the influence of *Ammophila* rather than native vegetation. The established *Ammophila* foredune was severely scarpd prior to the winter 2016 survey, leaving a 5 m vertical scarp and presumably lowering the beach. Since that time the beach has gradually recovered 2+ m of elevation. By summer 2018 a scarp-fill ramp had formed, and was present in similar proportions in summer 2019.

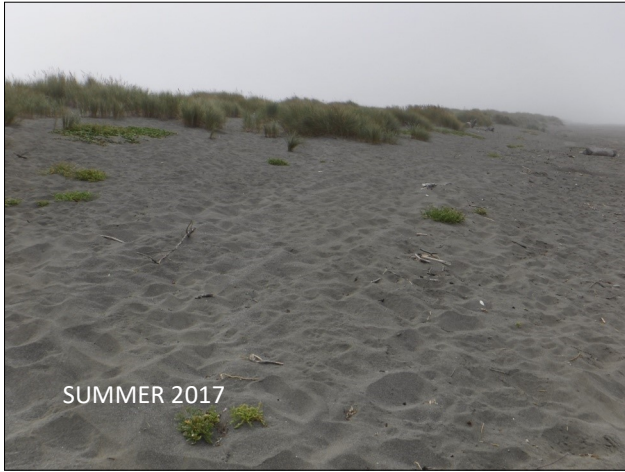
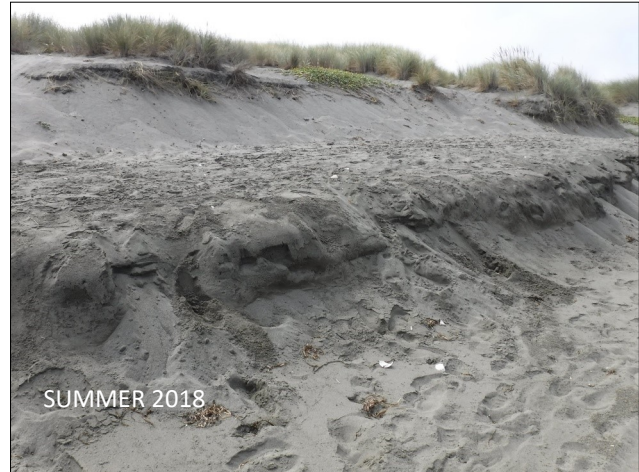
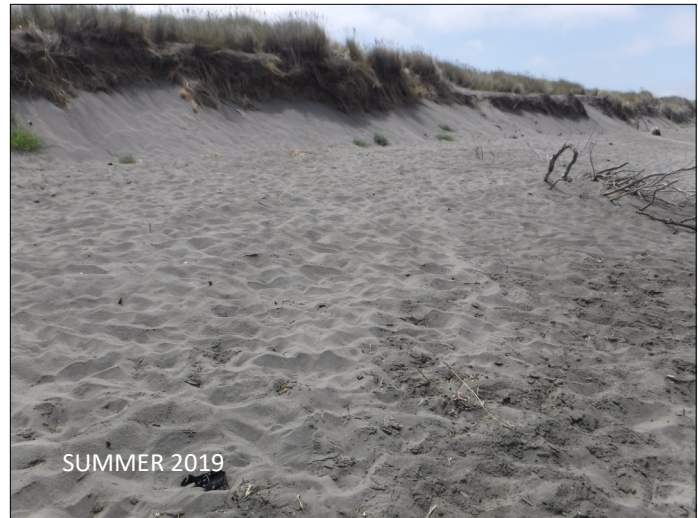
Cal Redwoods Transect 48

View southeast along transect at 148 m (backshore) looking towards foredune.

Notes: The profile describes a low *Ammophila* foredune in front of a lower backdune area. Deposition of 0.4 m occurred on the backshore in summer 2016 suggesting the start of an incipient foredune, along with up to 1.0 m seasonal deposition on the beach at 184 m. Erosion in winter 2017 removed substantial sediment from the beach (2.2 m at 184 m), creating a steeply sloping beach. However, some deposition occurred on the incipient foredune. In summer 2017 the beach did not increase in elevation, but there was 0.8 m deposition on the crest of the incipient foredune, essentially merging it with the established foredune. In winter 2017 scarping removed 2.0 m of vertical sediment from the backshore (see photo above above right) and very little change occurred between winter and summer 2018 other than deposition in the foreshore. In winter 2019 additional scarping occurred, the scarp being preserved through summer 2019.

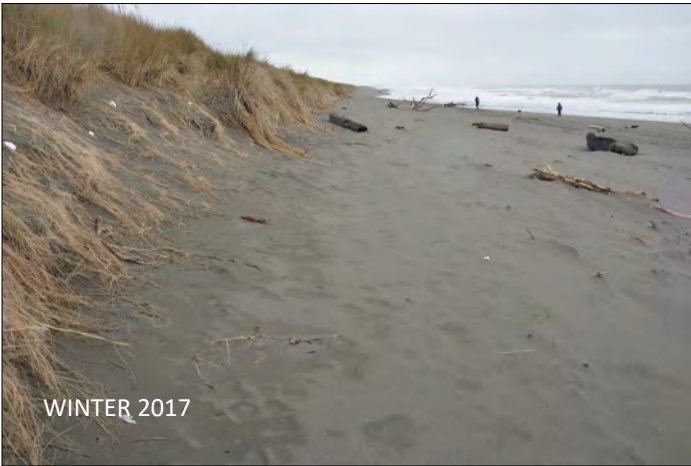
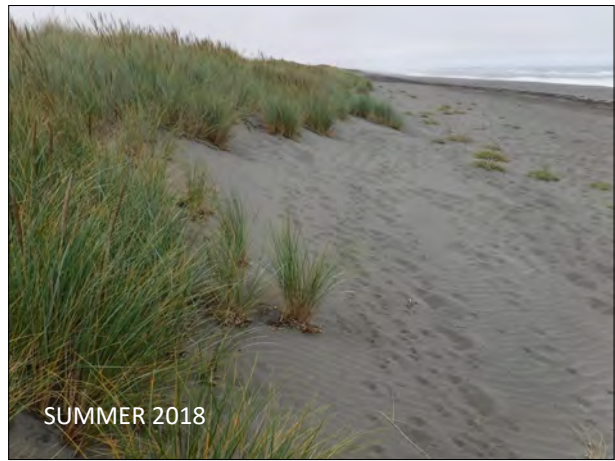
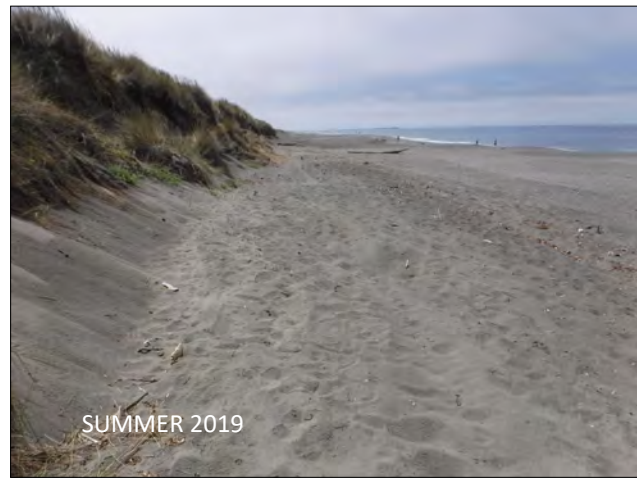
Fairhaven Power Transect 49

View south at 100 m (foredune base)

Notes: The established *Ammophila* foredune was severely eroded in winter 2016 prior to the survey, resulting in a 2.0 m vertical scarp. The beach steadily regained elevation in the following two years, and by summer 2017 a scarp-fill ramp had almost completely welded to the former crest of the foredune as can be seen to the south in the photograph. By summer 2018 deposition was occurring on the stoss face of the foredune (photo above right). However, between winter and summer 2019 major scarping occurred, eroding the foredune 5 m horizontally.

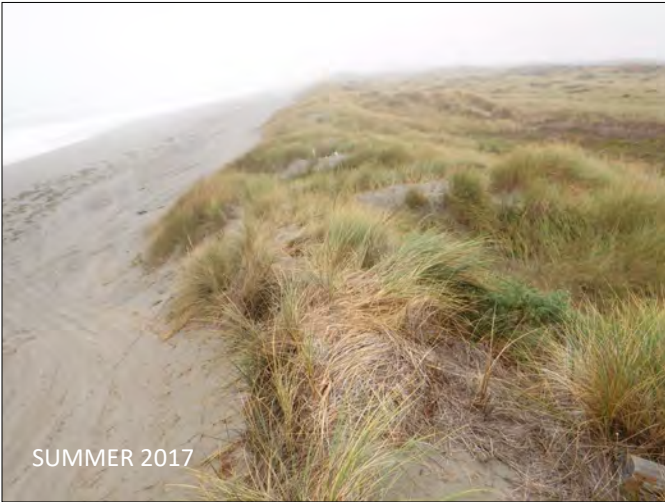
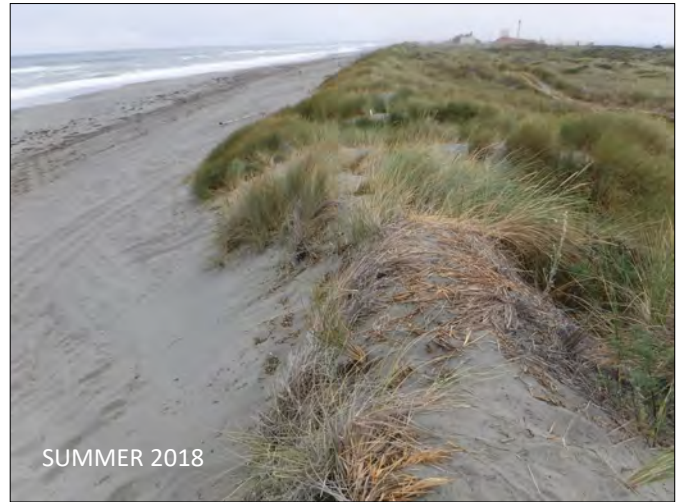
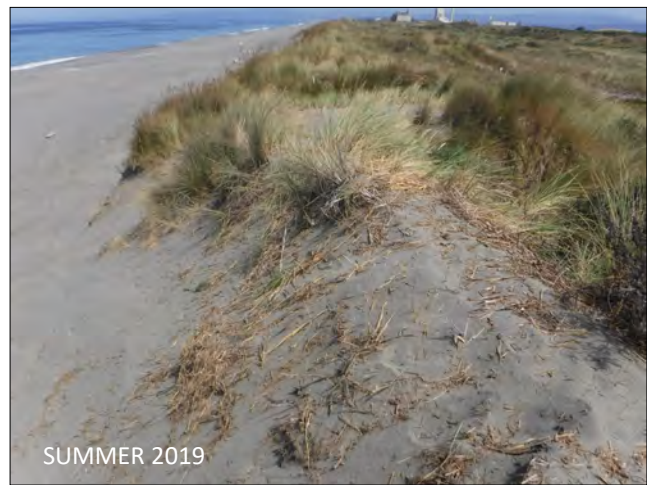
City of Eureka Transect 50

View north at 120 m (foredune crest)

Notes: The transect is located near the City of Eureka’s Samoa airstrip, and depicts a peaked *Ammophila* foredune backed by a low *Ammophila*-stabilized backdune area. The backshore was relatively stable during 2016, with the foreshore exhibiting typical seasonal changes. In winter 2017 the backshore was scarped and lowered by 1.0 m vertically. By summer 2017 the backshore was still low, and the steep beach is visible in the photo taken at the crest of the foredune looking north. Between summer 2017 and summer 2018 deposition occurred in the foreshore and additional deposition occurred behind the foredune crest (see photos above). Between 2018 and 2019 the backshore lost up to 1.0 m in elevation.

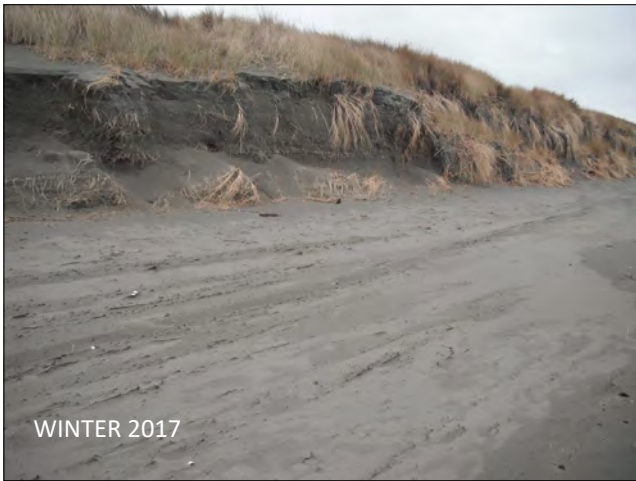
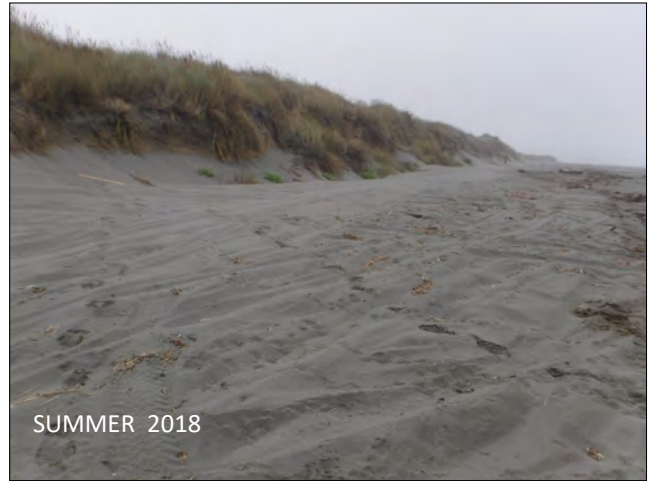
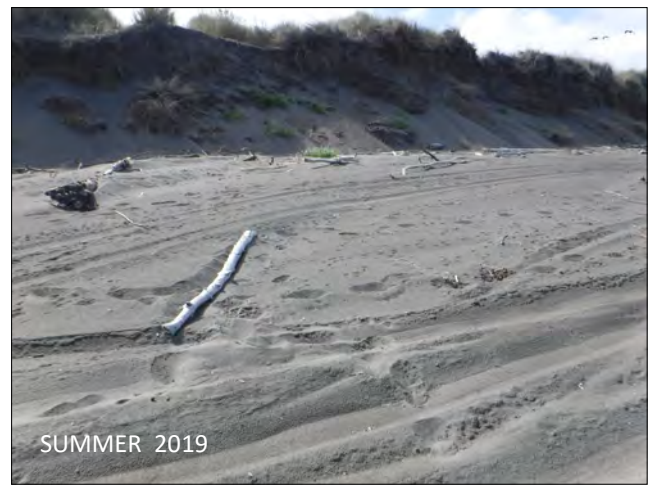
City of Eureka Transect 51

View southeast along transect at 154 m (upper beach) looking towards foredune

Notes: The transect extends through an *Ammophila* dominated area that includes ATV trails in the extended area of the Samoa Dunes Recreation Area. The foredune was severely scarped in the winter of 2017, with approximately 2.0 m of vertical loss of foredune. By summer 2017, slumping had occurred but the upper beach had regained only 0.5 m of elevation. During 2018 deposition on the upper beach resulted in scarp fill ramping (see photos above). However, in 2019 the foredune rescarped, losing up to 5 m horizontally.

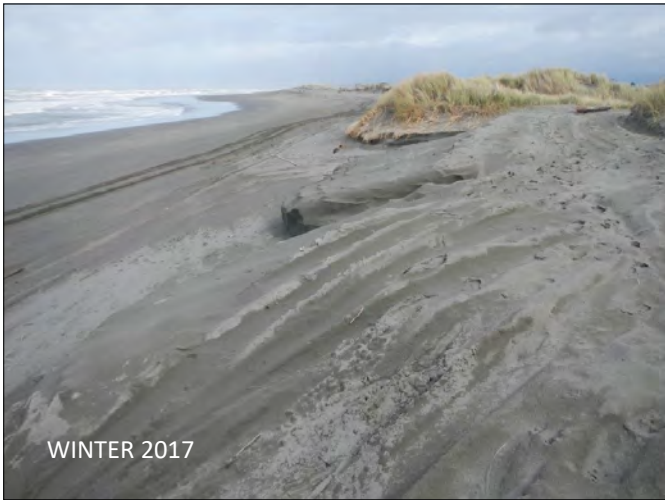
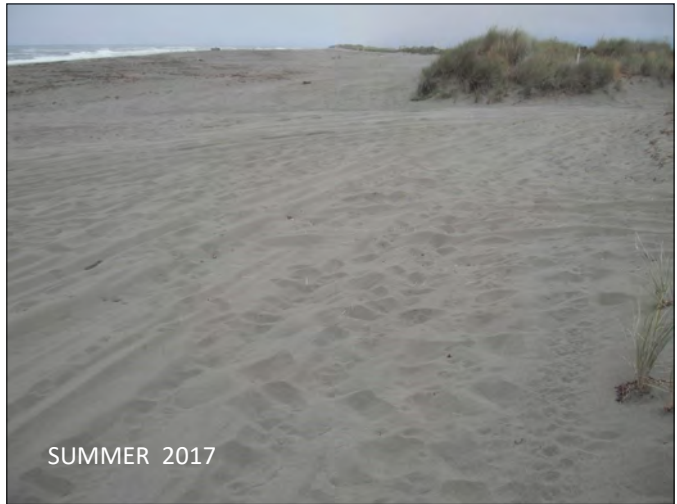
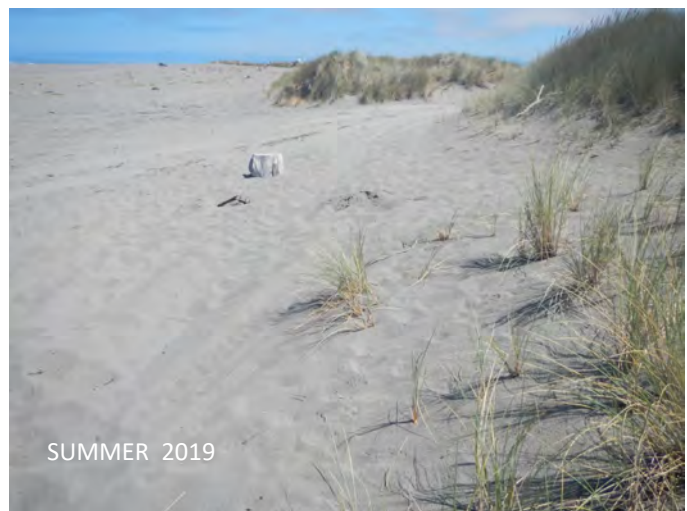
Samoa Transect 52

View north at 162 m (foredune base)

Notes: The transect is within the Samoa Dunes Recreation area and crosses several ATV trails that bisect an area stabilized by *Ammophila*. This is also an area of continuing high erosion since at least the 1930s, influenced by its proximity to the north jetty. In winter 2016 the backshore was characterized by a bench-like feature that may have been caused by beach scarping prior to the survey. In summer 2016 1 m of sediment was deposited below the bench. In winter 2017 the backshore was scarped and the bench removed, losing 1 m vertically and retreating 10 m horizontally. Additional erosion occurred after the survey, lowering the beach by another meter at the base of the foredune in the summer 2017 profile. By summer 2018 1.5 m of deposition had occurred on the backshore, returning the profile to near 2016 levels. In summer 2019 deposition of up to 1 m occurred on the backshore, bringing it to its highest elevation since monitoring began.

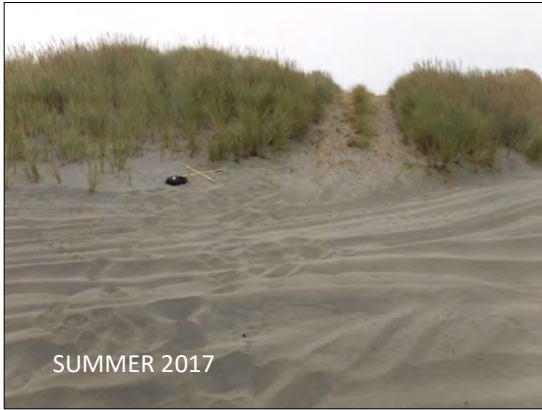
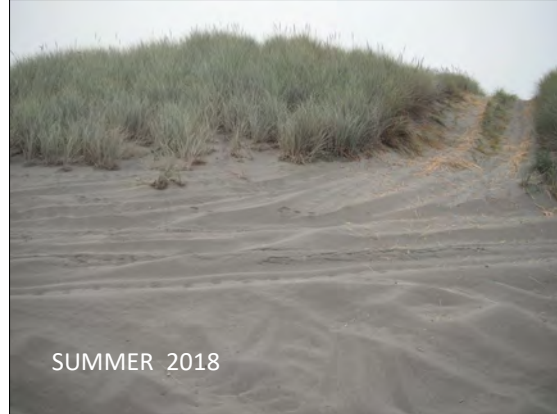
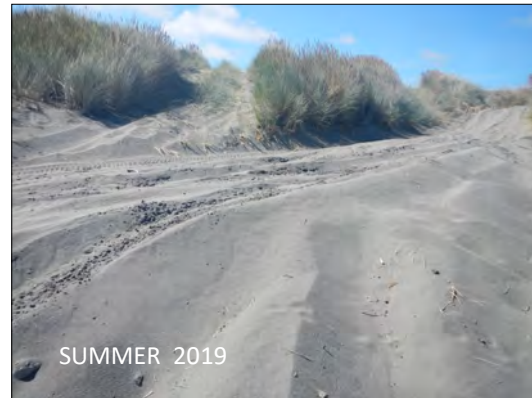
Samoa Transect 53

View southeast at 144 m (upper beach) looking towards foredune

Notes: The transect is within the Samoa Dunes Recreation area and crosses several ATV trails that bisect an area stabilized by *Ammophila*. This is also an area of continuing high erosion since at least the 1930s, influenced by its proximity to the north jetty. The foreshore lost 1 m of elevation between 2016 and 2017, but the backshore gained 0.4 m and there was deposition on the foredune, especially on the lee slope where an ATV trail crosses the transect at 116 m. Between summer 2017 and summer 2018 up to 1.2 m eroded vertically from the upper beach, and there was additional deposition on the lee slope. In winter 2019 10+ m was eroded vertically from the backshore, which stayed at that elevation through summer 2019.
