Humboldt Coastal Resilience Project

Phase 3 Beach-Dune Transect Profiles

November 2019

Submitted by: Andrea Pickart, Candace Reynolds, US Fish and Wildlife Service and Ian Walker
Arizona State University

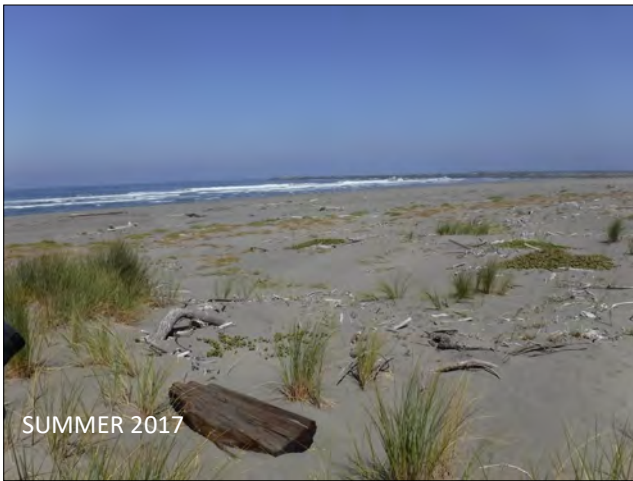
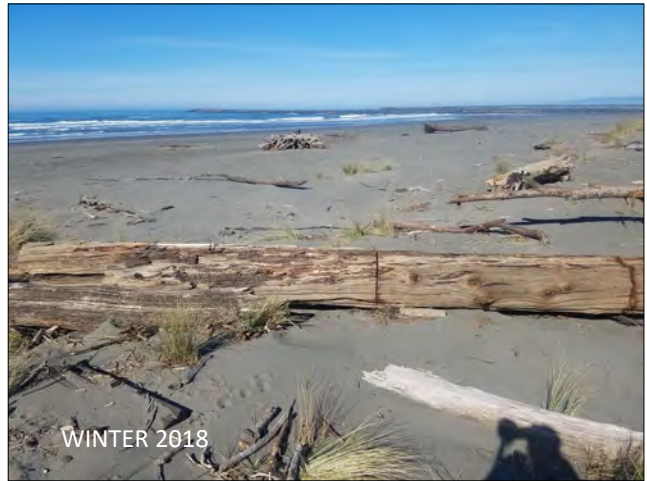
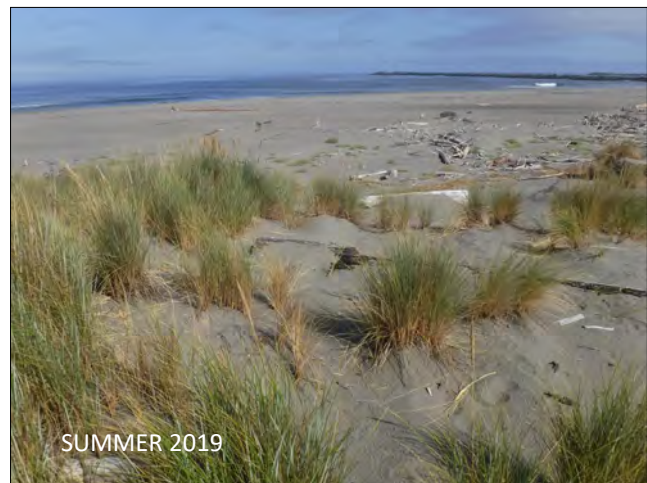
South Spit Transect 54

View northwest along transect at 322 m (incipient foredune)

Notes: This transect intersects the South Spit at its widest point, in an area that vegetation is not managed. The profile demonstrates multiple, relict *Ammophila* foredune ridges from shoreline accretion. Data are not available for winter 2016. From summer 2016 through summer 2017 the backshore increased in elevation up to 1 m, becoming colonized by *Cakile* spp.. In summer 2017 transverse dunes were migrating inland on the beach below the vegetation line, visible as ridges in the profile. The incipient foredune crest also gained in elevation up to 0.5 m between summer 2016 and summer 2017. Between summer 2017 and summer 2019 the upper beach assumed incipient foredune morphology.

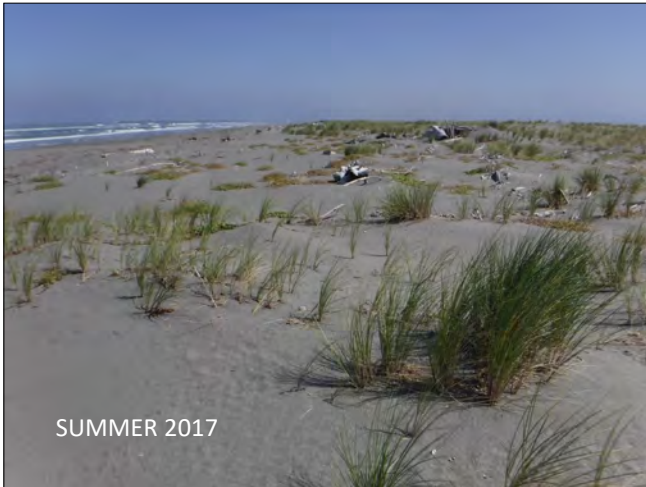
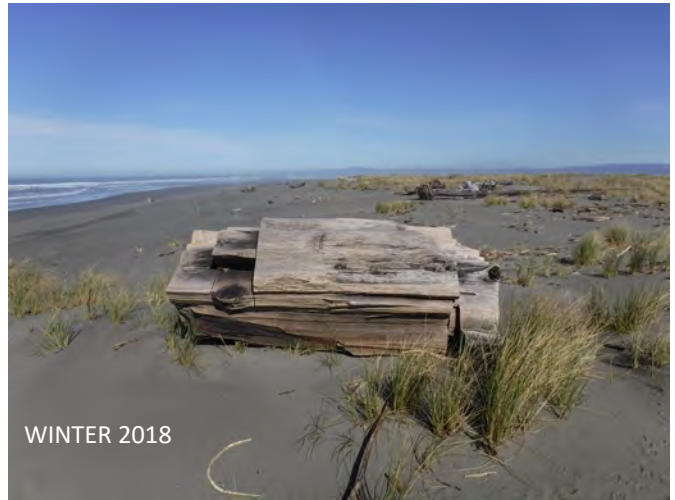
South Spit Transect 55

View north at 480 m (foredune base)

Notes: This transect intersects the BLM's Western Snowy Plover Management Area, which was bulldozed to decrease vegetation cover and is maintained through dozing and/or disking annually. As a result, there is no distinct foredune feature, and the profile in the managed area shows shifting sand, as can be seen in the photographs taken near the vegetation line looking north. In winter 2016 the backshore was steep, but the summer 2016 profile shows backshore deposition of 0.4 m landward of offshore bars. In summer 2017 the backshore gained an additional 0.5 m of elevation. By summer 2018 there was additional minor deposition on parts of the backshore. In winter 2019 the upper beach scarped. The topographic rise at approximately 330 m is the east edge of the restoration area. Bulldozed sand was pushed up at this location. In summer 2017 localized deposition occurred here, where dense vegetation slows winds.

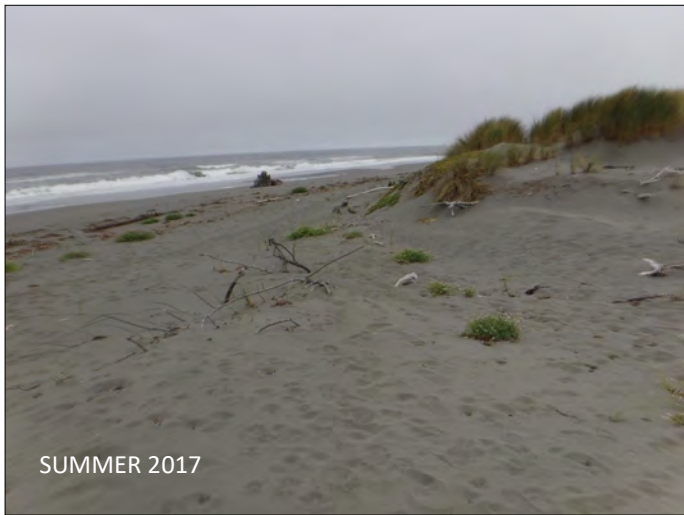
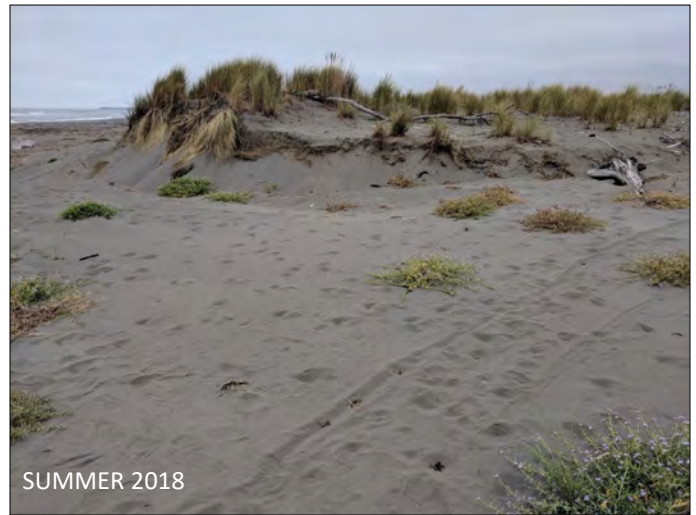
South Spit Transect 56

View northwest along transect at 406 m (foredune)

Notes: Similar to Transect 55, Transect 56 intersects the BLM's Western Snowy Plover management area. There is more of a foredune-like feature in this profile (with a similar feature visible to the north in the photograph which is taken northwest along the transect from the base of the ridge). This feature originated as a wave cut escarpment in winter 2017, and managers did not grade it in 2017. Aeolian deposition occurred on its crest in summer 2017. There was only minor filling of the scarp in summer 2017 and by summer 2018 those sediments had eroded. Similar to T55, there was deposition in summers 2017-2019 at the east end of the management area where dense, unmanaged *Ammophila* begins. In winter 2018 there was erosion on the upper beach and in summer 2019 there was erosion throughout the managed area, which might have been the result of grading.

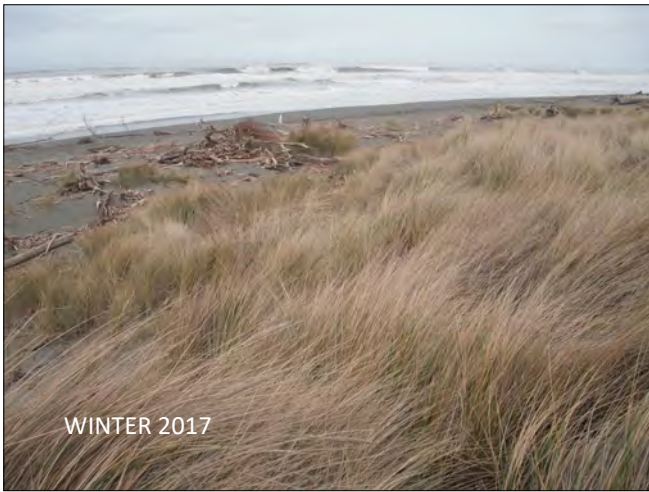
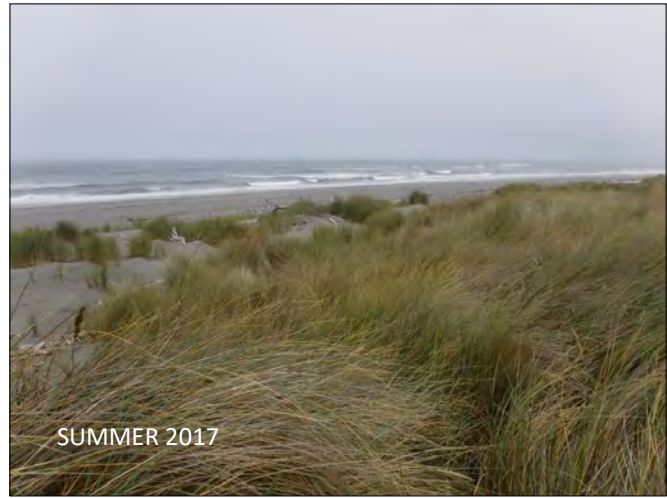
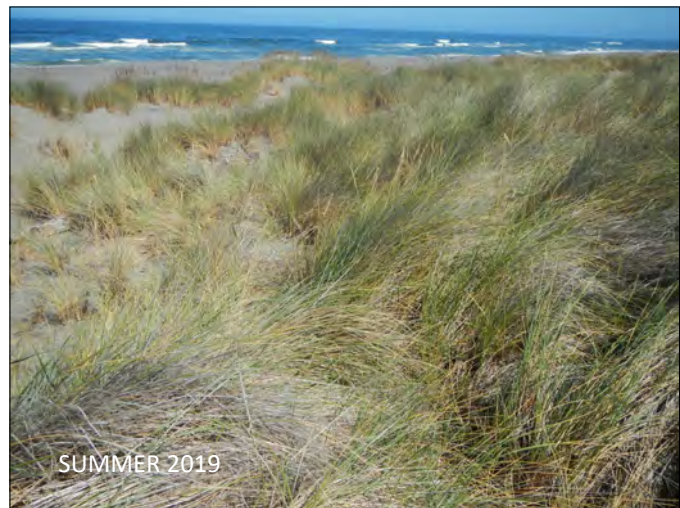
South Spit Transect 57

View northwest along transect at 352 m (foredune crest)

Notes: There are no data available from winter 2016, but the upper beach was relatively steep in summer 2017, and underwent significant deposition by winter 2017. By summer 2017 deposition had also occurred on the incipient foredune, visible in the upper left of the 2017 photograph (taken from the foredune crest northwest along the transect) and in summer 2018 up to 0.4 m was added to the incipient foredune. In summer 2019 the incipient foredune was built up even further. The profile is located in an unmanaged portion of the spit, and two relict *Ammophila* foredunes can be seen east of the present day foredune in the profile. The third ridge to the east is a relict native foredune. This transect spans the entire width of the spit and depicts a stable profile east of the incipient foredune over the three-year period.

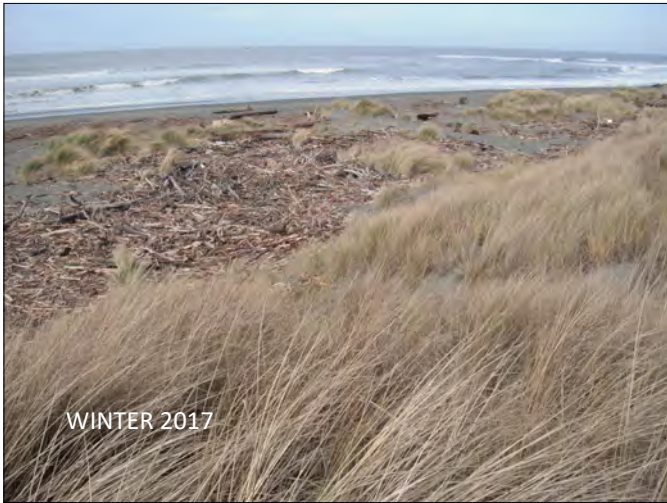
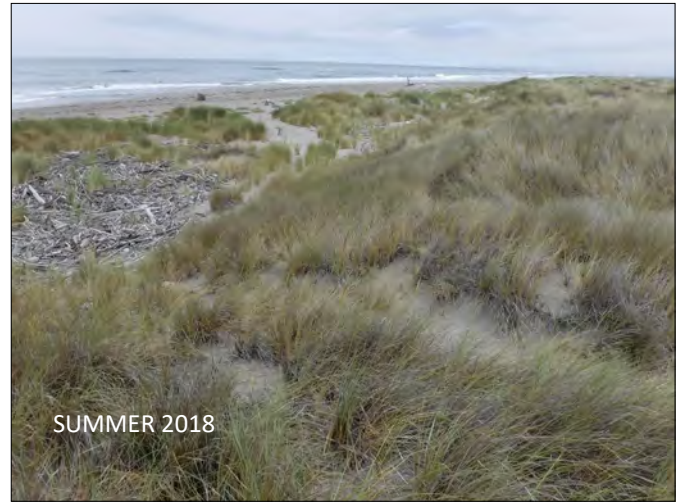
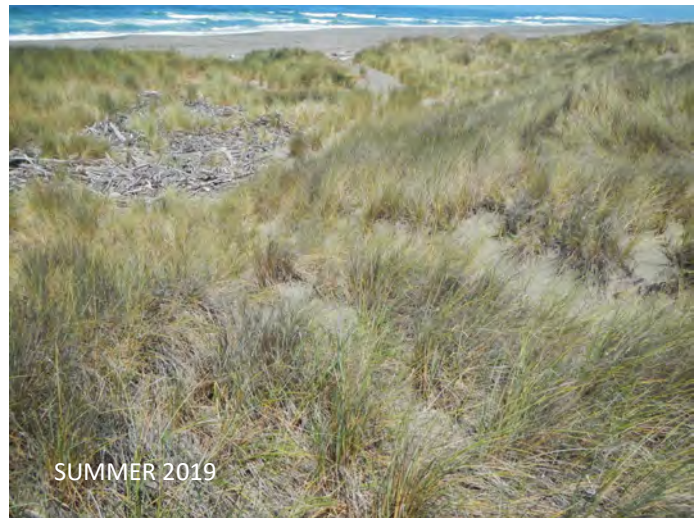
South Spit Transect 58

View northwest along transect at 216 m (foredune crest)

Notes: There are no data available from winter 2016. The transect is located in a portion of the South Spit in which vegetation is not managed and *Ammophila* is dominant. An incipient foredune topography was forming and was scarped during high water events in winter 2017. The scarp emphasized the incipient foredune morphology, and a driftwood deposit was placed in the swale of the incipient foredune, remaining through summer 2019 and visible in the photographs taken from the crest of the foredune and looking northwest along the transect. In summer 2017 the upper beach and incipient foredune did not change significantly but by summer 2018 additional deposition had occurred on the incipient foredune, with the morphology shifting in summer 2019 into transverse dunes climbing up the incipient foredune.

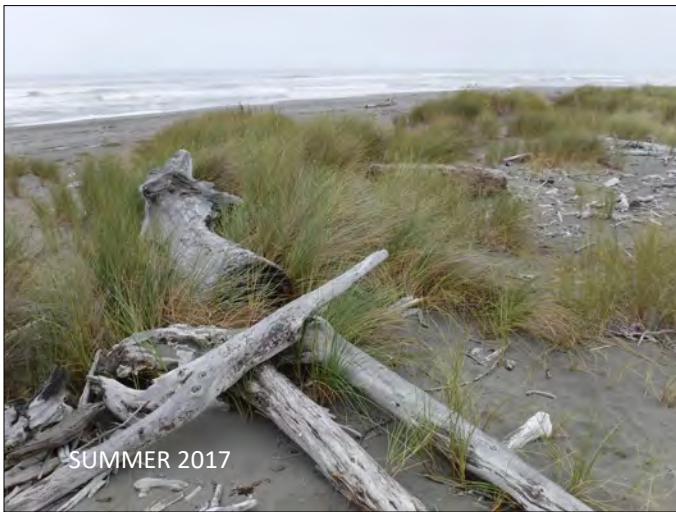
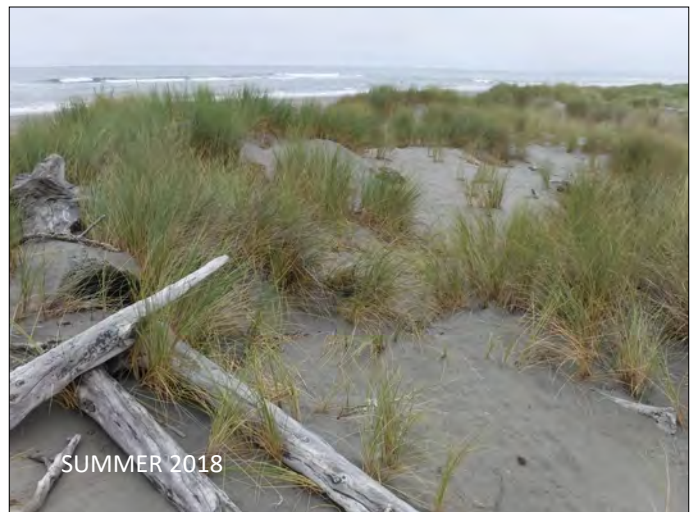
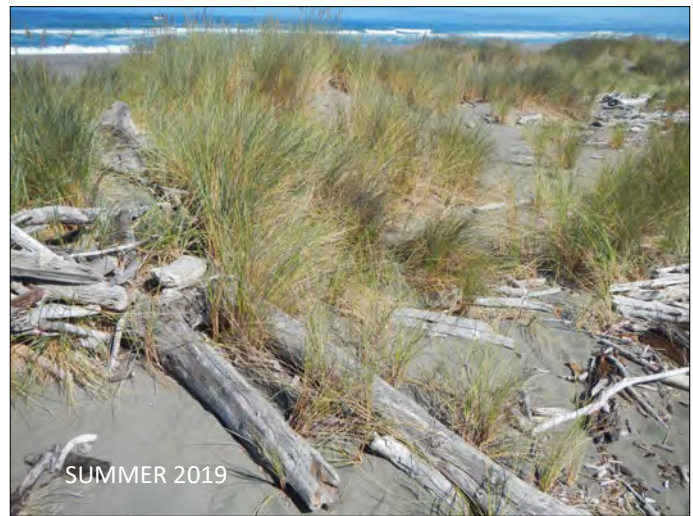
South Spit Transect 59

View northwest along transect at 170 m taken at foredune base

Notes: There are no data available from winter 2016. The profile is located on a portion of the South Spit that does not receive vegetation management. Multiple relict *Ammophila* foredunes are present reflecting accretion events. Between summer 2016 and winter 2017 the western edge of the incipient foredune scarped, but by summer 2017 a scarp-fill ramp had formed as can be seen in the photograph looking northwest along the transect from the incipient foredune towards the backshore. The beach regained elevation levels present in summer 2016. By summer 2019 the incipient foredune had gained in elevation and breadth (deposition can be seen in right rear of summer 2019 photograph).

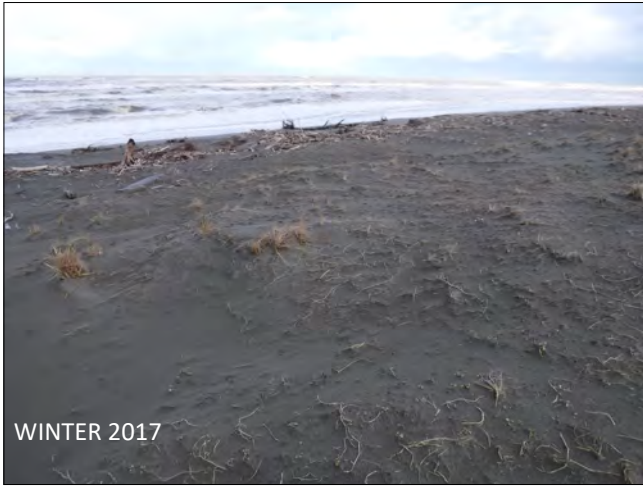
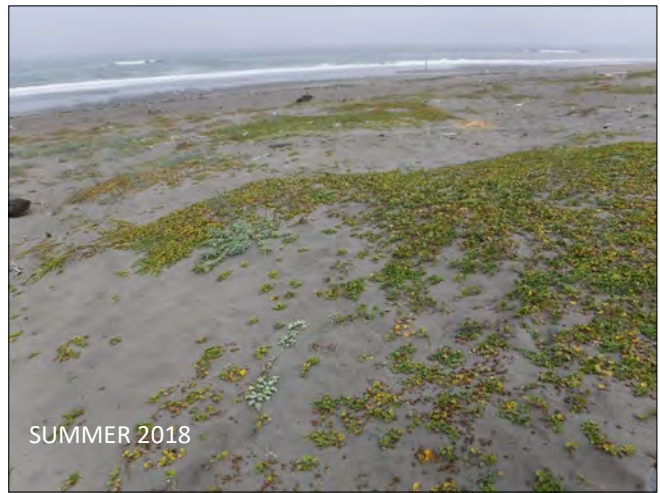
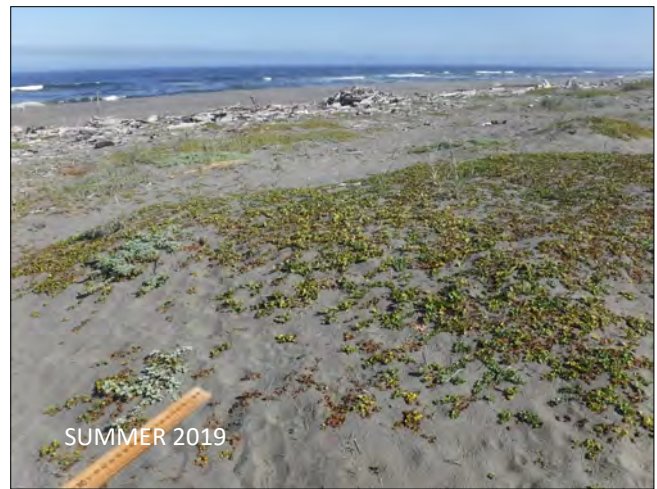
South Spit Transect 60

View northwest along transect at 138 m (foredune crest)

Notes: This portion of the South Spit has been restored by the manual removal of *Ammophila* and vegetation is native. The profile exhibited normal seasonal changes from winter 2016 through summer 2017 with a relatively stable vegetated backshore and established foredune. The peak at 180 m was a large stump. In winter 2017 the backshore was eroded up to the base of the established foredune resulting in a vertical loss of up to 1.2 m. By summer 2018 there was only minimal rebuilding. Further scarping occurred in winter 2019. Over the three year period, there was some sediment movement on the established foredune, with 0.4 m of deposition at 126 m.

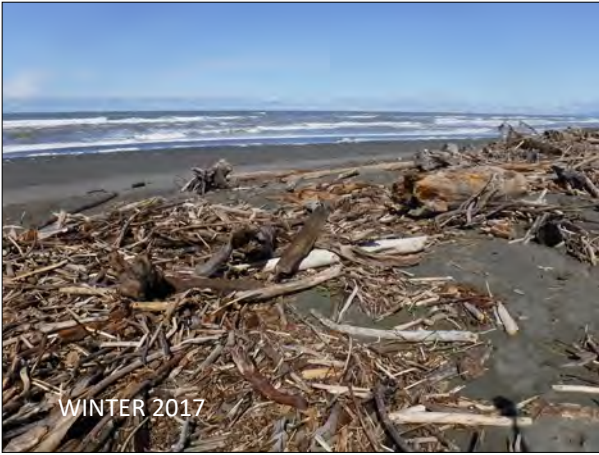
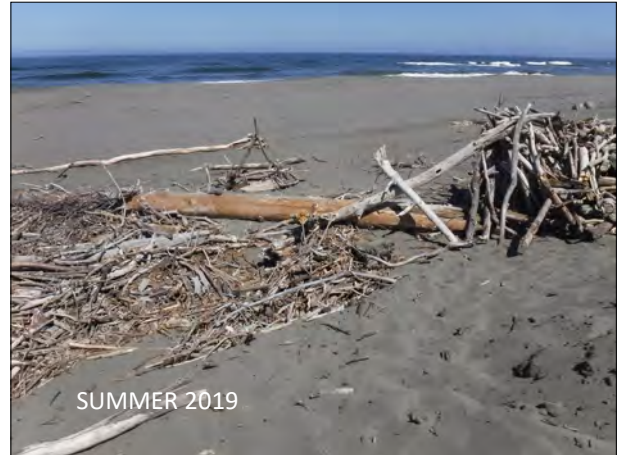
Table Bluff Transect 61

View northwest at 100 m (foredune base)

Notes: This transect is located where the dune system narrows at the base of Table Bluff and restoration to native dune mat has occurred.

In winter 2019 this feature was scarped, losing 1 m vertically. The vegetated backshore west of 76 m has experienced deposition over the three year period. The greatest deposition (0.5 m) occurred west of the vegetation line. Large wood was deposited in this area in winter 2017. The newly deposited sand from summer 2019 is visible in the photographs taken from near the vegetation line looking northwest along the transect.

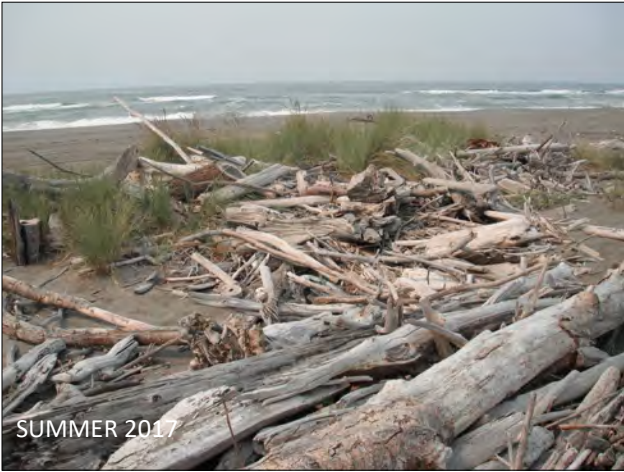
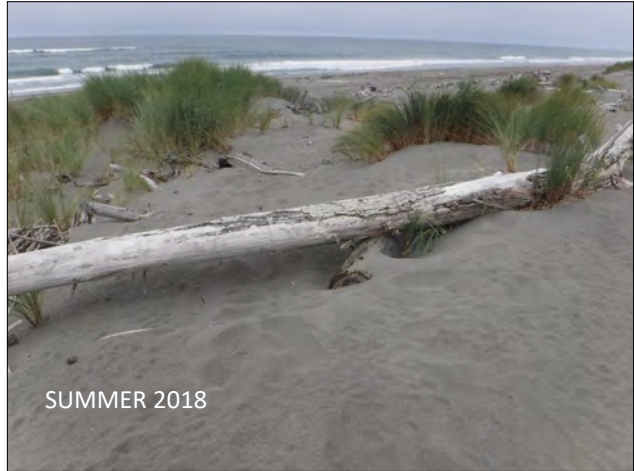
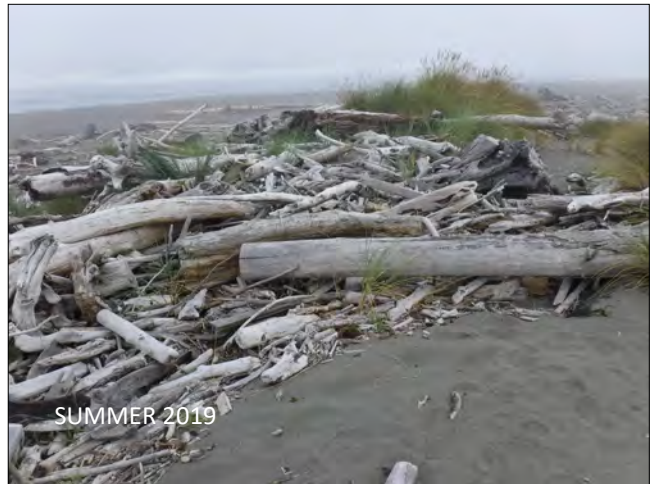
Eel River Wildlife Area Transect 62

View northwest at 246 m (foredune base) looking towards incipient foredune

Notes: The transect is located on the north barrier of the Eel River in an unrestored system stabilized by *Ammophila*. The backshore had been scarped at 276 m prior to the winter 2016 survey. By the summer 2016 survey, scarp-fill ramping had occurred. In winter 2017 high water events deposited a large amount of wood on the backshore. All points from 258-268 m were taken on wood and create the peaks in the graph. In Summer 2017 sand had been deposited among the wood and *Ammophila* was increasing, creating something of a wood incipient foredune. By summer 2018 most of the wood had been buried by sand, although the elevation had increased by only approximately 0.2 m. In winter 2019 additional wood was deposited and by summer deposition had occurred. The photograph is taken from the base of the established foredune looking northwest along the transect, showing the new incipient foredune.

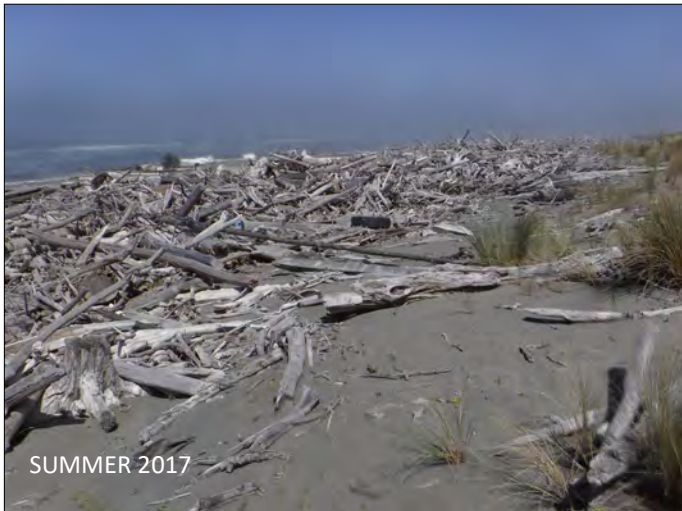
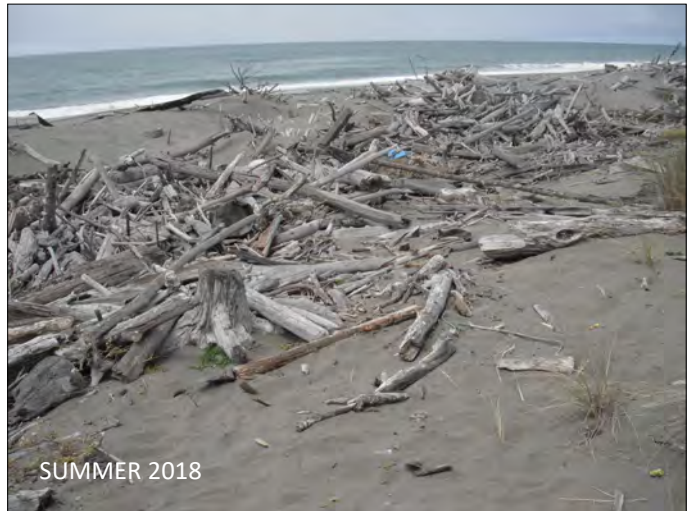
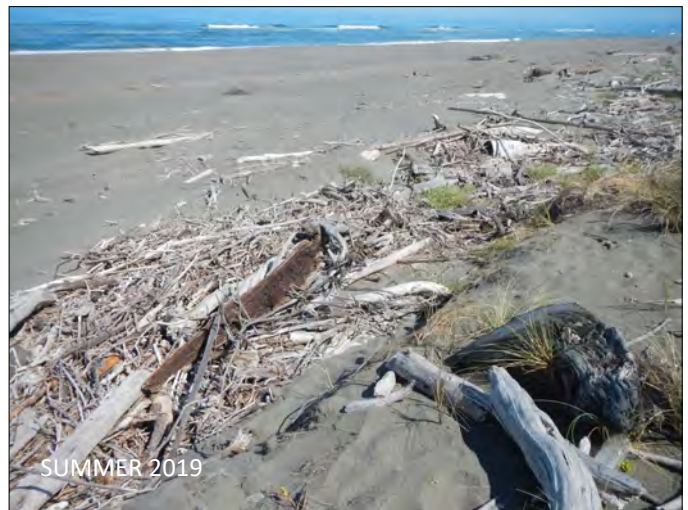
Eel River Wildlife Area Transect 63

View northwest at 242 m (foredune base) looking towards incipient foredune

Notes: The transect is located on the north barrier of the Eel River in an unrestored system stabilized by *Ammophila*. Data from winter 2016 are not available. In winter 2017 a large amount of wood was deposited on the upper beach, and all points from 248-270 m were taken on top of wood. In summer 2017 the backshore was virtually unchanged, and the wood deposit can be seen in the left photograph taken from the base of the foredune looking northwest along the transect. By summer 2018 sand had been deposited on the incipient foredune, burying a portion of the wood deposit (see photos above). In winter 2019 a significant scarping event occurred on the upper beach, with some recovery through deposition in summer 2019. The profile is distinctive in having broad foredune swale between the relict and present day foredunes.

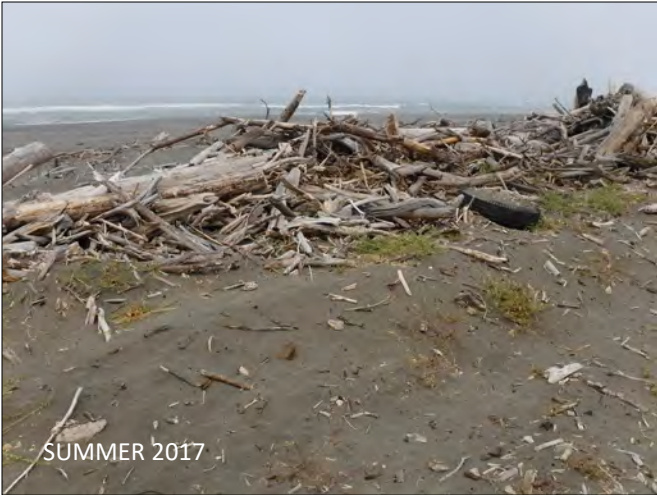
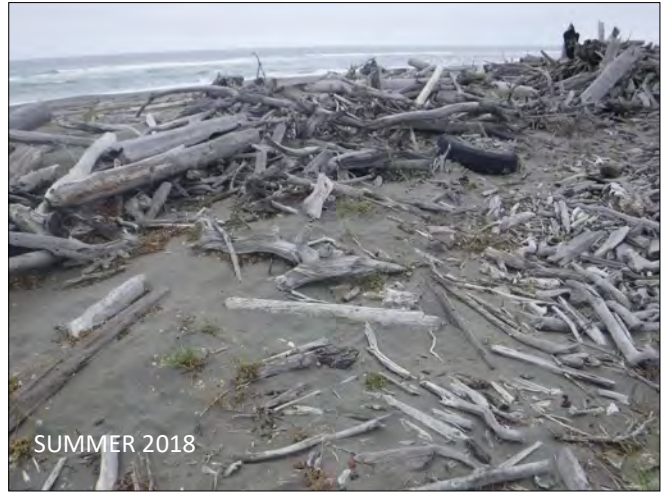
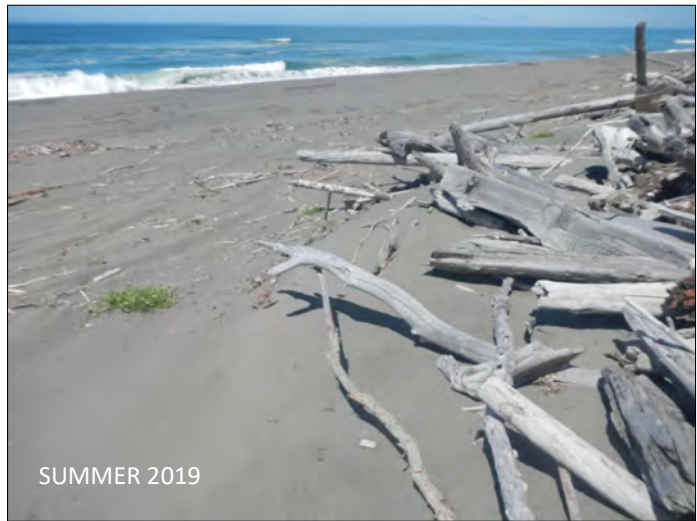
Eel River Wildlife Area Transect 64

View northwest at 230 m (foredune base) looking towards incipient foredune

Notes: The transect is located on the north barrier of the Eel River in an unrestored system stabilized by *Ammophila*. Data from winter 2016 are not available. In summer 2016 a wood deposit was present in the vicinity of 282 m. In winter 2017 during high water events the beach eroded and a 1+ m vertical loss occurred in that vicinity. At that time a large amount of wood was deposited higher up on the beach up against the base of the foredune. By summer 2017 the wood deposit had moved lower on the beach and was higher in elevation. Points at 236 to 240 m were taken on wood. Sand deposition had occurred within the wood, forming a distinctive incipient foredune-like feature, visible in the photograph taken from the base of the foredune and looking northwest along the profile. In winter 2019 there was significant erosion of the upper beach, causing 2 m of vertical loss. In summer 2019 approximately half of the elevation was regained and the incipient foredune received depo-

sition that covered much of the wood. Similar to the previous transect, the profile is distinctive in having a broad foredune swale between the relict and present-day foredunes.

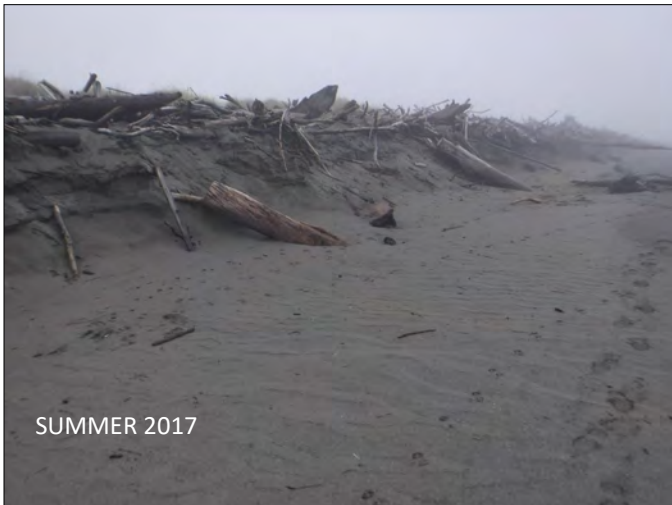
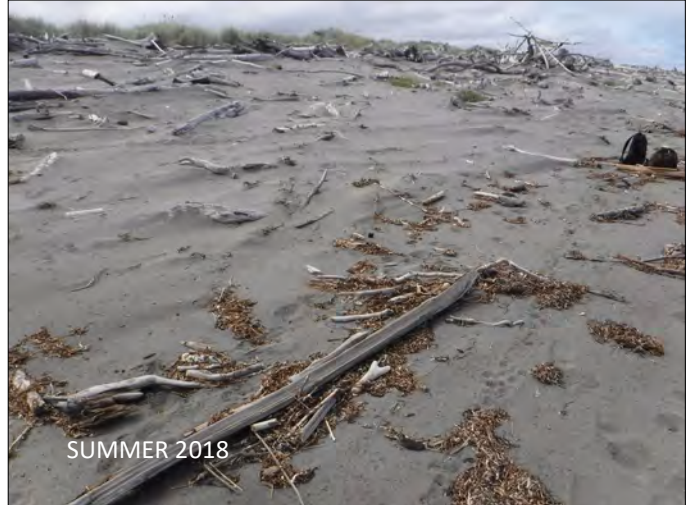
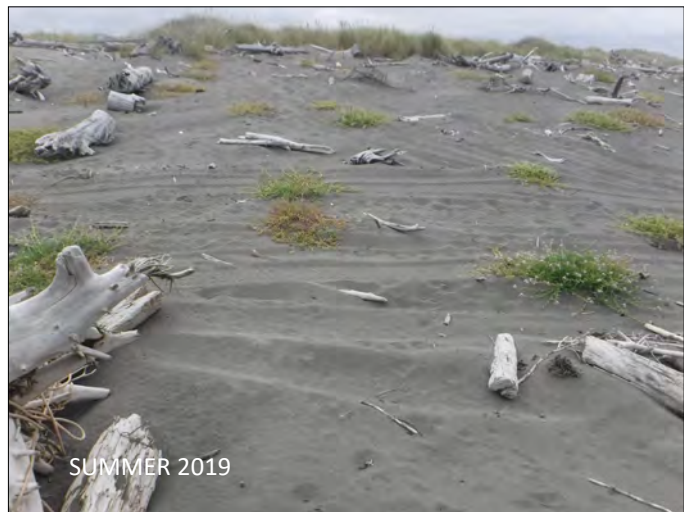
Eel River Wildlife Area Transect 65

View southeast at 384 m (upper beach) looking towards incipient foredune

Notes: This transect is located near the dynamic spit at the mouth of the Eel River and exhibits high variability on its seaward side. Topographic data from winter 2016 are not available. The transect passes through a relict foredune scarp associated with mouth migration at 132 m. In summer 2016 the beach was wide and the backshore extended west to approximately 468 m. A wood deposit was present from 372-396 m. In winter 2017 during high water events the foreshore was eroded up to 3 m vertically, and the backshore retreated landward to 396 m leaving a very steep beach. The wood deposit remained, and sand infilling occurred, forming an incipient foredune-like morphology, with a net rise in elevation of up to 0.5 m. By summer 2017 further erosion had scarped and removed the western portion of the wood deposit/incipient foredune, as seen in the photo taken from the backshore and looking southeast back along the transect towards the scarp. Between summer 2017 and summer 2018 there

was almost 1 m of deposition that filled the scarp (see photo on right). In winter 2019 there was scarping of the upper beach, with infilling the following summer.

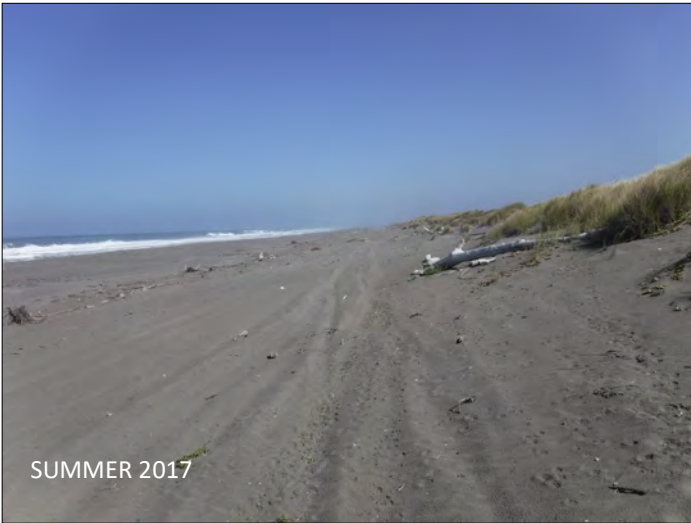
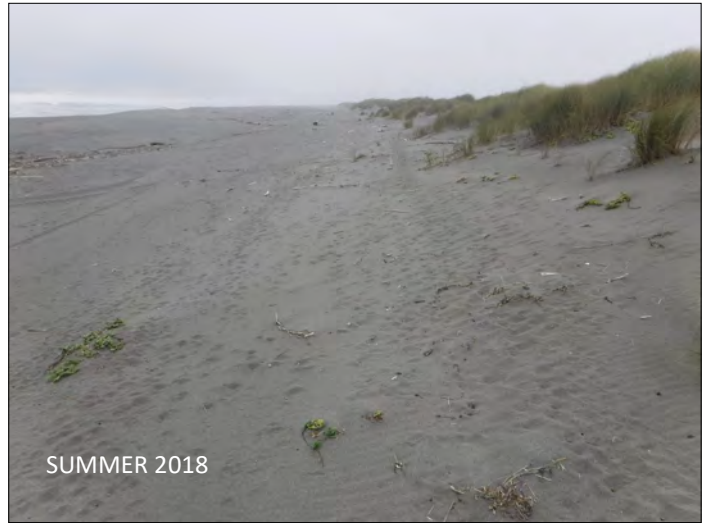
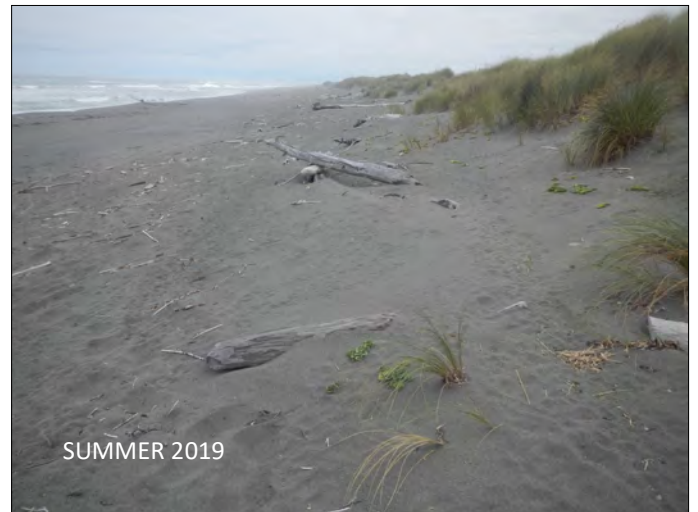
Eel River Estuary Preserve Transect 66

View north at 210 m (foredune base)

Notes: This transect is located on the Eel River southern barrier, south of the true spit, and consists of a dynamic beach and a narrow peaked *Ammophila* foredune in front of a low backdune area that slopes down to the estuary. The foredune was scarped in winter 2016 prior to the survey, creating a 2.0-2.5 m drop in elevation. By summer 2016 the foredune had eroded back an additional 0.4 m horizontally, while the backshore regained approximately half of the elevation lost, forming a berm. By the following winter the berm had eroded, but a ramp had formed, creating the smoothly sloping rather steep backshore visible in the photo (taken from the base of the foredune looking north). By summer 2018 the berm had partially rebuilt on the upper beach. By summer 2019 the berm was no longer present and there was a continuous slope from the upper beach to the foredune. The profiles suggests a dynamic beach with high rates of annual volumetric change.

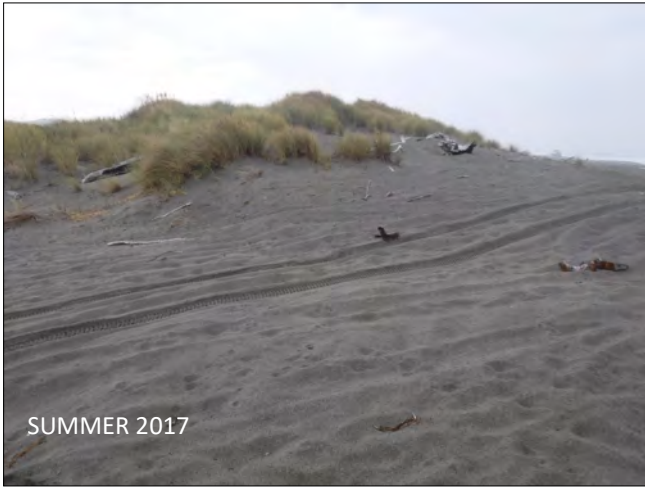
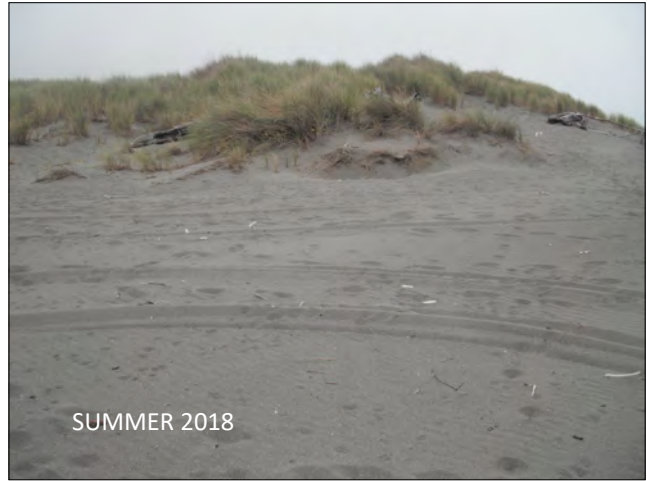
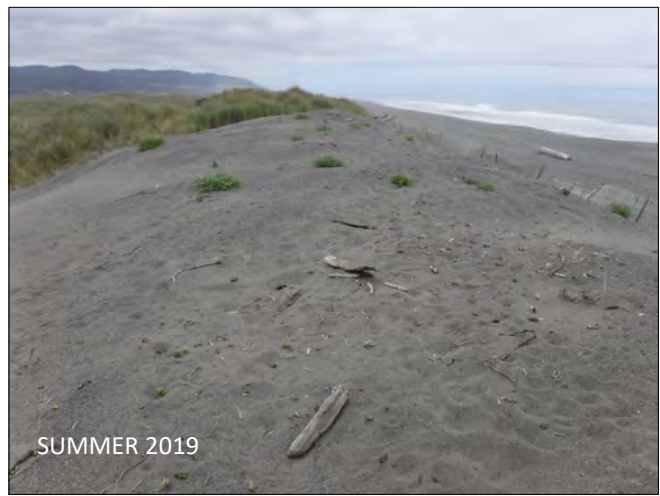
Eel River Estuary Preserve Transect 67

View south at 102 m (foredune crest)

Notes: This transect was placed within a foredune breach that was overwashed during high water events. The transect was placed perpendicular to the shoreline (rather than parallel with predominant wind) in order to include the overwash lobe. The lack of foredune is apparent from the initial low profile. Overwash occurred in winter 2016, but was followed by a large depositional event on the beach which led to aeolian deposition at the position of the foredune in summer 2016. High water events in winter 2017 again eroded 0.6 m of the aeolian deposits through overwashing, but built a 2 m beach berm present at the time of the winter survey. Subsequent aeolian deposition recurred in the region of the foredune, but to a lower elevation than the previous year. The abrupt peaks in the profiles at 110 and 116 m represent a large piece of driftwood that moved during winter storms. The winter 2017 beach berm persisted into summer and can be seen on the photograph taken on the foredune crest looking south. There was only minor deposition by the

summer 2018 survey. In summer 2019 the foredune was rebuilt by recontouring sand in the overwash fan and creating a new foredune. There was no erosion of the foredune in winter 2019.

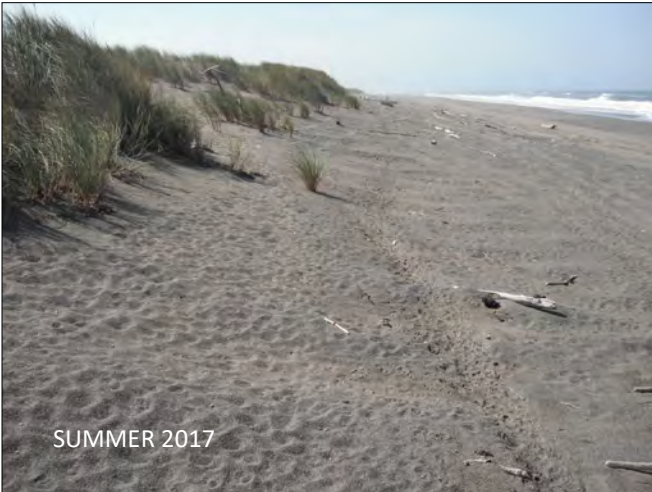
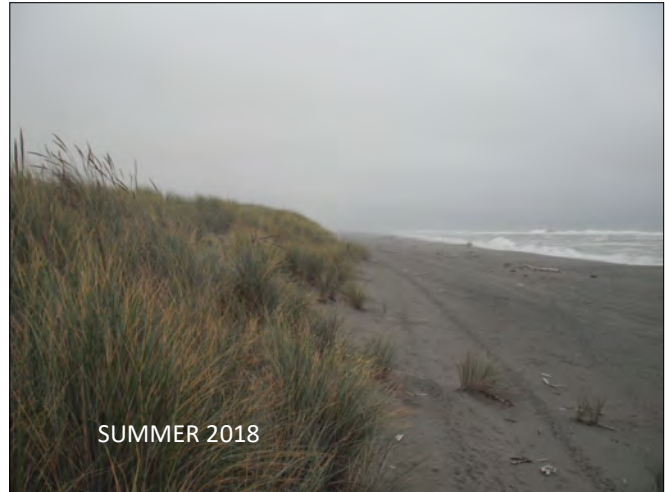
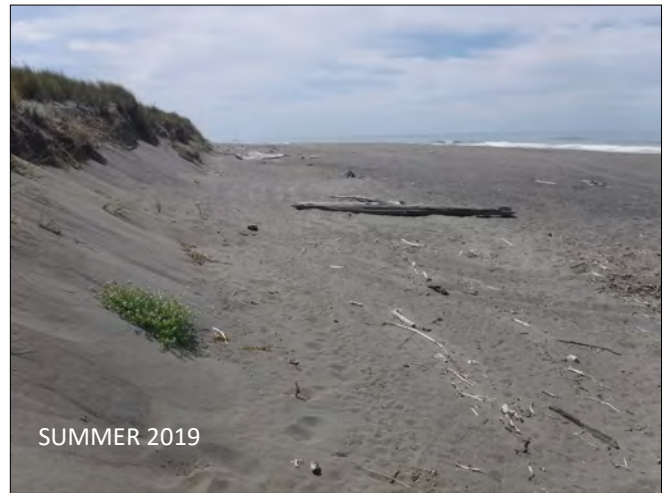
Eel River Estuary Preserve Transect 68

View south at 316 m (foredune base)

Notes: The transect intersects the dune system at one of its widest points, and the profile depicts multiple relict *Ammophila* foredunes. The present-day foredune had been recently scarped, with up to 3.0 m of elevation loss, at the time of the 2016 survey. Between winter 2016 and summer 2017 a scarp-fill ramp gradually reconnected the backshore to the foredune crest, resulting in deposition on the stoss and lee face of the foredune by summer 2017. The foreshore lost 1 m of elevation in winter 2017 and regained only part of it in summer 2017, with additional loss of up to 2 m by summer 2018. Deposition occurred at the base of the foredune prior to the winter 2018 survey, but had been removed by summer 2018. Scarping of the foredune in winter 2019 resulted in a steep stoss face that persisted into summer 2019.

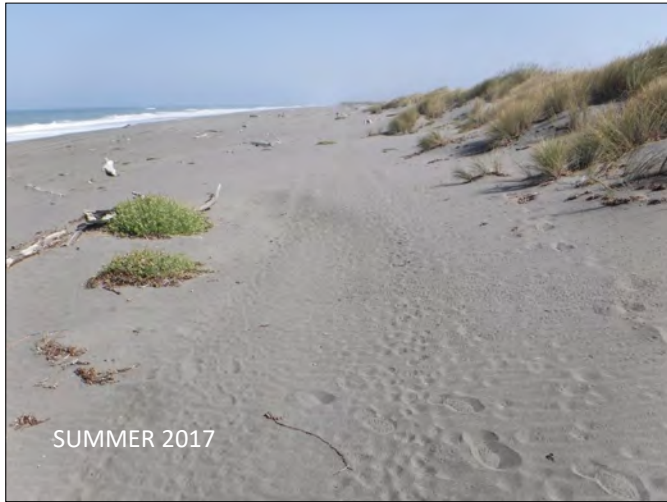
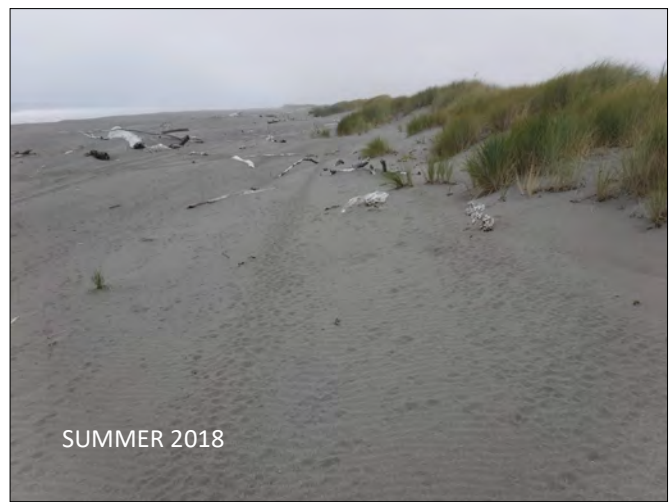
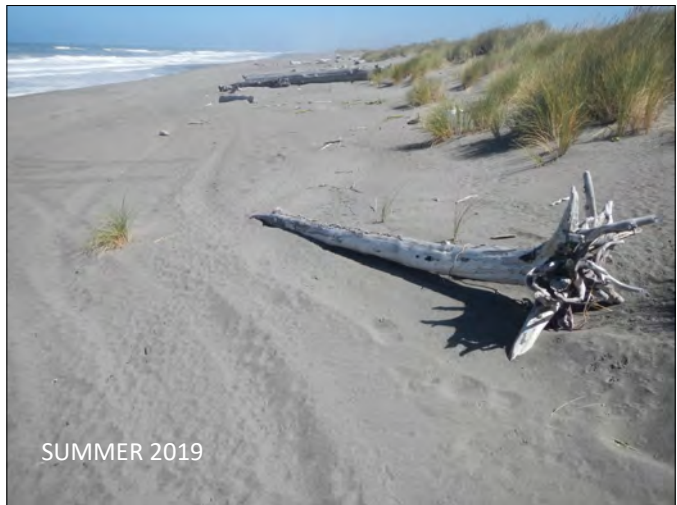
Eel River Estuary Preserve Transect 69

View north at 294 m (foredune base)

Notes: The profiles describe a peaked *Ammophila* foredune and foredune swale backed by a relict foredune, and a stable back-dune area sloping down to the estuary. The foredune was scarped during winter 2016 prior to the survey. Between winter 2016 and summer 2016 significant deposition occurred in the mid to lower beach (up to 1+ m) while the beach at the base of the scarp changed little. By winter 2017 the backshore had experienced deposition, which continued through summer 2017, resulting in a net gain of 1+ m. The resulting gently sloping backshore can be seen in the photograph taken from the transect and looking north (above left). However, the foreshore stayed up to 2.4 m below summer 2016 levels. In summer 2018 the backshore received up to 1 m of deposition. Between winter and summer 2019 the upper beach eroded, losing up to 2.5 m vertically.

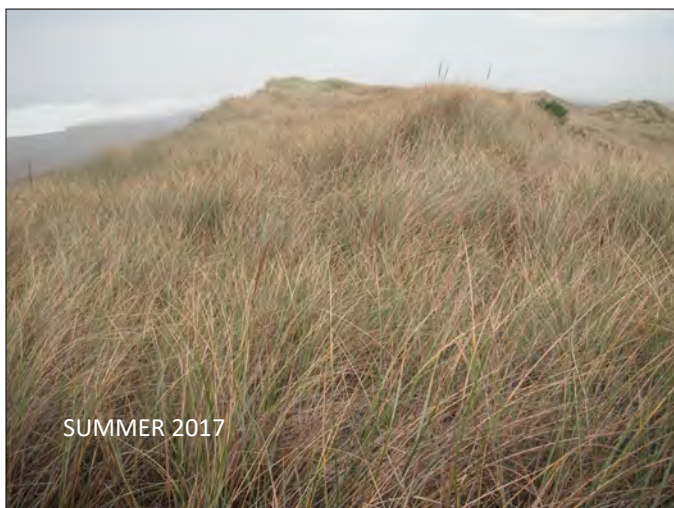
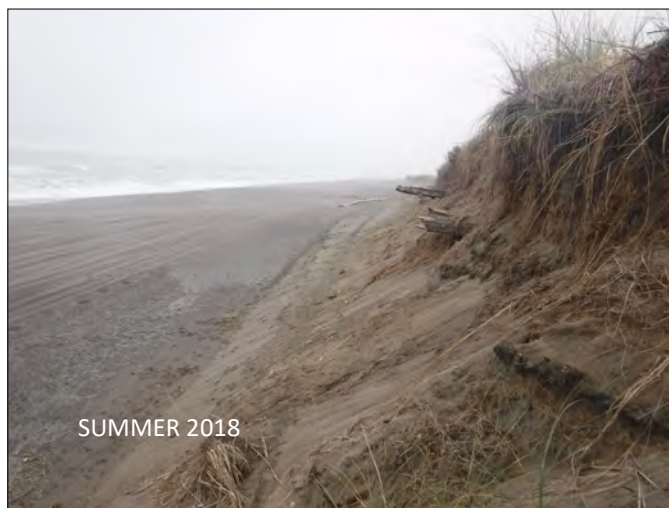
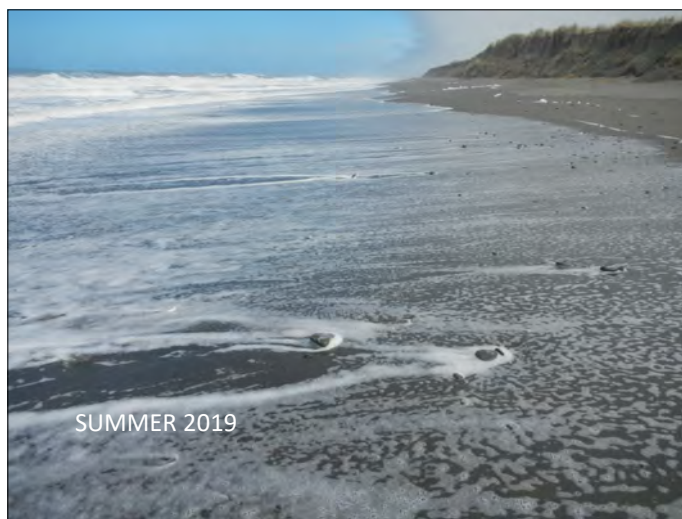
Eel River Estuary Preserve Transect 70

View north at 256 m (foredune crest, left and scarp, right) and below at 252 m

Notes: The transect is located near the south end of the barrier where the dune system narrows just north of a fore-dune breach area. The *Ammophila* foredune was scarped during winter 2016 prior to the survey. By summer 2016 additional scarping had occurred and the foreshore lost 1.5 m of elevation. A Scarp-fill ramp was created during winter and summer 2017. Between the summer 2017 and winter 2018 survey a major scarping event eroded the foredune 10 m horizontally (see photos above). By the summer 2018 survey the scarp had further eroded at the base but up to 1 m of sediment was deposited on the upper beach, forming a bench. Between winter and summer 2019 the foredune was breached and eroded entirely (see photo to right).

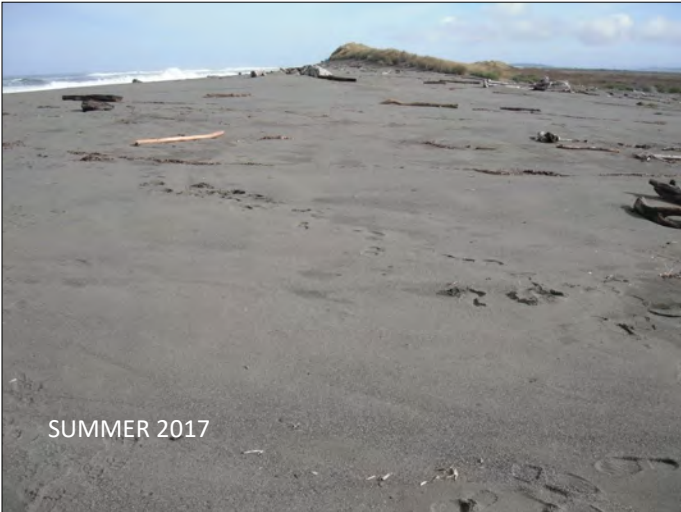
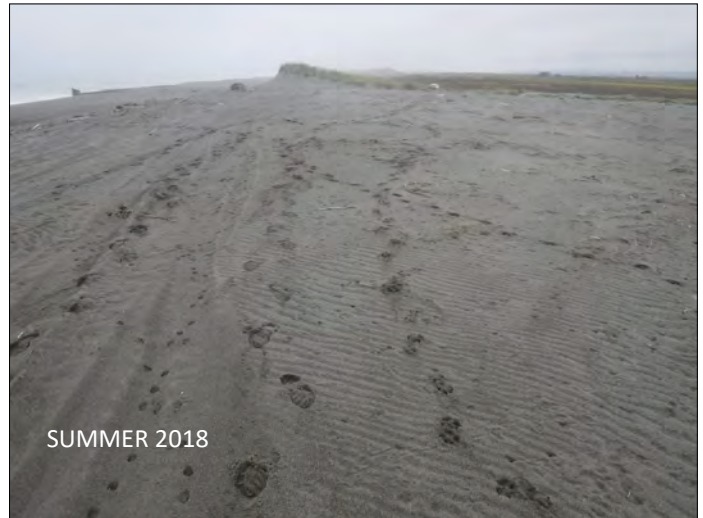
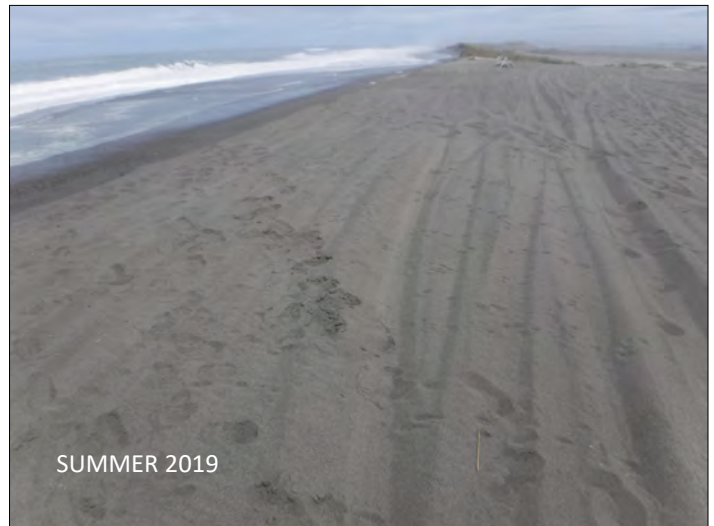
Eel River Estuary Preserve Transect 71

View north at 166 m (overwash area)

Notes: The transect passes through a large foredune breach area that is subject to washover during high water events. The profile describes a berm that is primarily influenced by waves in the winter months and modified by aeolian action in the summer, and is translating inland. Extensive beach erosion occurred in winter 2016 after the survey, creating a steep berm in summer 2016. Additional erosion occurred on the seaward side of the berm in winter 2017, but deposition of 0.3 m occurred on the crest of the berm. Minor deposition by aeolian processes occurred in summer 2017 at the crest. The berm eroded back 30 m between summer 2017 and winter 2018, but deposition by summer 2018 replaced some of it, leaving a swale in the area of the former crest of the berm. Between winter and summer 2019 there was major erosion of the berm, which retreated horizontally and lost up to 2 m vertically.
