Humboldt Coastal Resilience Project

Phase 3 Beach-Dune Transect Profiles

November 2019

Submitted by: Andrea Pickart, Candace Reynolds, US Fish and Wildlife Service and Ian Walker
Arizona State University

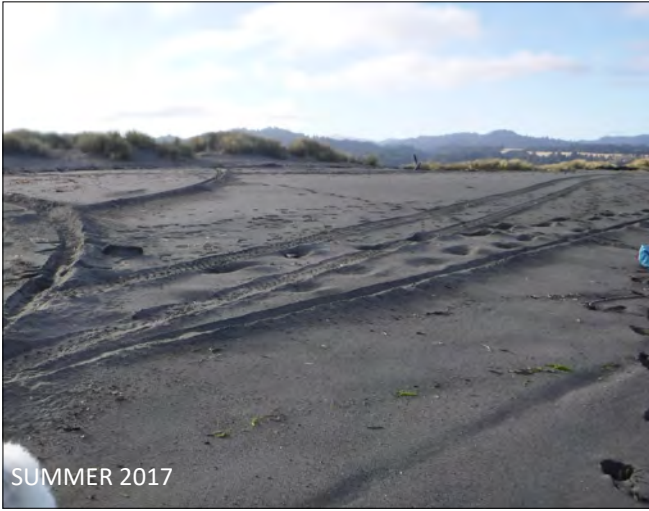
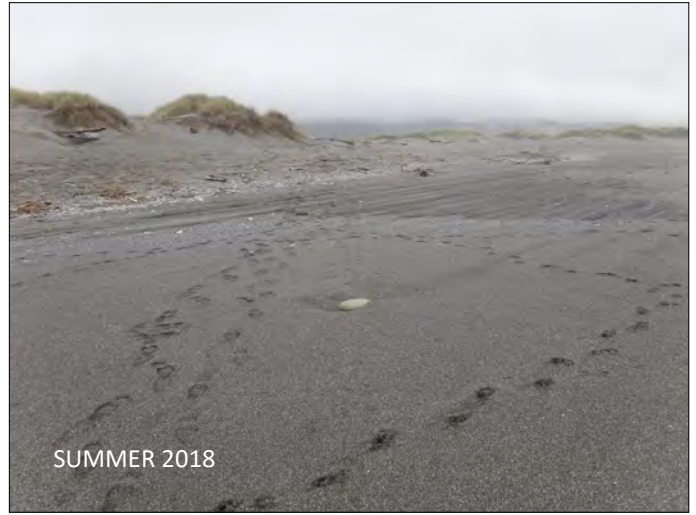
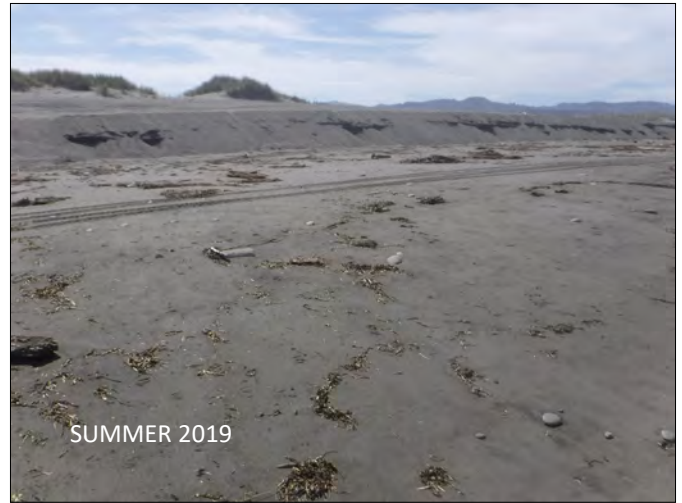
Eel River Estuary Preserve Transect 72

View southeast at 190 m (upper beach) looking southeast towards breach

Notes: The transect passes through remnant vegetated areas between narrow breach areas that are subject to washover during high water events. The former foredune area is within the washover and is now a berm that is primarily influenced by waves in the winter months and modified by aeolian action in the summer. The transect skirts the edge of the remnant foredune to the north as can be seen in the photograph above taken southeast along the transects from the upper beach. As in Transect 71 to the north, there was significant beach scarping between winter and summer 2016 forming a berm. The area was overwashed in winter 2017, and the berm was reshaped to a gradually sloping beach. Some aeolian deposition occurred during summer 2017, moving the crest of the berm landward. Between summer 2017 and winter 2018, the crest of the berm eroded 40 m horizontally and lost 1.0 m of elevation. Up to 0.5 m was deposited in the overwash lobe. Additional erosion of the berm occurred between winter and summer

mer 2019. The berm has translated significantly inland since monitoring began in 2016.

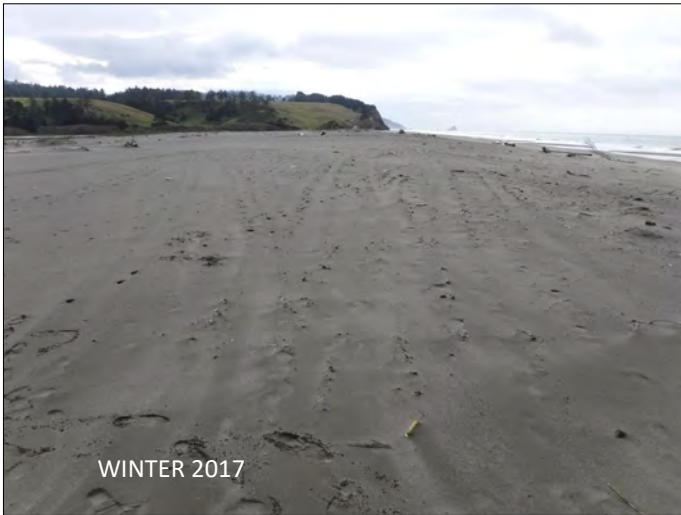
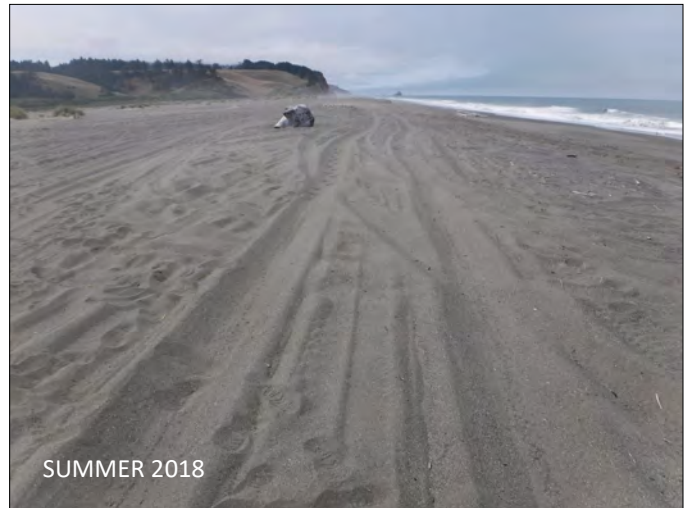
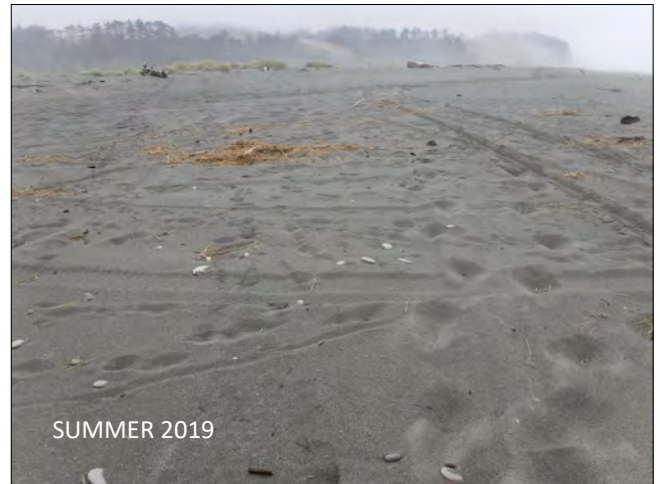
Russ Property Transect 73

View south at 296 (upper beach)

Notes: The transect is located within the long, continuous overwash area north of Centerville Beach. Similar to washovers to the north, the profile describes a berm that is primarily influenced by waves in the winter months and modified by aeolian action in the summer. Extensive beach erosion and overwash occurred in winter 2016 after the survey, creating a steep beach scarp in summer 2016 that was 30 m landward of the former berm crest, but adding 0.2 m of elevation to the overwash fan. The area was again overwashed in winter 2017, which filled in the scarp and added an additional 0.2 m to the overwash fan. In summer 2017 there was a large pulse of sediment from intertidal bars welding to the beach, and additional aeolian deposition occurred on the berm crest. During 2018 the bar was removed and the profile returned to conditions similar to winter 2017. In winter and summer 2019 erosion occurred on the berm, causing further retreat. The peak in the graph at 198 m is an *Ammophila nebkha* that has continued to trap sediment.
